1/4 Cor. between Sections 4 & 5

T31S R6W WM

C.S. File No. 41/338A

To the County Surveyor
Roseburg, Oregon

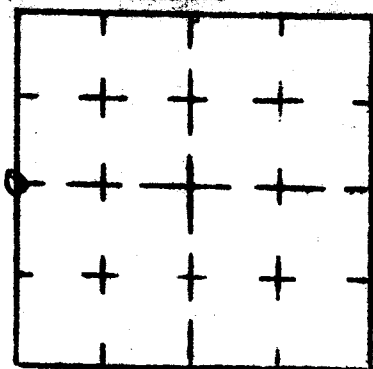
How was the corner found and identified?

By RANDOM LINE North from
SW corner Section 5

Quadrant	NE	NW	SE	SW
Species & size			GONG	Laurel
Dist. & Bearing From Corner				$\frac{1}{4}$ S 8 distinct
Condition of Scribe or Scar				distinct.
Original or Resurvey BT				Original
Appearance of BT				Down
Tags, Marks, Etc. on BT				None

Other remarks Down Laurel root hole plain - Reset corner with
iron pipe using center of stump hole and recorded distance
& bearing - Put in 2 NEW B.T.'s which bear from corner as
follows: Fir 14" N33°W 3.4 ft. Scribed $\frac{1}{4}$ S 5 T 31 S R 6 W W M B T
Fir 14" S48°10'E 6.8 ft. " $\frac{1}{4}$ S 4 T 31 S R 6 W W M B.T.
