T 24 S R 8 W

COR. 15/14
SECS. 22/23

Section 15/14
22/23

TWP 24 S Rge 8 W

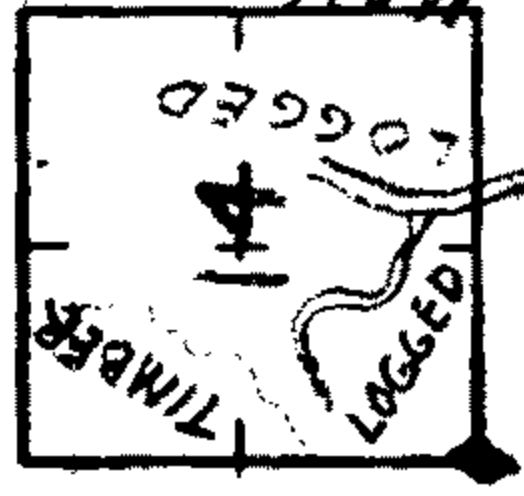
How was corner identified? 2 original B.T.'s

Condition of corner: Very bad shape - should be removed before it gets destroyed.

Quadrant	NE	NW	SE	SW
Species & Size	FIR	FIR		FIR
Dist. & Bearing	N4°E 25kfs	N15°W 35kfs		
Condition of Scribe	POOR	NEEDS CHOPPED OUT		
Original of Resurvey	ORIGINAL	ORIGINAL		ORIGINAL
Appearance of B.T.	STUB	SNAG	GONE	DOWN
Tags, Marks, etc.		YELLOW TAG
