REPLACEMENT OF DAMAGED BEARING TREE

1/4 Corner Sections 14 and 13 Twp. 20 S. -R. 8 W.

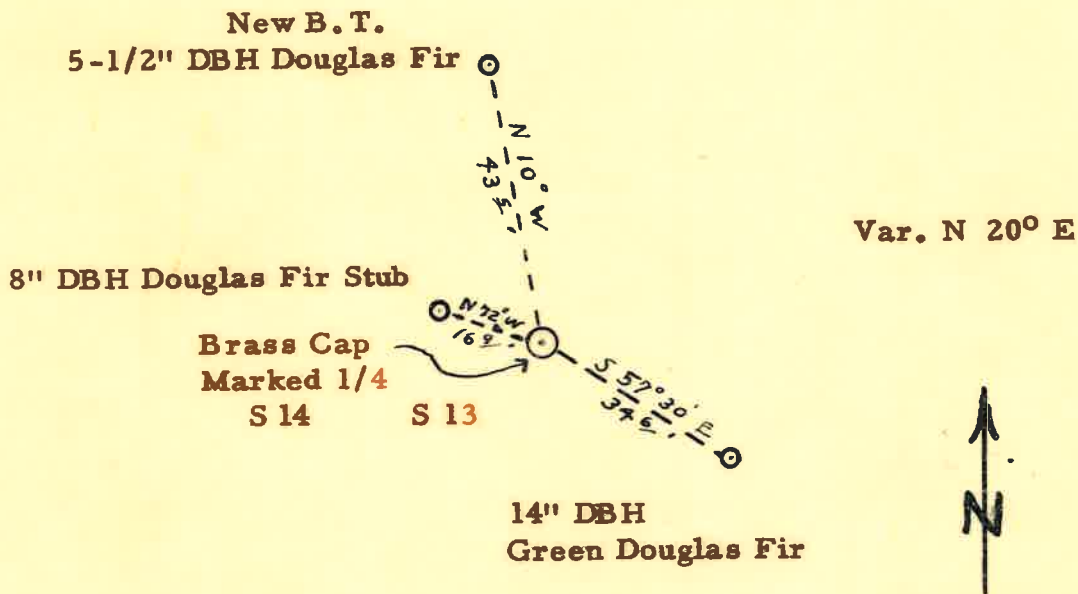
Having had a report from the United States Bureau of Land Management Unit Forester that this corner had been damaged in the course of slash burning, I inspected it on June 15, 1959. I found the following:

- (1) A Brass Cap marked
- (2) Section 14 B. T.: A Douglas Fir Stub 3' high  
Approximately 8" DBH (Burnt Down)  
N 72° W 16.9 ft. Distant
- (3) Section 13 B. T.: A Green Douglas Fir, Scorched, But should survive in good shape.  
14" DBH  
S 57° 30' E 34.6 ft. Distant

I replaced the destroyed B. T. by:

A Douglas Fir                      5-1/2" DBH  
 N 10° W                      43.5 ft. Distant  
 Marked: 1/4 S 13 B. T.
