July 14, 1959

Resetting of Damaged 1/4 Corner

Section 27 Twp. 21 S., R. 8 W., W.M., Douglas County, Oregon
34

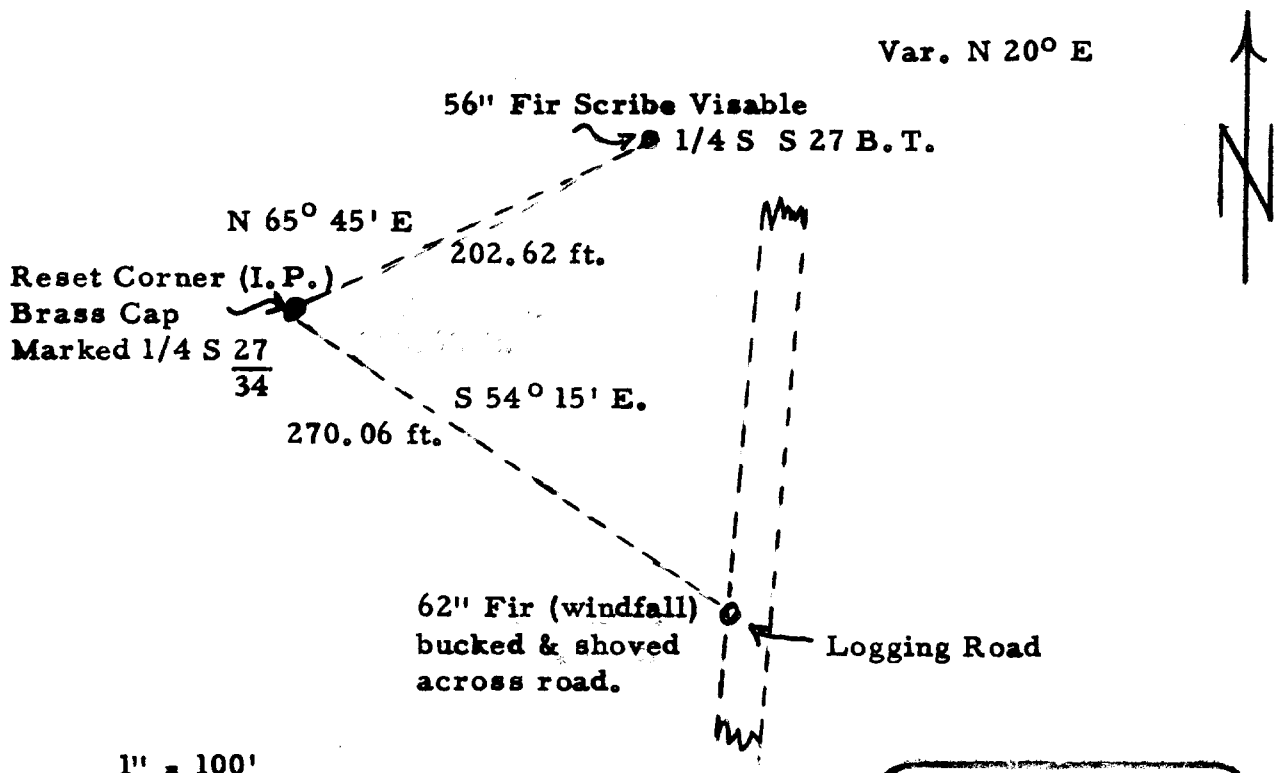
I found the brass capped iron pipe marked 1/4 S 27 at approximately the loca-
34
tion it was before being disturbed by tractor operations. It was pulled loose from the ground and the pipe was bent.

I found the 56" Fir and a hole on the edge of the road where the 62" Fir apparently used to be. It is now a windfall and has been bucked. I reset the pipe from the 56" Fir. This location tallies with the original location I remember before the logging commenced.
