Resetting of Damaged 1/4 Corner

Section 14 Twp. 20 S., R. 9 W., W.M., Douglas County, Oregon
23

Done at the request of the Bureau of Land Management for the Snellstrom Lumber Co., P. O. Box 449, Eugene, Oregon.

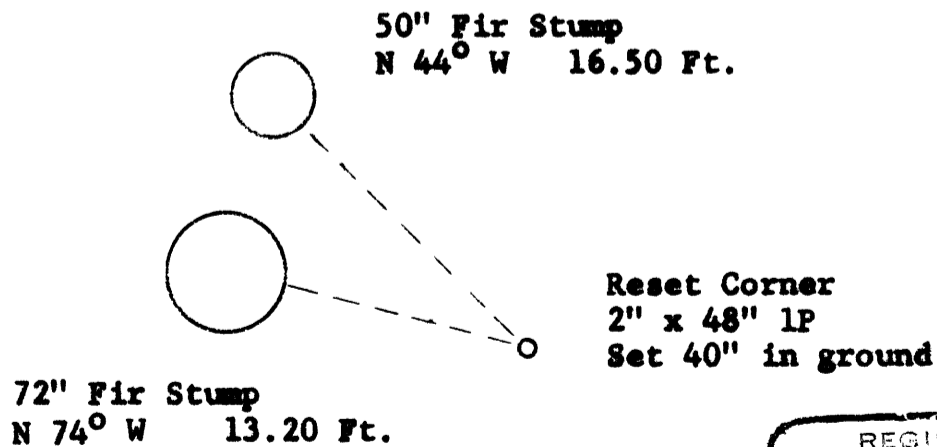
1. I found the 72" Fir stump and put a Bureau of Land Management B. T. tag on it. Scribe is in good shape.
2. I also found the 50" Fir stump and put a tag on it. Scribe was not found, however.
3. I found a broken off Cedar stump where the 24" Cedar was called for. No identification.
4. Where Cedar Corner was located I found only a root hole.

I reset this 1/4 Corner from the two Fir B. T. stumps and marked the Corner with a 2" pipe four feet long sunk 40" in the ground.
