BATE PLYWOOD COMPANY, INCORPORATED

January 14, 1964

I wish to submit a corrected statement regarding section corners described in my letter of November 22, 1963.

CORNER RESTORATION

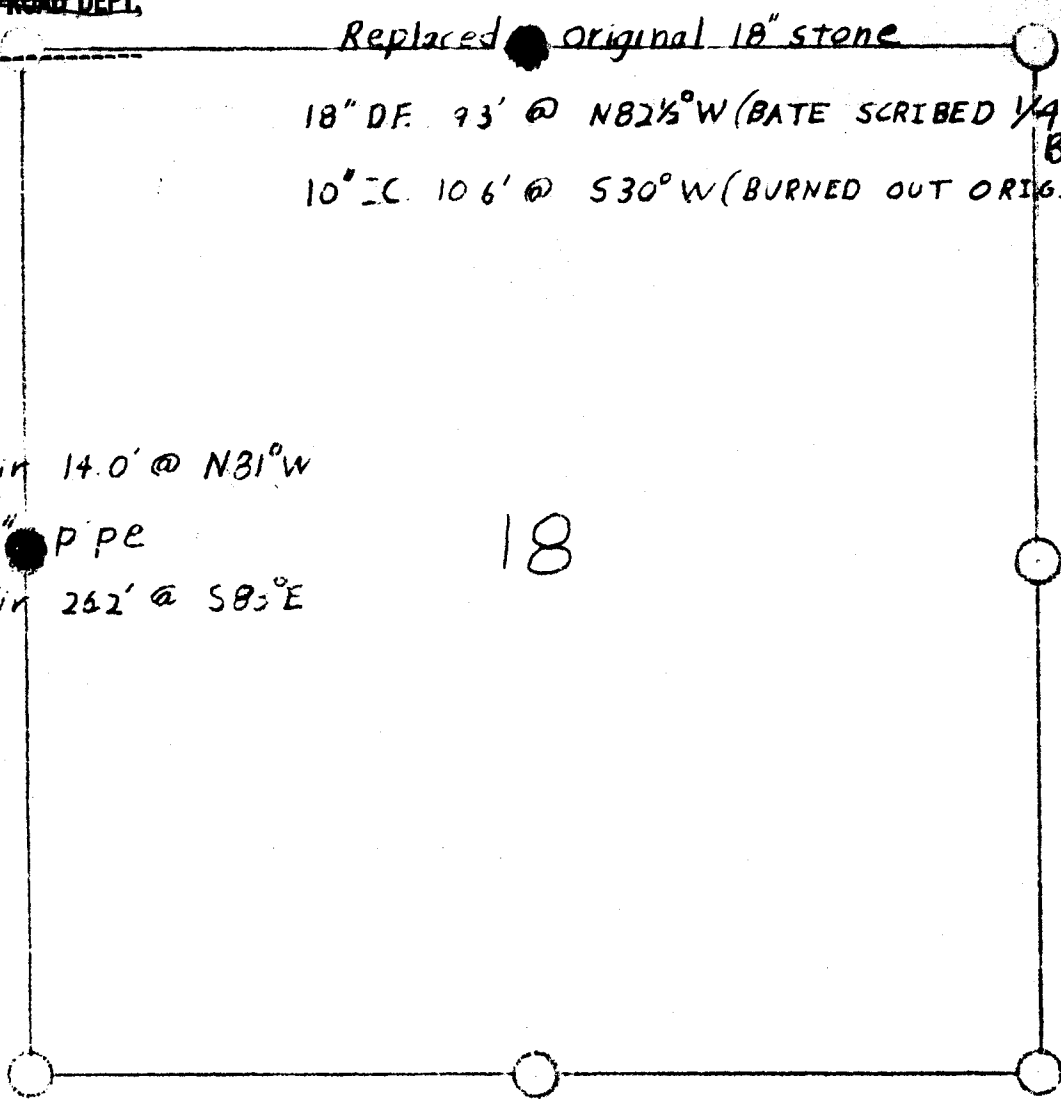
Sec. 18 Twp. 32S. R3W W.M.

48' S.P. 158' @ N50°W (ORIGINAL)

Replaced ● original 18" stone

18" D.F. 93' @ N82½°W (BATE SCRIBED ¼ S)

10" I.C. 106' @ S30°W (BURNED OUT ORIGINAL)

48' D.F. in 14.0' @ N81°W

Set 2" pipe ●

18" D. Fir 262' @ S85°E

West ¼ Corner B.T.'s
have been restored by
a previous Survey.

One North ¼ Corner
BT replaced as shown.
