Renew $\frac{1}{4}$ $\frac{1}{2}$ 530 only of T265 R1W

**COUNTY SURVEYOR
DOUGLAS COUNTY, ORE.**

C.S. File No. 52/77 $\frac{1}{4}$

Section 30

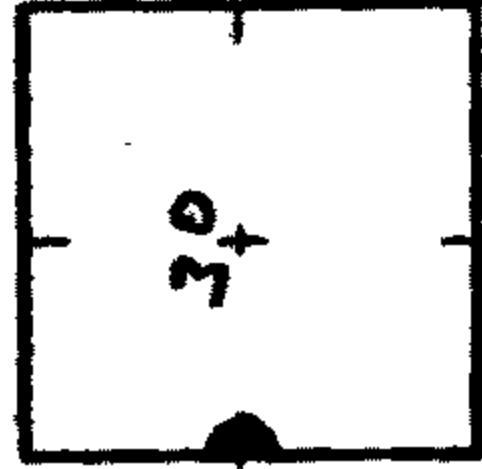
How was corner identified? Stone not found & only one.

BT located

Condition of corner: Bad

Corner apparently
destroyed by logging.
Needs iron pipe &
cap set. Mark new.
