T 23 SR 6 W

1/4 S 1/4 S
19 30

FD. G. L. D. BRASS CAP AT COR.

Section 19 Twp 23S. Rge 6W W

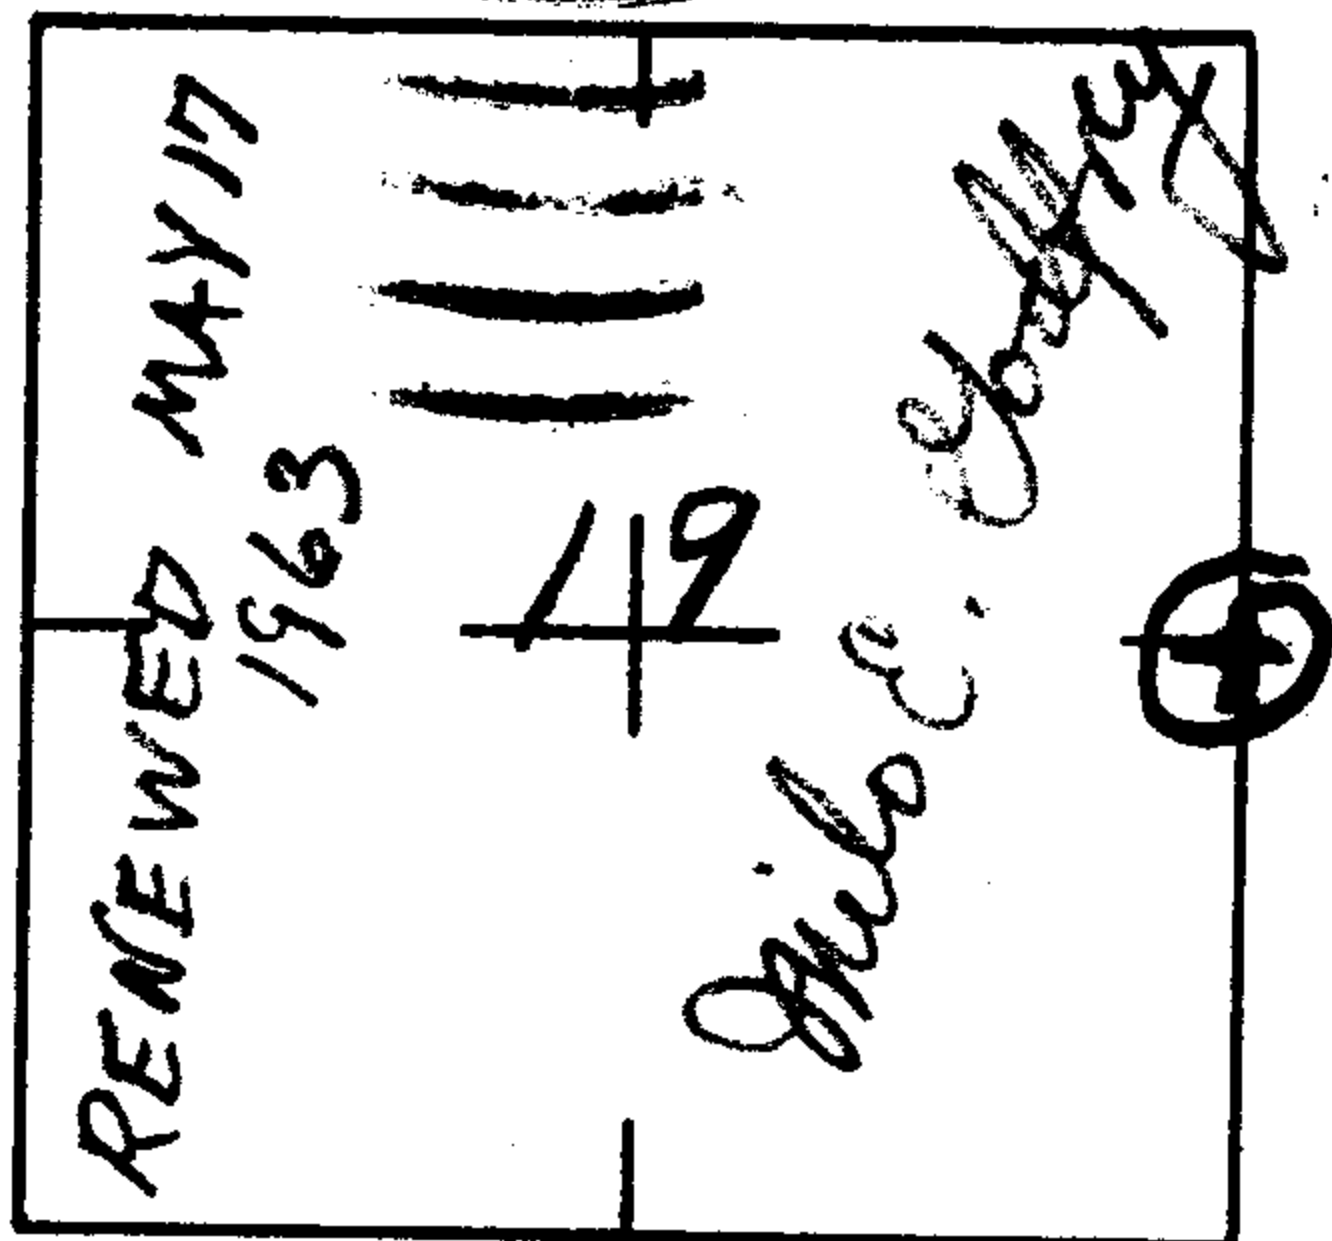
How was corner identified? Brass Cap

2 down B.T.'s (E 1/4)

Condition of corner: Both B.T.'s
