REN. T 23 S R 6 4 & 5 W $\frac{1}{4}$ S 1 S
24 19

Section 19 TWP 23 S Rge 4 Date: 4/22/63

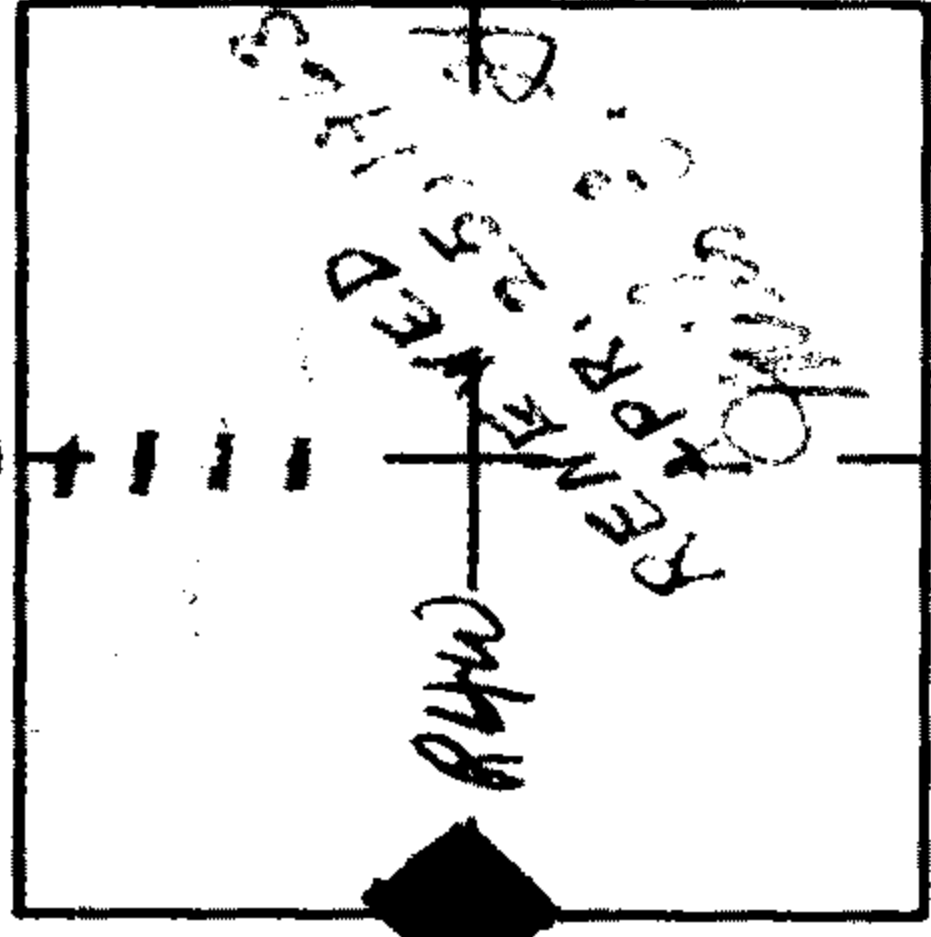
How was corner identified? Iron pipe and old 4x4 scribed wooden stake

Condition of corner: Wooden stake rotting away and only part of scribe legible

Other Remarks: No B.T.'s found. Is a old corner area. One downed tree has a Haines tag on it.
