REN. TWPS. 25 & 26 S R 4 W $\frac{1}{4}$ $\frac{935}{32}$

C.S. File No. 53/47-B

Section 35

RENEWED. AUG. 24, 1964

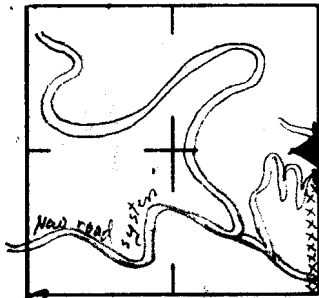
How was corner identified? Cadastral brass cap

Condition of corner: Good

Both BT's seem to be lost. Both are small trees & both are dead. Should rescribe some new BT's sometime

Quadrant	SW	SE	SW
Species & Size	DF 12"	DF 10"?	
Dist. & Bearing			
Condition of Scribe	OK	OK	
Original or Resurvey	New	New	
Appearance of B.T.	Dead stub	Bloodwood	
Tags, Marks, etc.	✓	✓	✓
