C. S. File No. 53/52-62

COR. FDR SECS 36 & 1 ONLY
 T 32+33S R 5 W.
 RENEWED JUNE 29, 1964

Section 36 & 1 Twp 32+33S Rge 5 W
 Date: 12/11/58

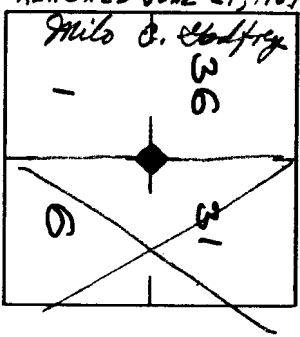
How was corner identified? Post 1'x1'x18"
 Condition of corner: Good
 Best route to reach corner: _____

Quadrant	NE	NW	SE	SW
Species & Size	DF 24"	DF 22"	40' Cedar stump	DF 19"
Dist. & Bearing	N40°E 21'	N65°W 14'	S65°E 22'	S50°W 11'
Condition of Scribe	Good	Closed	Good	Good
Original or Resurvey	Resurvey	Resurvey	Resurvey	Resurvey
Appearance of B.T.	T 331	Good	T 333	RSW
Tags, Nails, etc.	-	-	-	-
