Renew  $\frac{1}{4}$   $\frac{53}{510}$  & Cor. #1 HES 190 T205 R11W  
Fd, sandstone Rock Broken & 1916 U.S.F.S.  
BRASS cap mkd. "H.E.S. 190" - concrete  
showing ~~TRAY~~ I.P. just under cap  
B.T.S 25 follows - mkd. by Fred Rose  
in 1916 -

C.S. File No. 53/66 (see Reverse)

T205 R11W

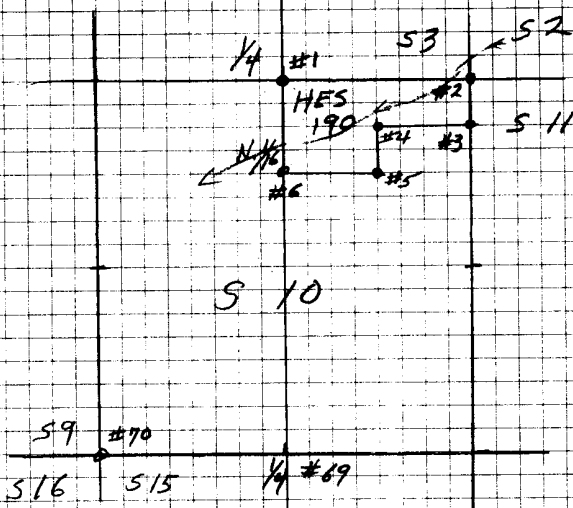
Note - Bell creek Runs S.W.  
 Through This H.E.S. in narrow  
 Valley - all cor.'s are up on  
 the sides of steep Brushy  
 Mtn's -
