Renew $\frac{1}{4}$ $\frac{59}{516}$ T305 R8W

COUNTY SURVEYOR
DOUGLAS COUNTY, ORE.

Section 9 Twp 30 Rge 8 W 531-64

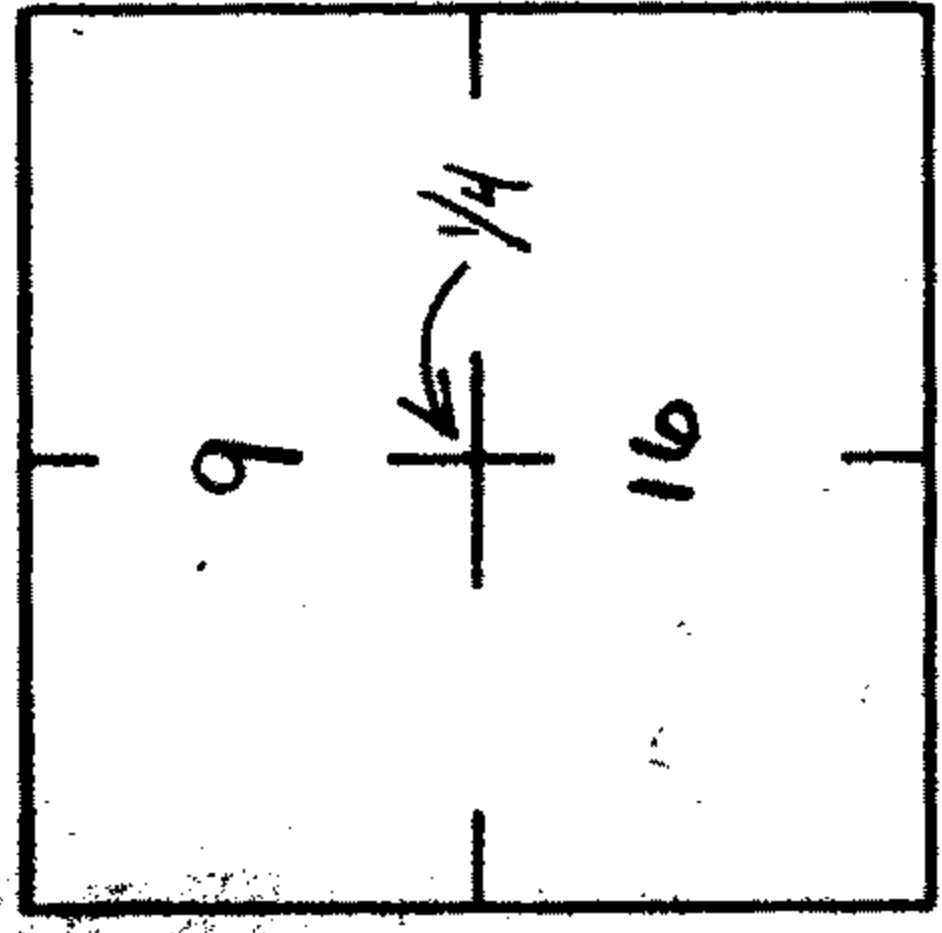
How was corner identified? By ORIG B.T.

Condition of corner: Poor

Quadrant	NE	NW	SE	SW
Species & Size				CEDAR 36"
Dist. & Bearing				S 65W 46 LNS
Condition of Scribe				Poor
Original or Resurvey				ORIG
Appearance of B.T.				DOWN
Tree marks, etc.				TAG
