PUBLIC LAND CORNERS

MEYERHAEUSER TIMBER COMPANY
 SPRINGFIELD BRANCH

TOWNSHIP 22 S RANGE 10 W
 SECTION 33 CORNER SW
 COUNTY DOUGLAS STATE OK

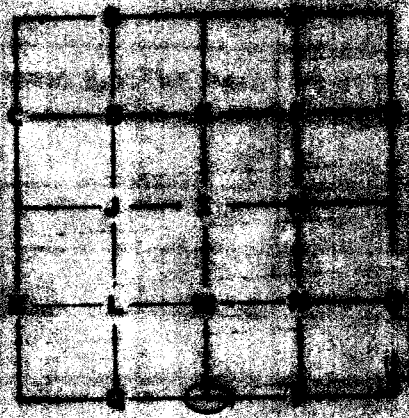
BEARING-	LINKS-	FEET-	
12" Laurel	S 38 E	16	10.6	down, hollow, rotted, but scribing visible. 18" GLO
8" Elm	N 18 W	60	39.6	Green-face chopped. Scribing Visible. 20" GLO

CORNER SET: Found 1" Iron Rod

DESCRIPTION OF GROUND COVER AND GROUND SLOPE AT CORNER: Salal, Wild

Slope Faces NORTH on Minor Blackberry center
