PUBLIC LAND CORNERS

WEYERHAEUSER TIMBER COMPANY
 SPRINGFIELD BRANCH

TOWNSHIP 25S RANGE 2W
 SECTION 22 CORNER S 1/4
 COUNTY Douglas OREGON

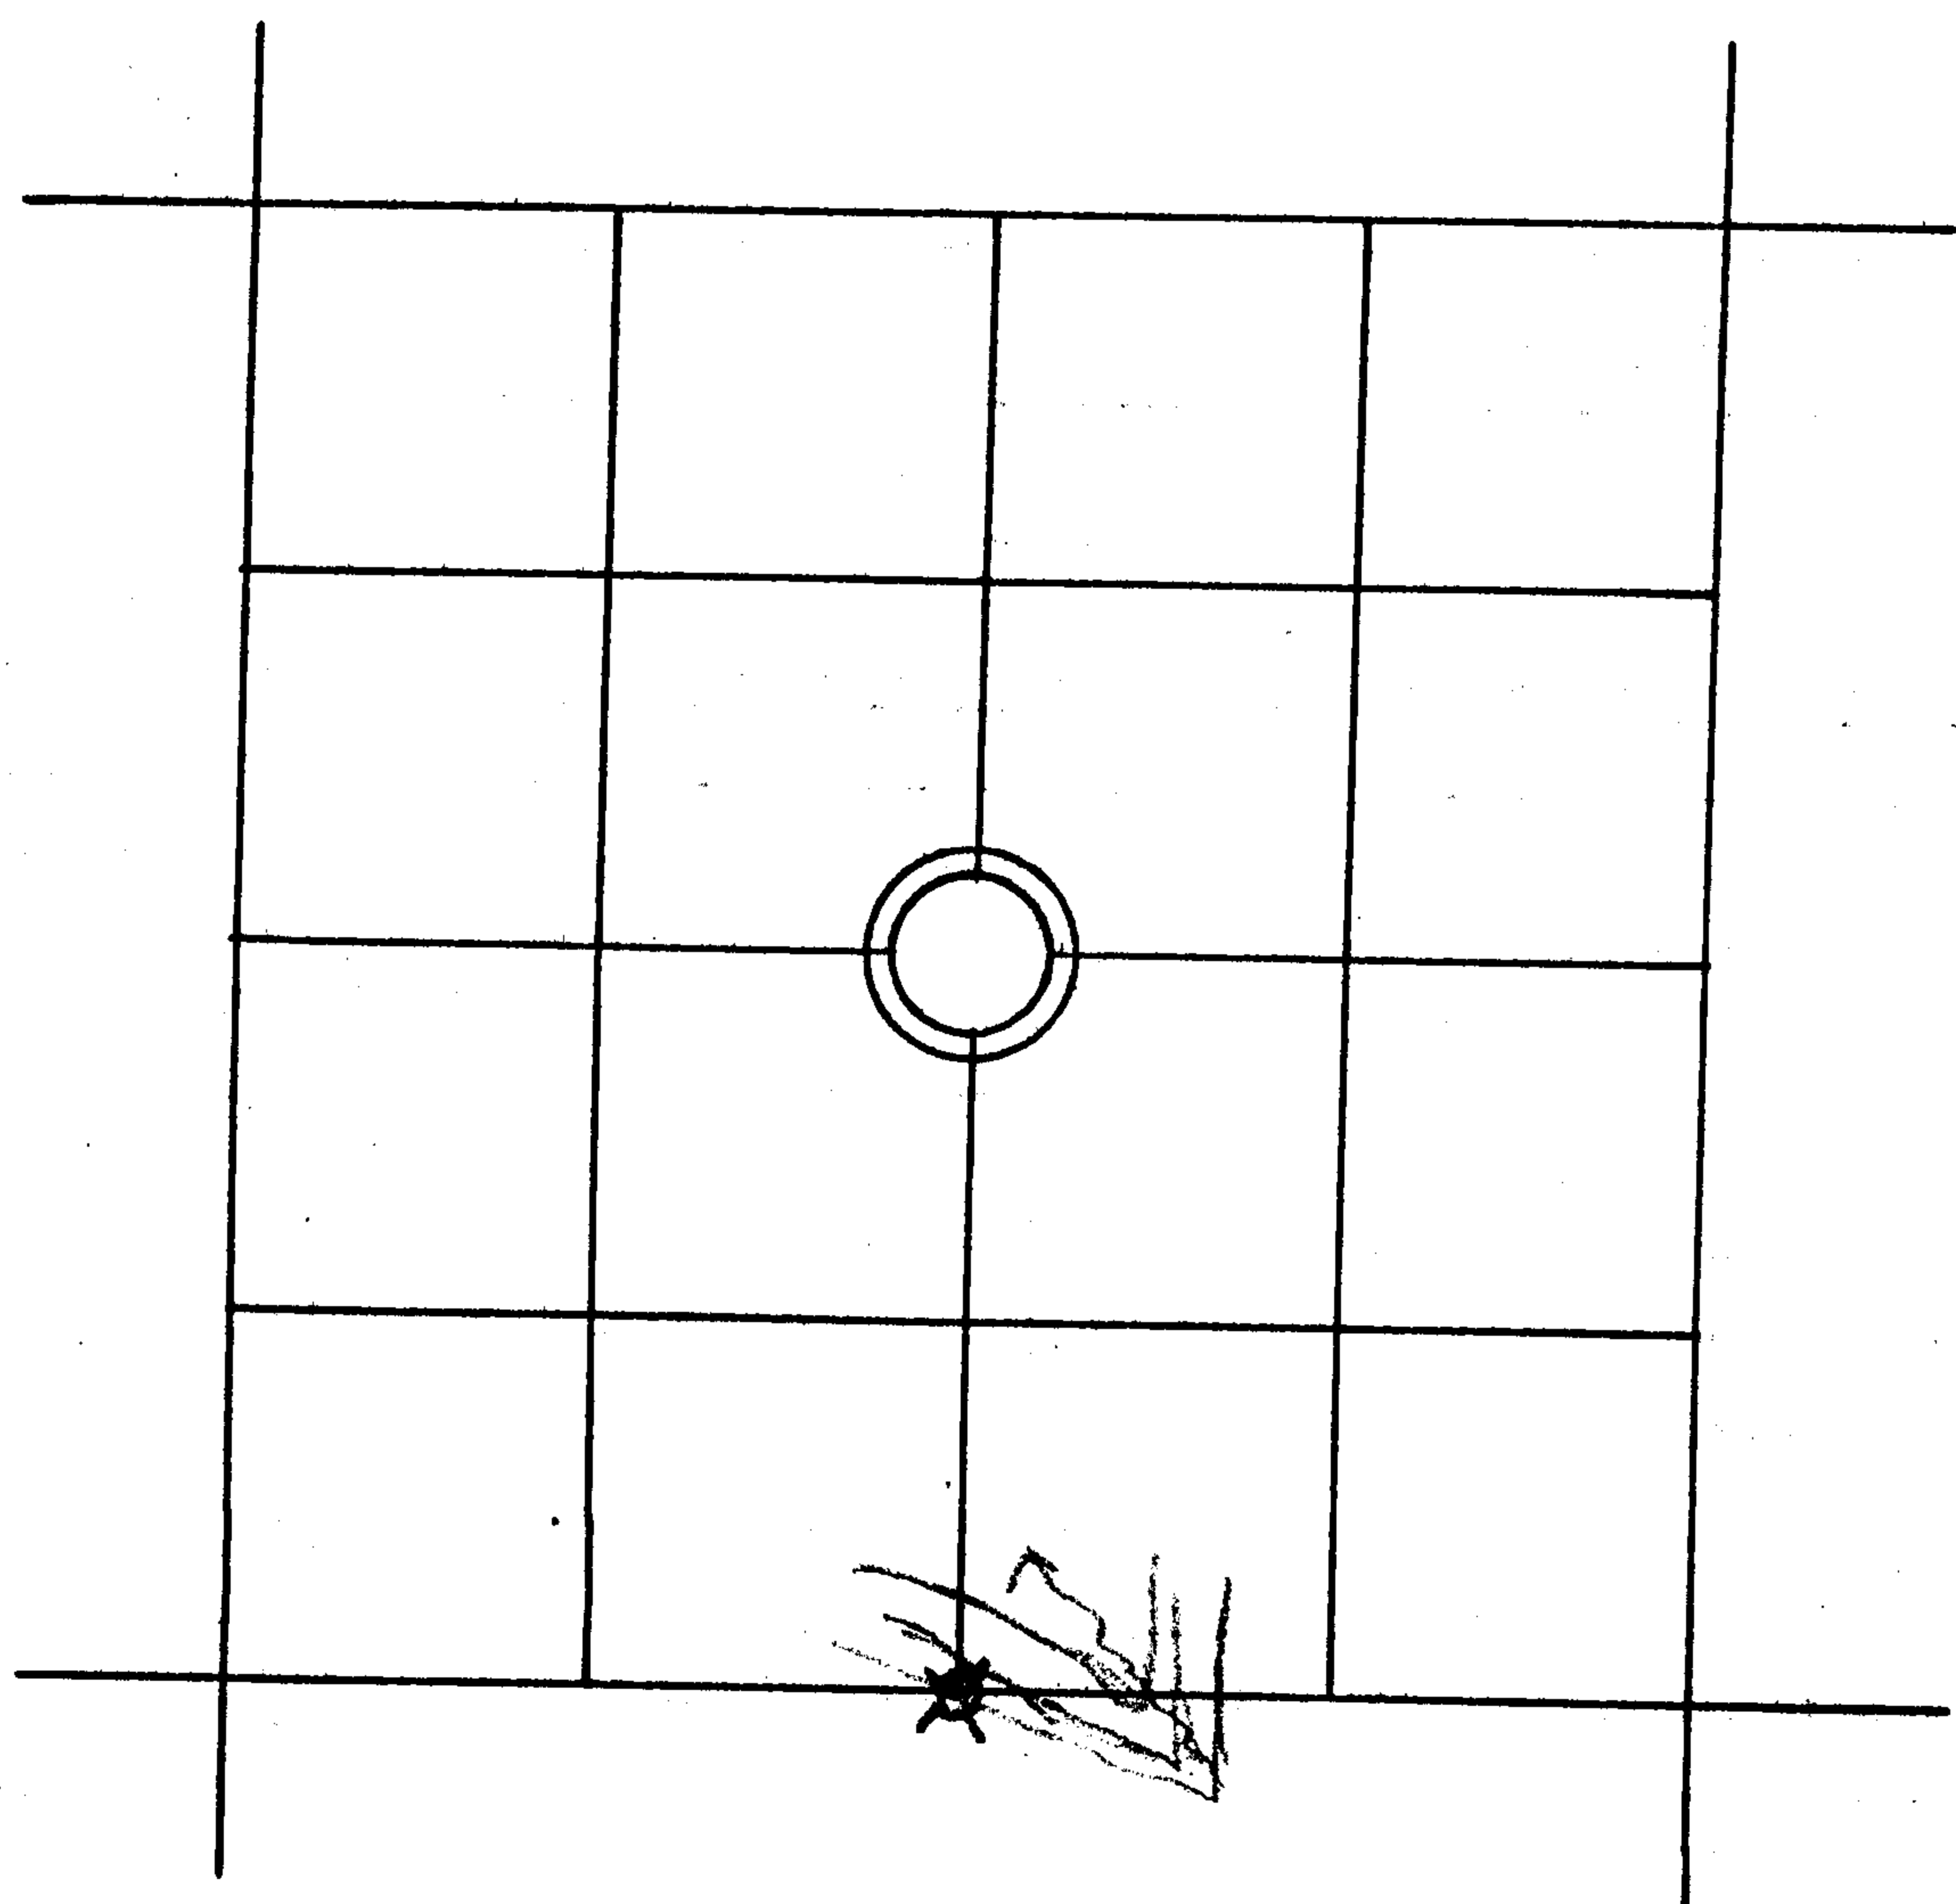
SECTION 22 TOWNSHIP 255 RANGE 2W

NORTH: - 45° 0'. Old growth to East and West.

SOUTH: + 55° 0'. Logged to East and West 1958.

EAST: - 64° 0' 160' cr CNW. Logged to Creek on South, Old growth to North.

WEST: + 60° 0' 20'. Logged to South, Old growth to North.
