PUBLIC LAND CORNERS

WEYERHAEUSER TIMBER COMPANY
SPRINGFIELD BRANCH

TOWNSHIP 25S RANGE 2W

SECTION 24 CORNER K 1/16

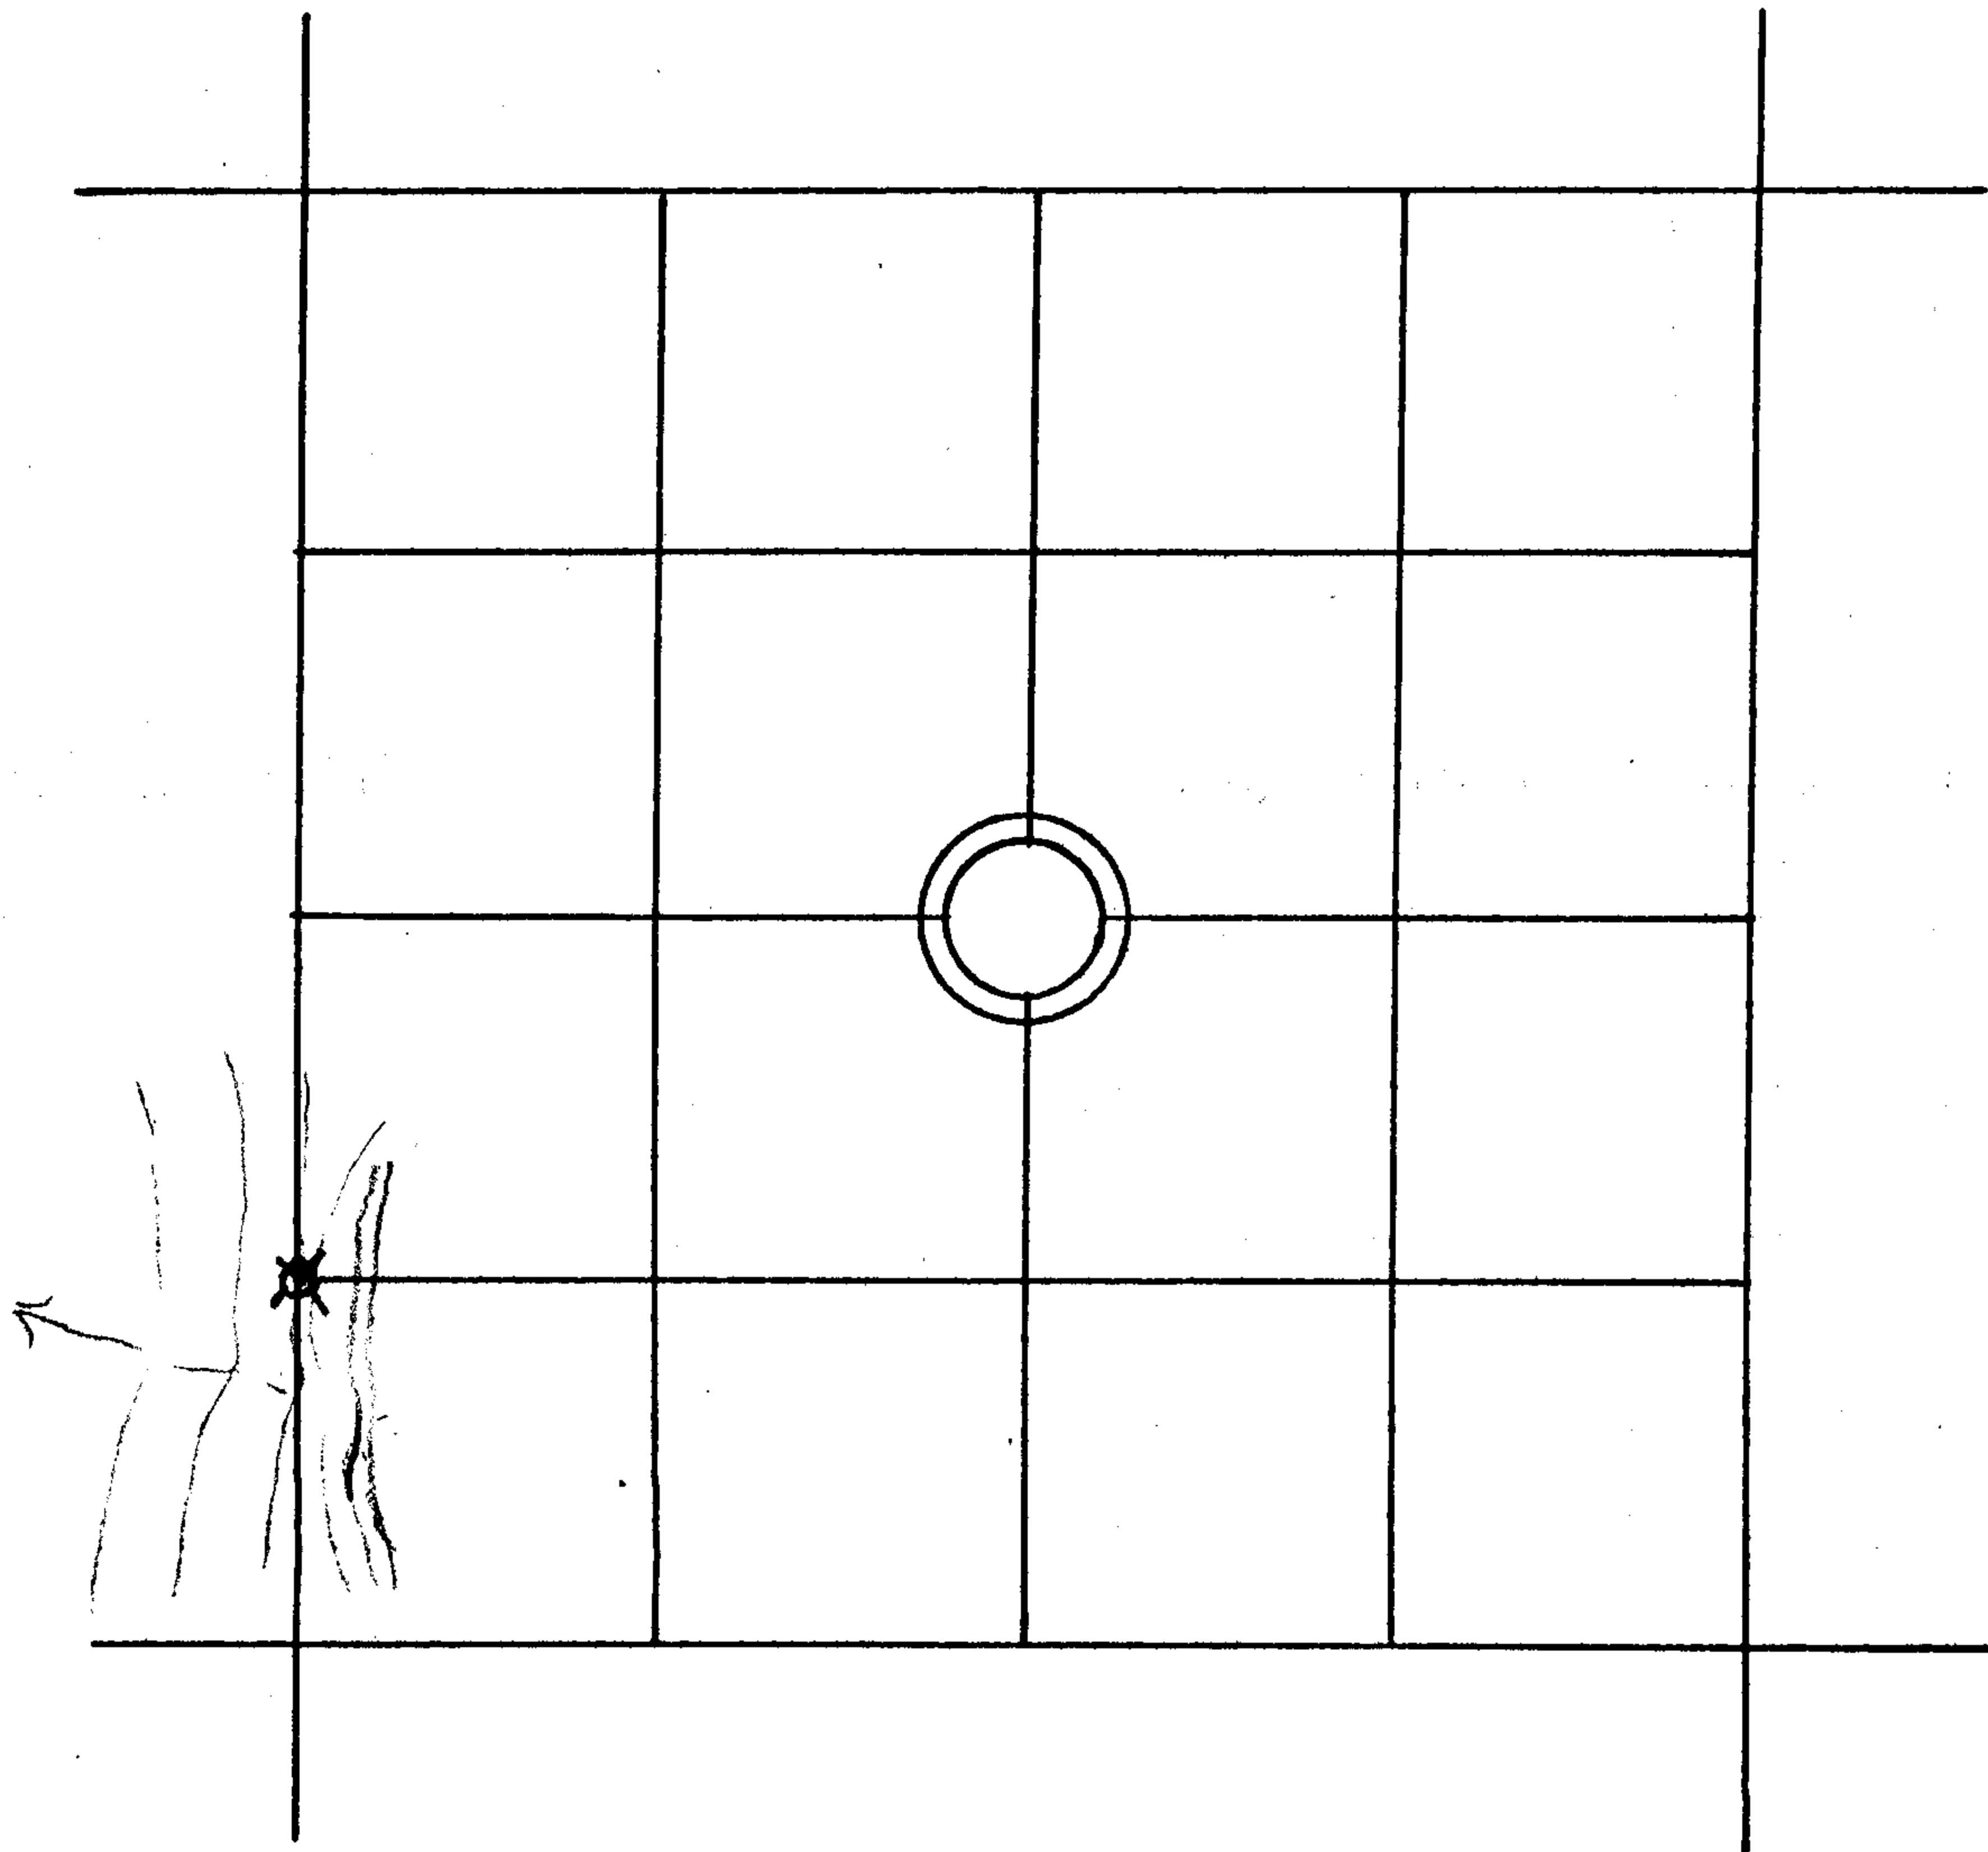
SECTION 24 TOWNSHIP 25S RANGE 2W

Found scribed, badly burned.
Fire-killed. Scribing visible.

6' Stub. Face badly burned.

Found
Scribed S 1/16 S 23 BT
" S 1/16 S 24 BT

CORNER SET: Found Hosford's Post and Pipe. MAG. DECL: 20°

GROUND COVER: Burned Slash

SLOPE FACES (GIVE BEARING IN DEGREES) West ON MINUS (-) 15 %

BEARING	FEET	ORIG. B.T.	"W" NAIL	PLATE	BRASS DISC
60" Fir	N5W	15.1	Hosford	X	X	
60" Fir Stamp	S48E	27.2		X	X
