COUNTY SURVEYOR'S OFFICE

G.S. FILE NO 57/26-1 (OVER)

COUNTY OF DOUGLAS

We would like to have your opinion on a problem concerning an original government survey corner, more particularly the southeast corner of Section 32, Township 27 South, Range 5 West, Willamette Meridian. We were requested by an interested party to remonument this corner based on their discovery of an original bearing tree and scribing.

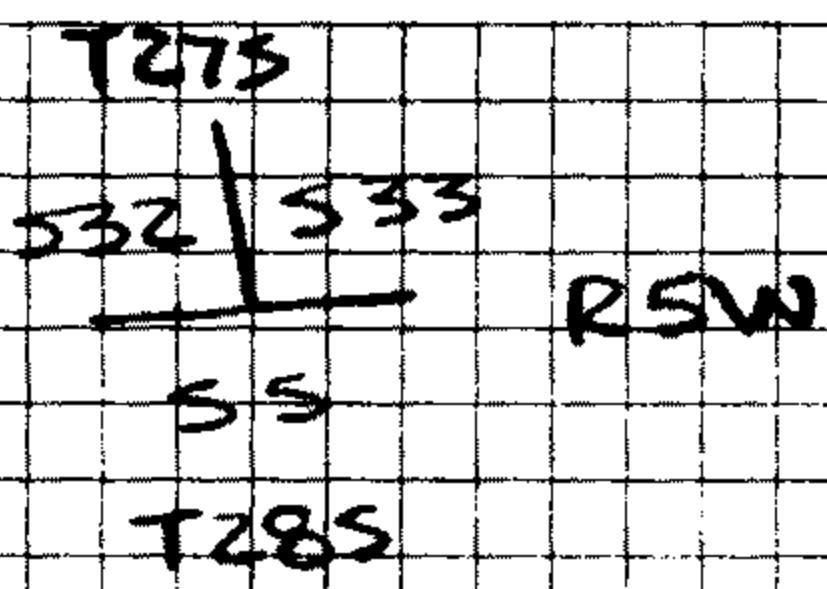
ORIG. 12" NOW 30" D. FIR, WITH SCRIBING
"R5W T275 S33 CC" VISIBLE ON
PREVIOUSLY OPENED BLAZE.

WE DO NOT FIND THE REMAINING ORIGINAL
BEARING TREE.

AT THE CORNER POINT DETERMINED BY
THE RECORD BEARING & DISTANCE FROM THE
ABOVE NOTED ORIGINAL BT, N42°E
5 ³/₄ FT. WE SET A 1" X 30" I. PIPE WITH
BRASS CAP ATTACHED, MARKED;

WE MARK THE FOLLOWING NEW BT,

A 12" INCENSE CEDAR BEARS N 24° W
8^B FT., SCRIBED "T27S R5W S32
CS BT" ON A DOUBLE BLAZE.
