RESTORED CORNER

WEYERHAEUSER COMPANY

CORNER CW 1/16 Sec 8 T. 25 S. R. 2 W. WM.  
NOTES DATED: 11/10/1958 BY: V.W. Hasford RPLS No. 253  
CORNER: 1 1/2" Iron Pipe  
ACCESSORIES: 24" Hemlock N21 1/2 E 31.0; 12" Hemlock S28 1/2 E 5.8'  
Survey For Evans Products Co.

C. S. File No. 58/8-33

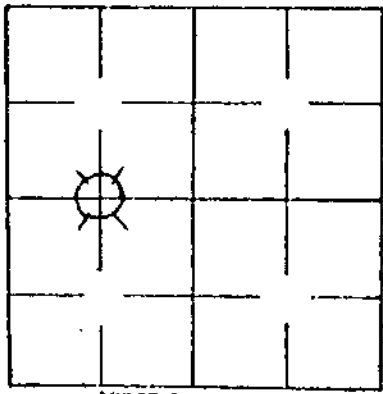
SECTION DIAGRAM

DATE: 8/11/1980 BY: Glen McChesney TITLE: Project Engineer FIRM: Weyerhaeuser Contract  
EVIDENCE RECOVERED: Hasford's Pipe in place; Down rotted 24" Hemlock N21 E 31.0;  
down, rotted 12" Hemlock S28 E 5.0, Scribing & W nail. Also found W nail,  
Plate gone, in rotted wood of 4 1/2" x 9" broken stub N30 W 27.2.

ACCESSORIES ESTABLISHED: W nail & plates on: 8" D. Fir N24 W 2.4';  
6" Incense Cedar S72 1/2 W 15.9  
Bearings & distances to W nail, destination 20° E
