RENEWAL OF $\frac{1}{4}$ CORNER ON WEST SIDE OF:

SECTION 30 T26S R1E W.M.

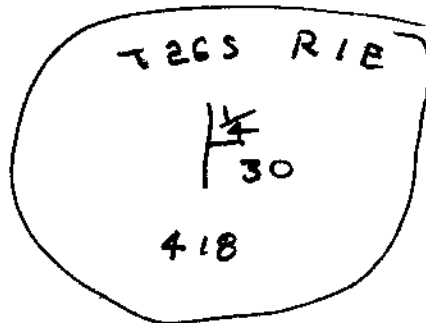
SET A $\frac{5}{8}$ " X 30" IRON ROD, IN THE ORIGINAL HOLE, WITH AN ALUMINUM CAP MARKED:
