RENEWAL

VT 29 S R 3 W

C.S. File No. 59/26-9 C

Section 23

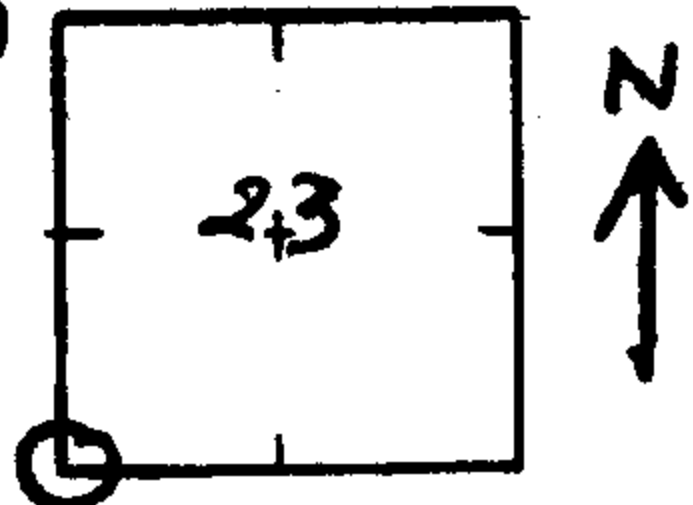
How was corner identified? 1" IRON PIPE

Condition of corner: BAD The IP is bent and the 23" DBH maple in the SW quad is on the ground now

Other Remarks:
Please RENEW CORNER with BRASS CAP AND NEW BT in SW quad.
