PUBLIC LAND CORNERS

WEYERHAEUSER COMPANY
 SPRINGFIELD BRANCH

TOWNSHIP 26S RANGE 2 W
 SECTION 18 (only) CORNER S₁
 COUNTY Douglas OREGON

GLO SURVEY RECORD

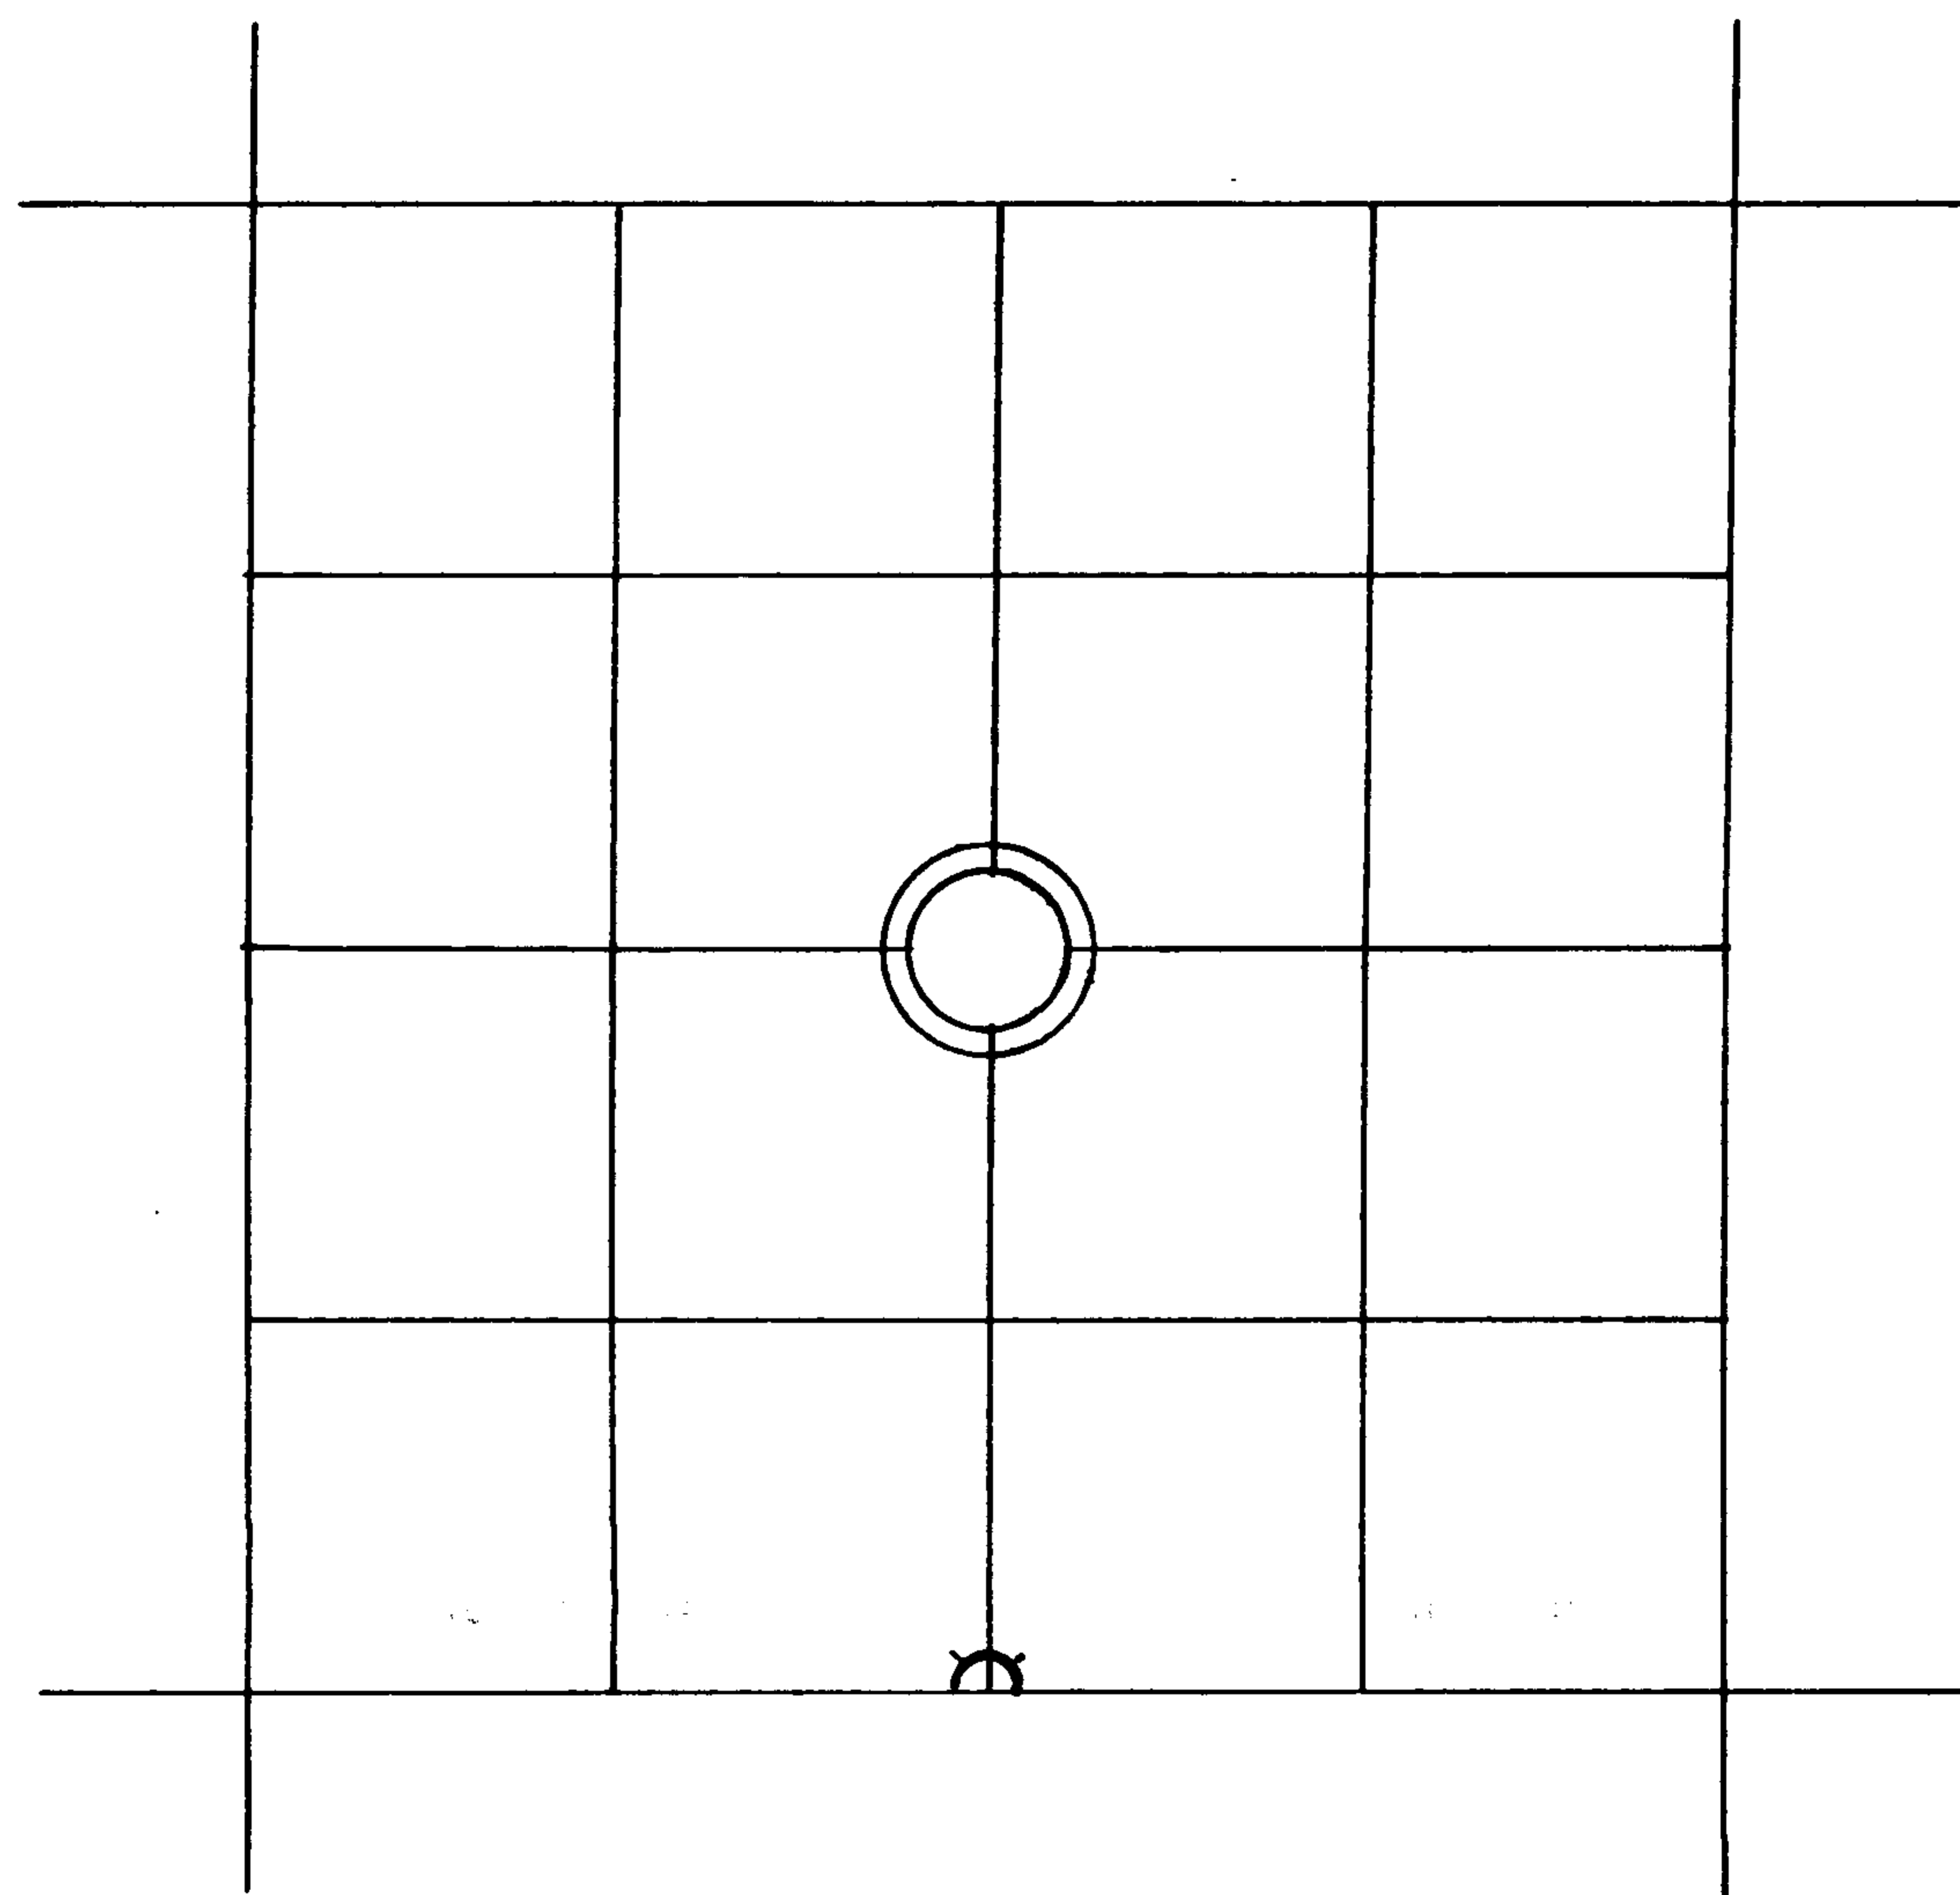
SECTION 18 TOWNSHIP 26S RANGE 3W

30° Fir, rotted face; BT plate lowered to top of face.
 22° Fir, face healed over; "W" nail at base of tree; BT Plate lowered to top of face.

This 1/4 corner is common only to Section 18.

SLOPE FACES (GIVE BEARING IN DEGREES) East ON MINUS (-) 65 %

BEARING	FEET	ORIG. B.T.	"W" NAIL	PLATE	BRASS DISC
↗ 44" Fir	S33W	26.1	--	X	X	--
