DATE: Jan 27, 1981

T25S R2W

1/4 523
526

Section 23 Twp. 25 Rge. 2W

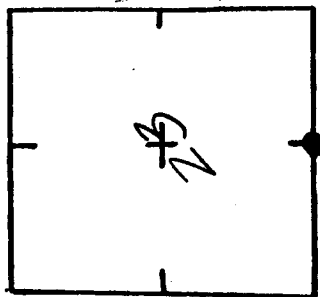
Condition of Corner and Accessories: SOME B.T.'S EXIST

CORNER HAS BEEN DESTROYED.
