DATE: March 12, 1982

G.S. File No. 61/32-4

RENEWAL

1/4 Corner btwn. S. 21 & S. 28
T195 R19W

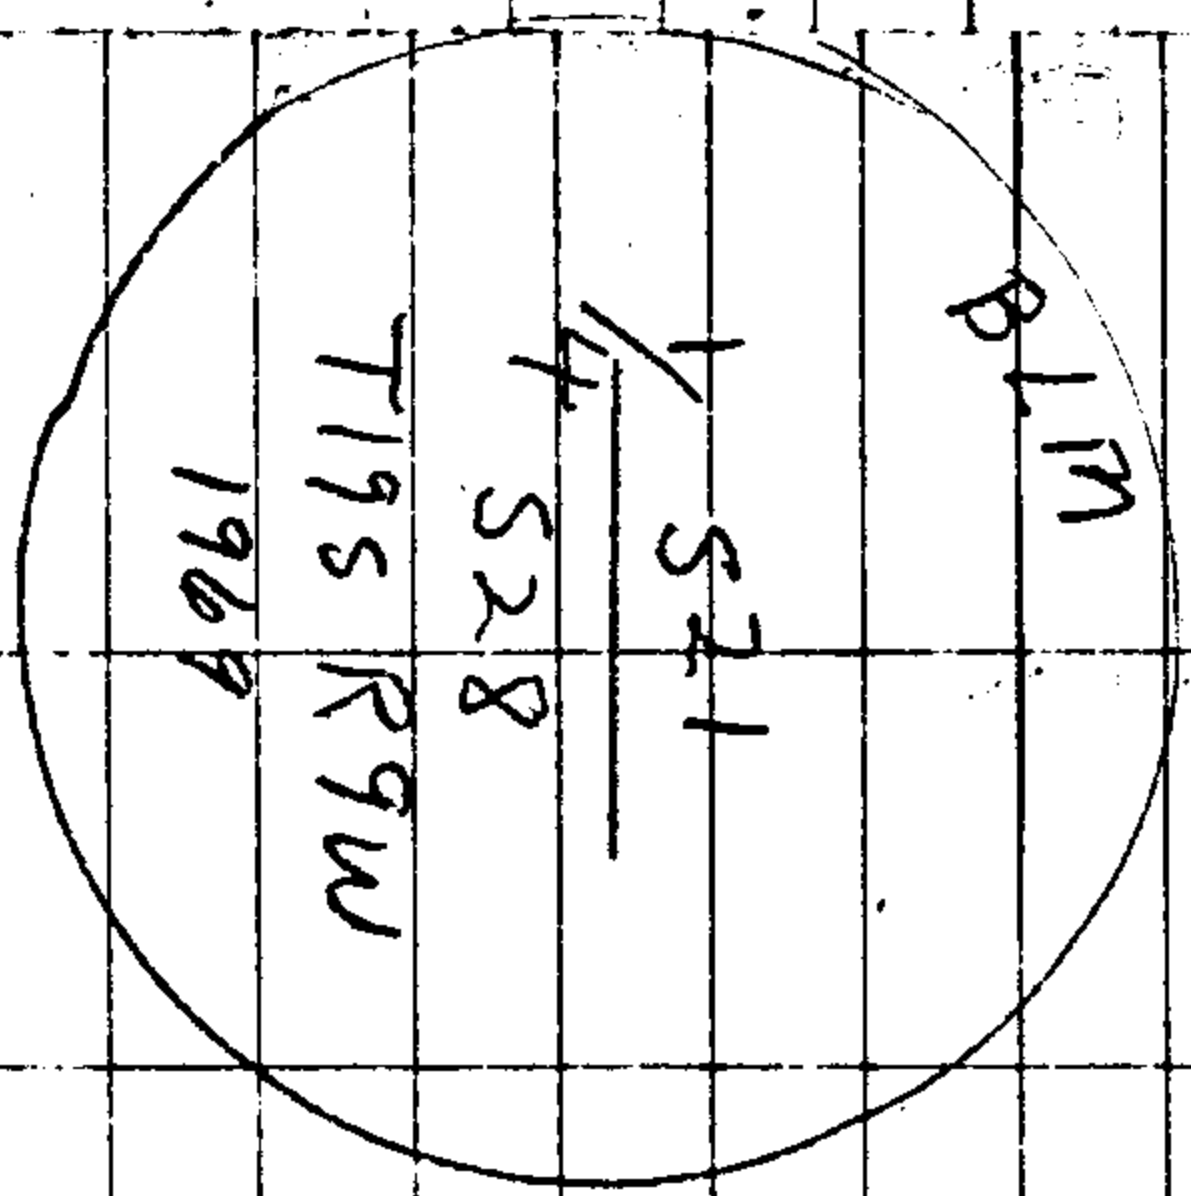
B.L.M. brass cap, 7" above ground, in good condition,

marked: S21 S28 1/4 T19s R9W 1969.

29" Hemlock, brs. N45 $\frac{1}{2}$ °W, dist. 15 $\frac{1}{4}$ ', scribing visible: 1/4 S21

S.E. B.T. has been destroyed by road construction.

New B.L.M.: 12" Hemlock, brs. S90W, dist. 438', marked: 1/4
