GOVERNMENT CORNER RESTORATION FORM

Township 31 S Range 2 W Sec. 3 County DOUGLAS

Corner Designation

PAUL CRUM A PROPERTY OWNER ALONG THIS BOUNDARY ASKED THAT WE LOOK AT THE EVIDENCE HE HAS FOUND WHICH HE BELIEVES TO BE EVIDENCE OF THE MONUMENT SET ORIGINALLY FOR THE QUARTER CORNER BETWEEN SECTIONS 3 AND 34.

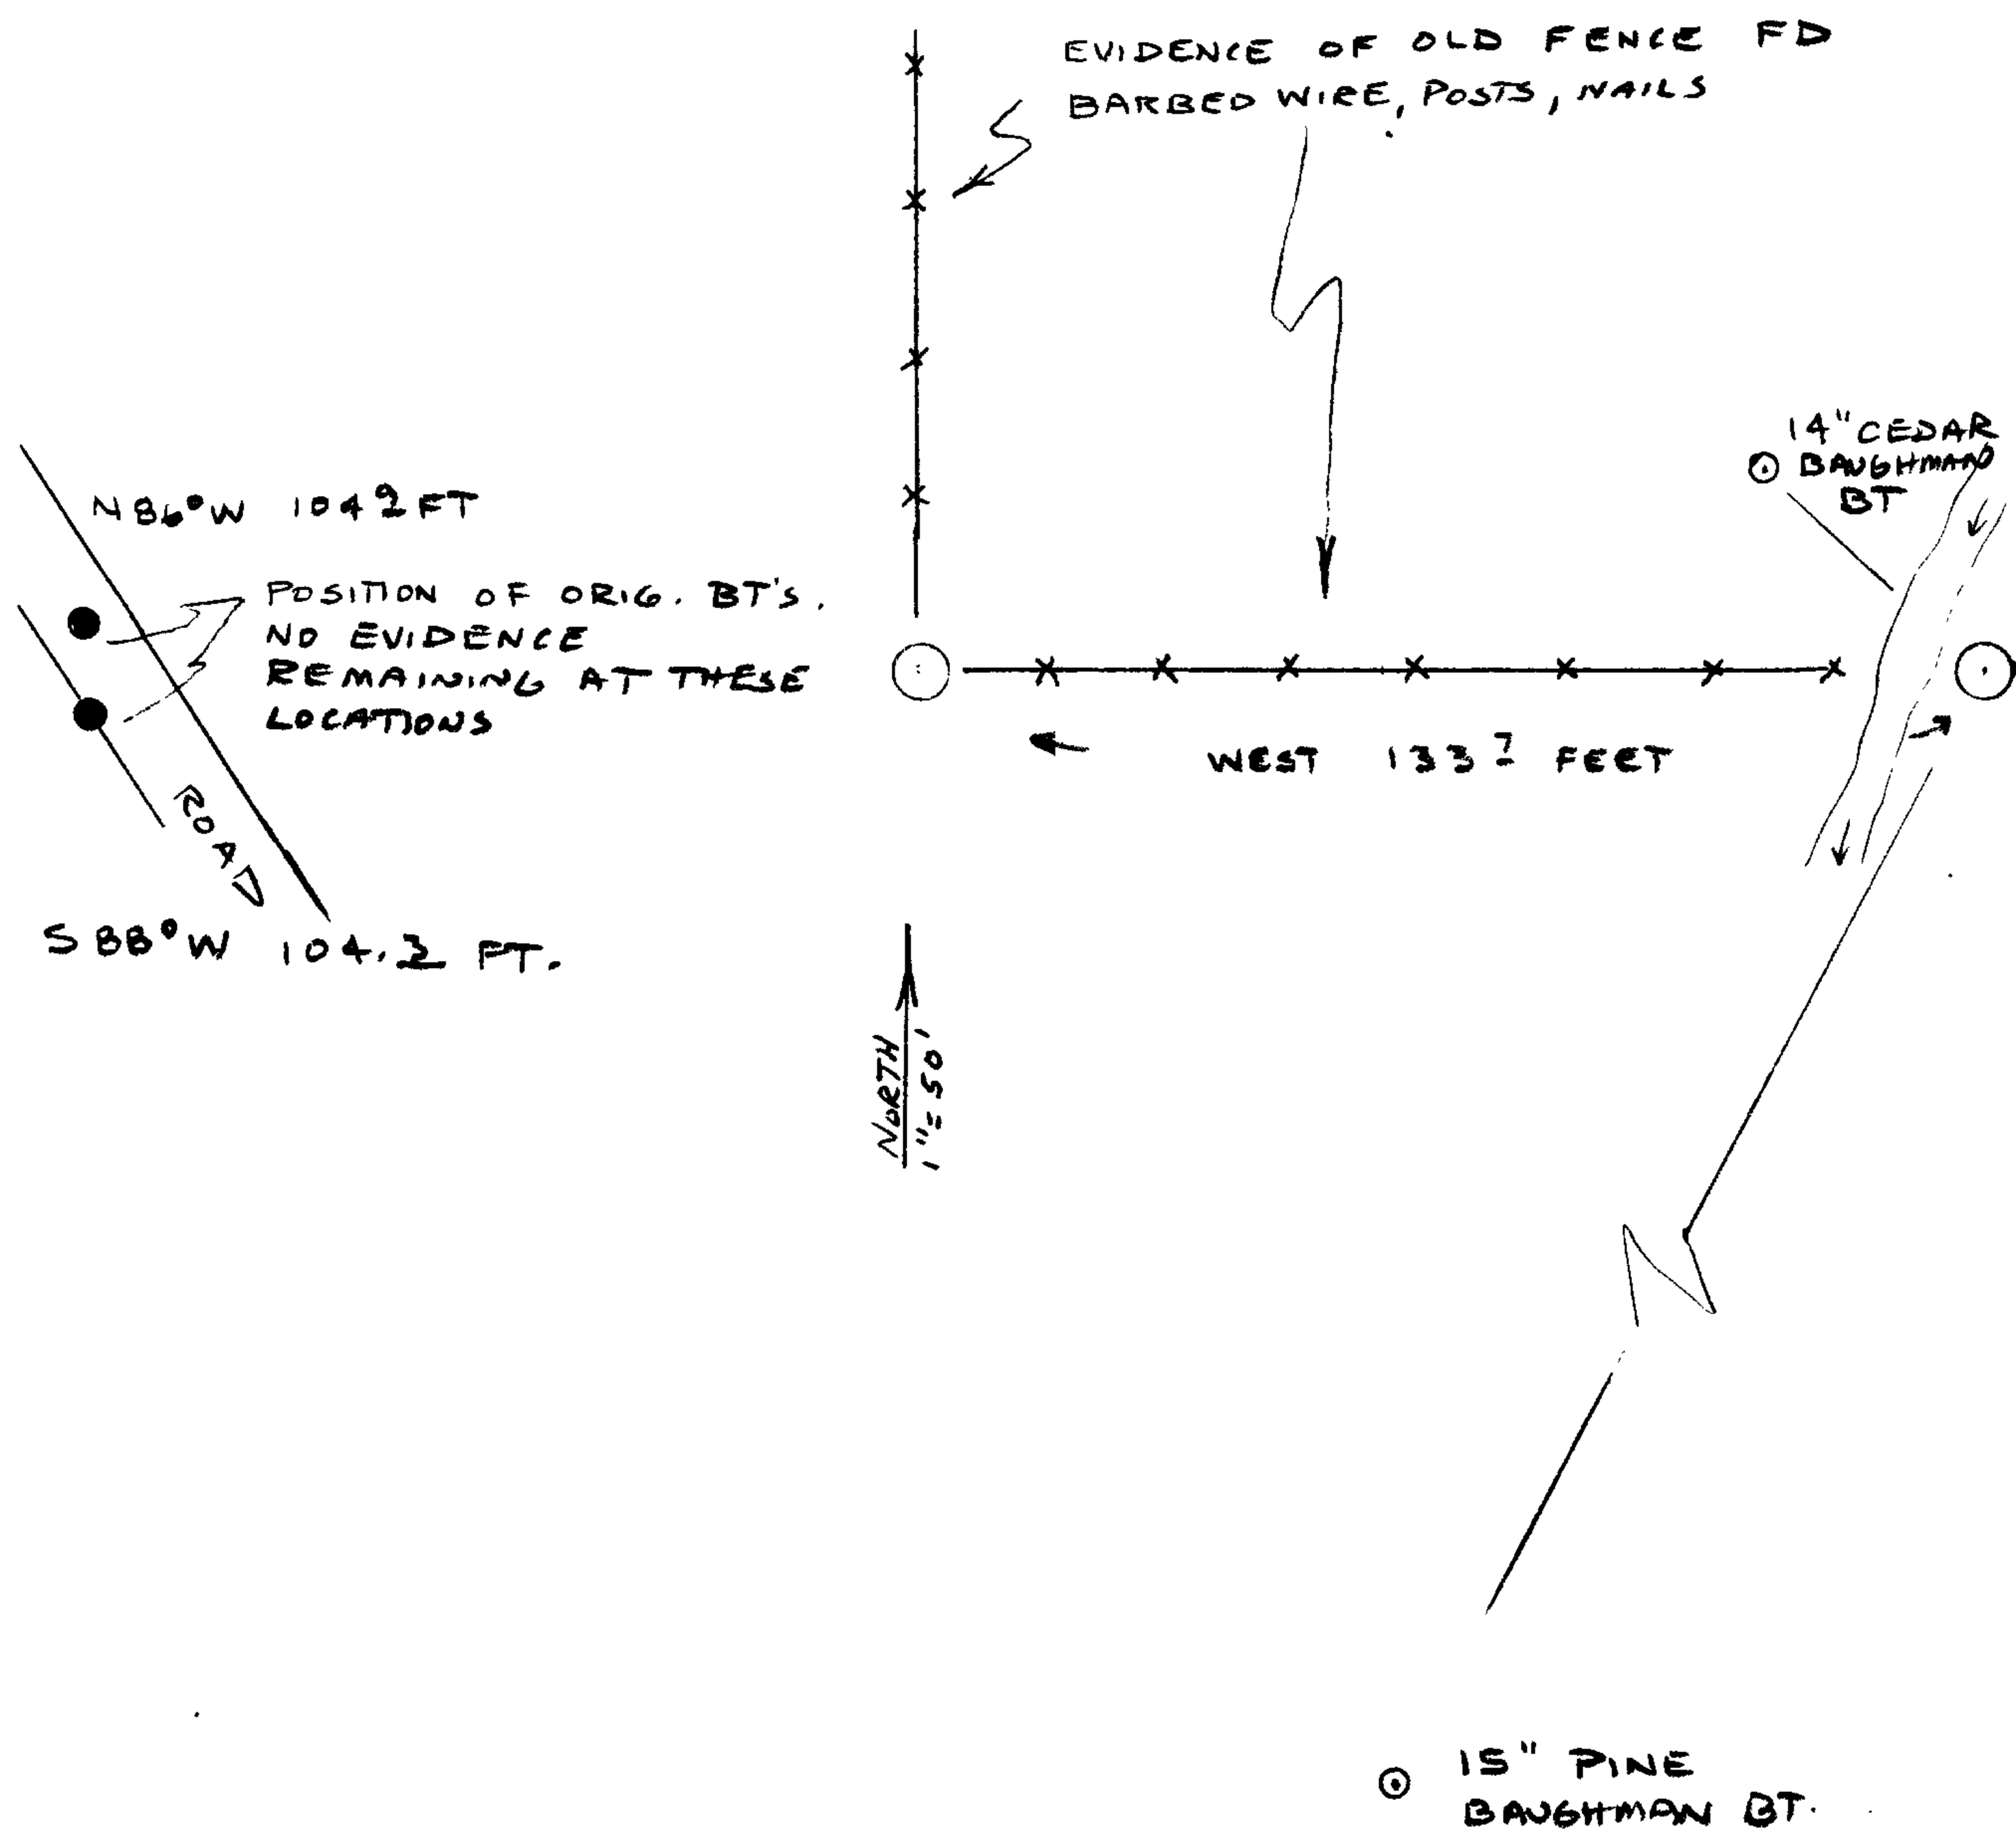
Sketch of Monument, Accessories, and General Area

WE FIRST FOUND THE MARCH 1978 BAUGHMAN SURVEY MONUMENT A 2 1/2" BRASS CAP ON A 2 1/2" IRON PIPE PROTRUDING 14" ABOVE THE GROUND (MARKED AS NOTED). THIS MONUMENT WAS SET AT A PROPORTIONATE POSITION.

133.7 FEET WEST OF THE BAUGHMAN MONUMENT WE WERE SHOWN A MOUND OF STONE 24" DIAMETER AND 7" HIGH. A METAL POST HAS BEEN SET DOWN INTO THE APPARENT OPENING OF THIS MOUND. (THE ORIGINAL SURVEY NOTES CALL A WOOD POST IN A MOUND OF STONE

AT THE CORNER POSITION.) CHECKING FOR THE ORIGINAL BEARING TREES REVEALED NO EVIDENCE. THE POSITION OF THE 40" PINE (S88°W 158 LKS) FALLS ALONG THE WESTERLY EDGE OF A ROAD BUILT FOR POWER LINE MAINTENANCE. THE POSITION OF THE 30" PINE (N86°W 159 LKS) FALLS IN THE TRAVELED WAY OF THE ROAD. NO CONCLUSIVE EVIDENCE OF EITHER ORIGINAL BEARING TREE WAS LOCATED AT THE RECORD POSITIONS FROM THE MOUND OF STONE. THE TOP SOIL IN THIS AREA IS SHALLOW AND ROCKY, THE TREES IN THIS AREA DO NOT MATURE TO A SIZE LARGER THAN THE RECORD BEARING TREES. THERE IS ALSO EVIDENCE OF FIRE IN THIS AREA.

FROM THE MOUND OF STONE EVIDENCE OF AN OLD FENCE (BARBED WIRE, WOODEN POSTS AND NAILS) RUNS EAST TO AND BEYOND THE MONUMENT SET BY BAUGHMAN. FENCE EVIDENCE WAS ALSO FOUND RUNNING NORTH FROM THE MOUND OF STONE. AS ACCORDING TO MR. CRUM, HE LOCATED THE STONE MOUND AFTER THE BAUGHMAN SURVEY MONUMENT WAS SET. HE INDICATED THAT THE BRUSH HAD TO BE CUT AWAY BEFORE THE MOUND COULD BE FOUND. MR. CRUM FIRST OCCUPIED THIS LAND IN 1946, THE OLD FENCE HAS BEEN AT THE PRESENT LOCATION FOR A PERIOD OF TIME PRIOR TO HIS TIME OF RESIDENCE.

New Accessories FOUND (BEARINGS AND DISTANCES TAKEN FROM BAUGHMAN MONUMENT).

A PINE 12" NOW 15" DIA BEARS S 28° W 349.6 FEET

A CEDAR 12" NOW 14" DIA. BEARS N 47° W 380 FEET.
