DATE: May 7, 1984

C.S. File No. 62/5-14

RENEWAL

Ren. #2

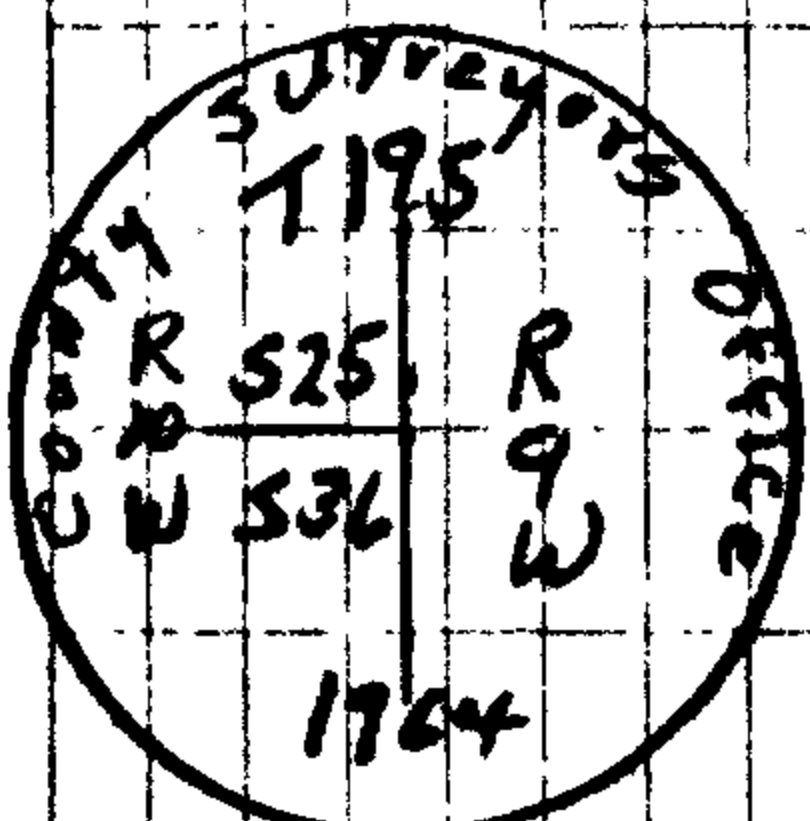
① Reset old county
BRASS CAP AT THE
CENTER OF THE ROOT
HOLE OF THE COR. TREE.

② NO STUMP AVAILABLE
IN SECTION 25

③ Posted Boundary MAINTENANCE
HAVE BEEN DONE ON THE
PERIMETER OF SECTION 36.

40" D-Fix UP rooted
BYS $N0\frac{1}{2}^{\circ}$ W
Dist. 196
(To center ROOT WAD)

up-rooted Cor. Tree
28" D-Fix
BYS $N28\frac{3}{4}^{\circ}$ E Dist. 152
(TO CENTER OF ROOT WAD)

0719
38" Uprouted Hemlocks
BYS. $S86\frac{1}{2}^{\circ}$ W
Dist. 48 7

3/8 Rebar on center
38" Hemlock stump
BYS $S75^{\circ}$ W
Dist. 51 05
scribed CSBT

3/8 Rebar on center
36" Hemlock stump
BYS. $S44^{\circ}$ W
Dist. 50 5
scribed T195 R10W
S-36 CSBT

[* old Referenced Point
BYS. $S11^{\circ}$ W Dist. 46]
