GOVERNMENT CORNER RESTORATION FORM

Township 26 S Range 6 W Sec. 13 County DOUGLAS

State OREGON Date 7-27-84 No. _____

1/4 S14|S13

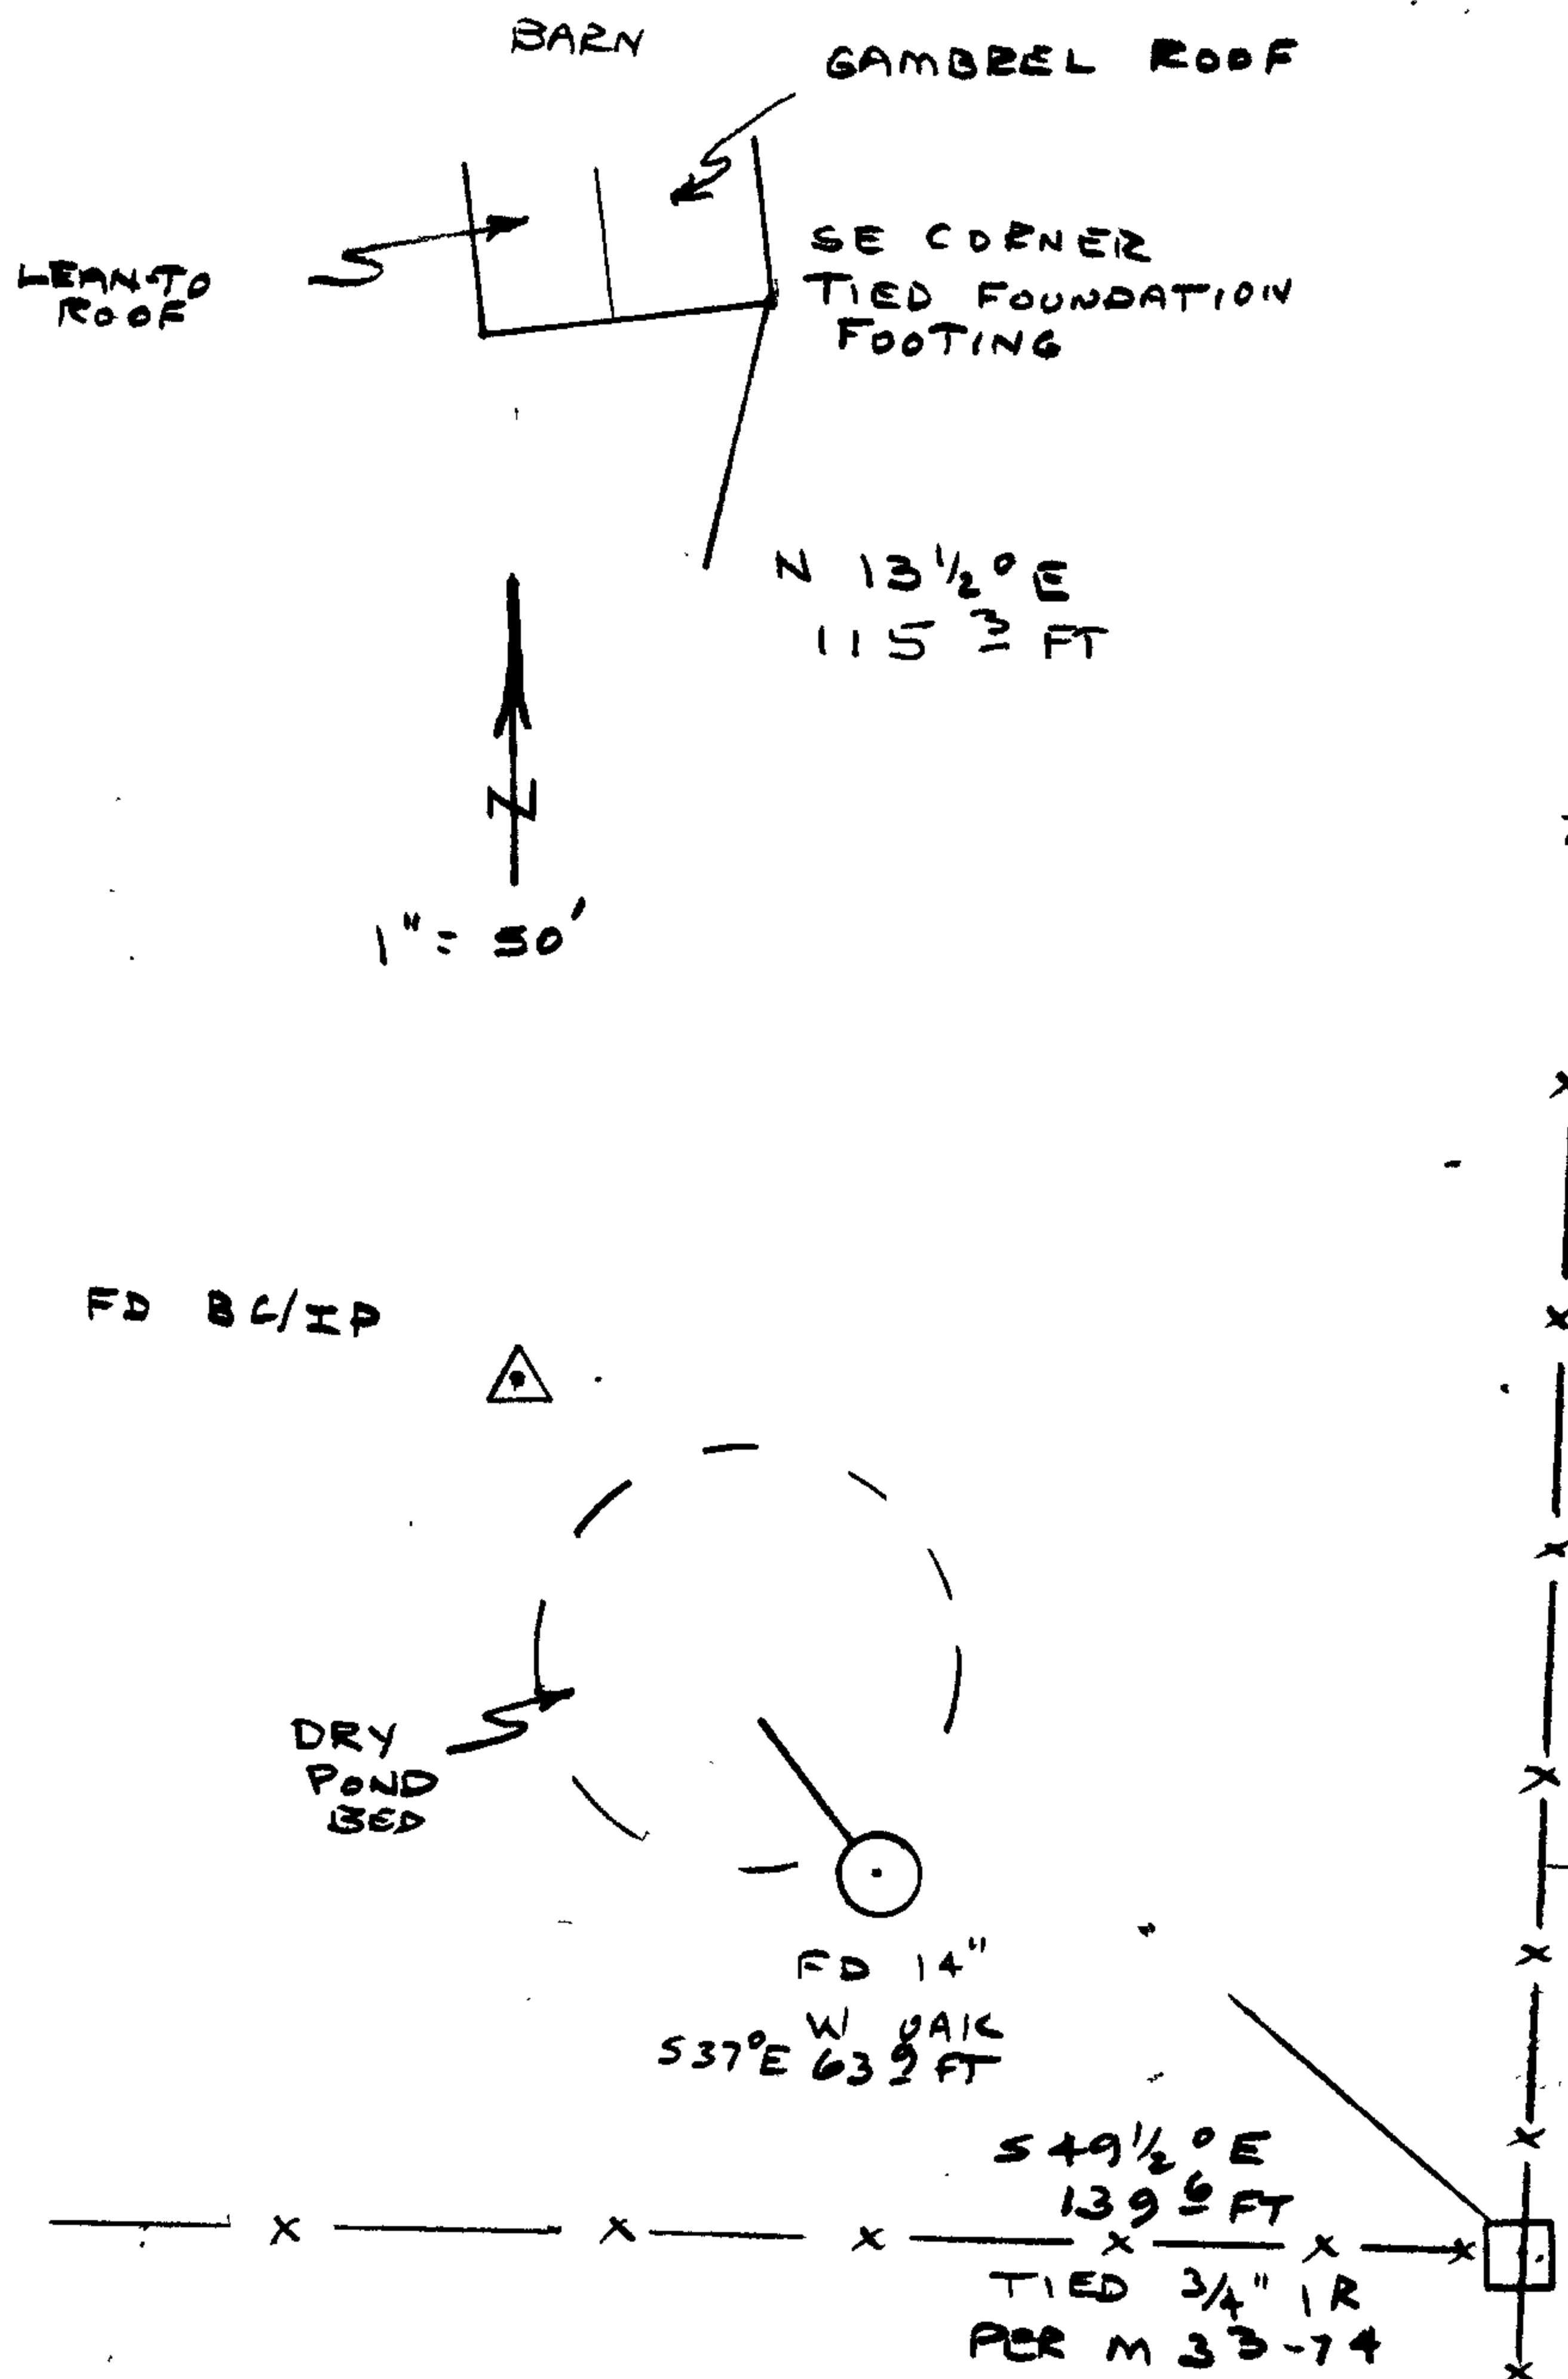
Sketch of Monument, Accessories, and General Area

ORIGINAL MONUMENT NOT FOUND

IRON PIPE AND BRASS CAP SET BY BYRON
 RECENTLY SET AND PROTRUDING 16" ABOVE
 GROUND IS MARKED

ORIGINAL NE BT NOT FOUND.

ORIGINAL 15" W. OAK IS DEAD AND DOWN. FOUND STUMP SHELL 30" DIAMETER WITH DECAYED REMAINS OF TRUNK LAYING ALONGSIDE (NO SCRIBING FOUND). STUMP BEARS S 62° W 207 3/4 FEET (RECORD BEARING N 59 1/4° E CHECKS WELL FROM BT STUMP TO CAP. AGREES WITH BYRON'S COMMENTS ON LOCAL MAGNETIC ATTRACTION NEAR THE CORNER MONUMENT).

BYRON BT: A 10" NOW 14" W. OAK WITH WELL HEALED DOUBLE BLAZE BEARS S 37° E 63 1/2 FEET. BT SITUATED ALONG S.E. EDGE OF DRY POND BED.

SE CORNER OF DEL RIO RANCH ESTATES (PER M 33-74) A 3/4" IRON ROD 2' SOUTHERLY OF FENCE INTERSECTION (FENCES RUNNING NORTHERLY - WESTERLY - AND SOUTHERLY) BEARS S 49 1/2° E 139 6 FEET.

TIED FOOTING CORNER (NOT BLOCK STEM WALL) AT SOUTH EAST CORNER OF BARN BEARS N 13 1/2° E 115 3 FEET. WE MARK SOUTHERLY FACE OF FOOTING "B O".
