GOVERNMENT CORNER RESTORATION FORM

Township 31S Range 5W Sec. 1 County DOUGLAS

State OR Date 9/26/88 No. _____

Station: W.C. SW COR S 1 T31 S, R 5W , Sec 11

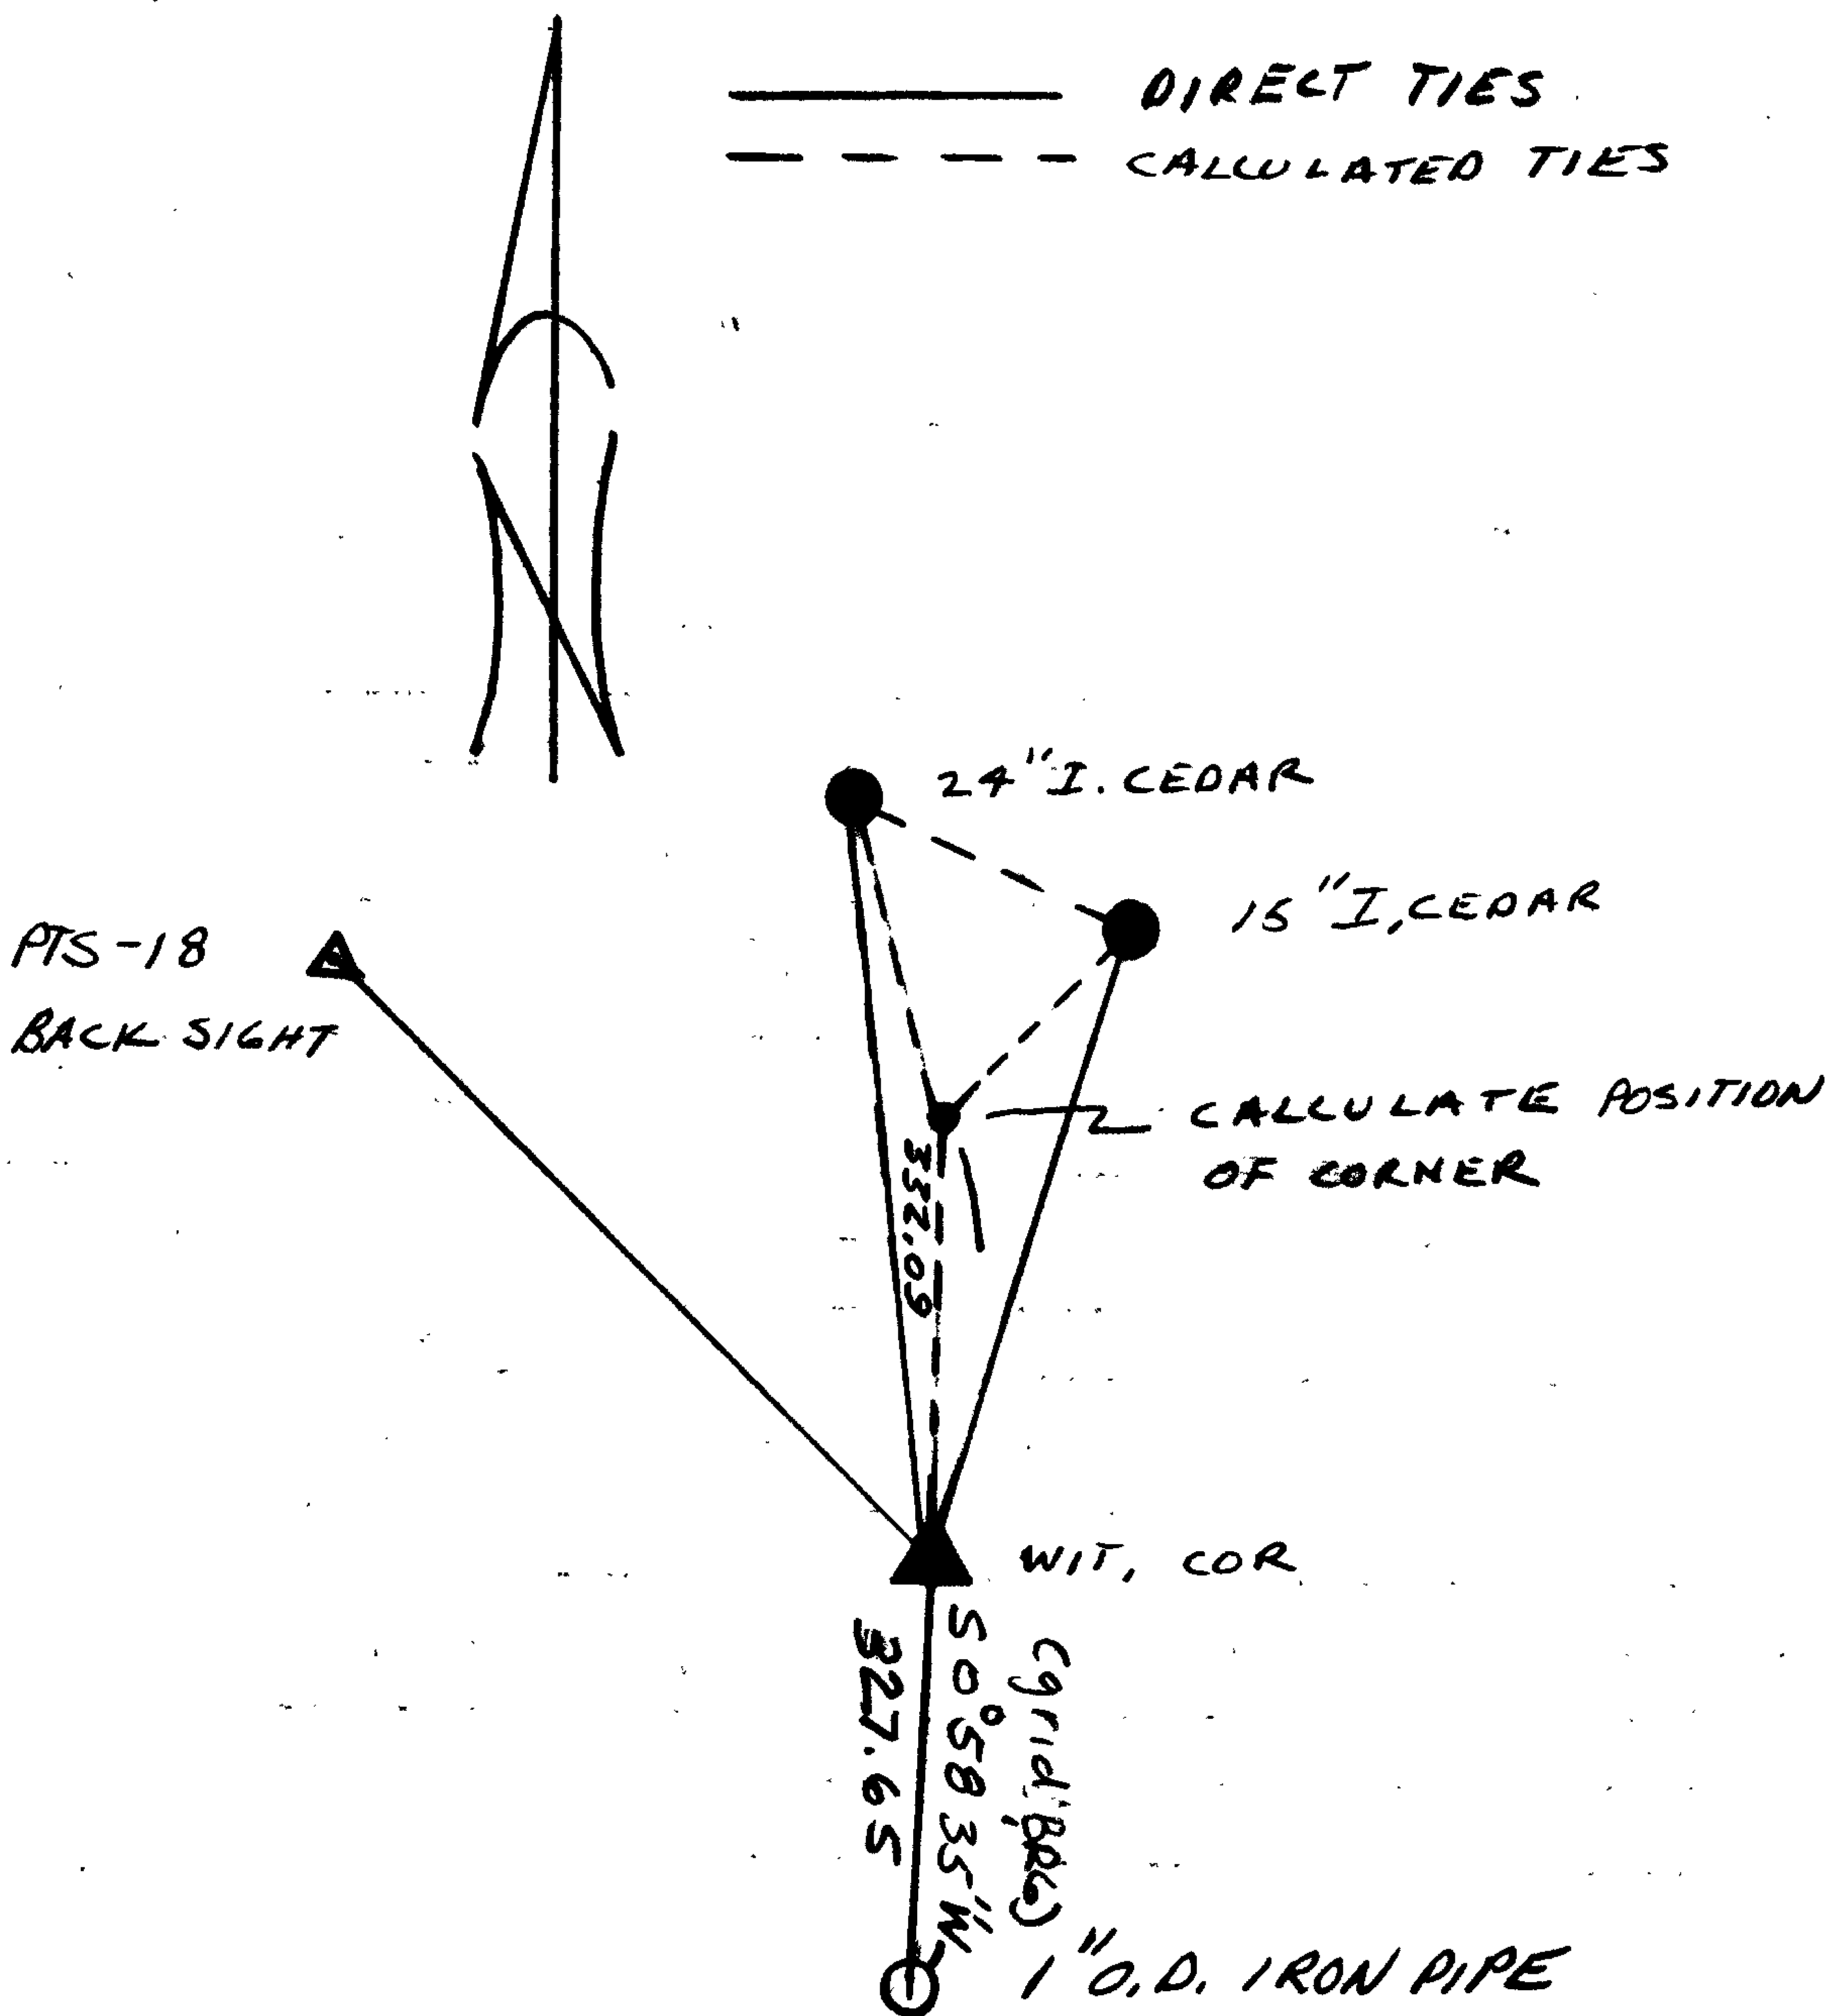
POSITION OF SECTION CORNER AS DETERMINED BY BYRON (REN #105) AND BLM IN 1973, WERE NOT LOOKED FOR. SECTION CORNER FALLS ON OR NEAR NORTH BOUND LANES OF I-5.

FOUND A 1969 DCSD BRASS CAP ON A IRON PIPE MARKED AS AT RIGHT. (SEE DCSD CORNER RENEWAL RECORDS #117, FOR WIT. CORNER BEARING TREE AND BEARING OBJECT INFORMATION)

12" NW 15" DIA. T. CEDAR WITH A PARTIALLY HEALED SINGLE BLAZE, SCRIBING VISIBLE "SR5WS1BT" BEARS N 17 1/4° W, 243.5 FT (RECORD N 19° W, 244.8 FT). PER 1973 BLM D. RESURVEY.

21" NW 24" DIA. I CEDAR WITH A PARTIALLY HEALED SINGLE BLAZE, SCRIBING VISIBLE "31S R5W SR BT" BEARS N 41 1/2° E, 199.9 FT (RECORD N 40° E, 197.3 FT). PER 1973 BLM D. RESURVEY.

A SECTION CORNER POSITION OF TRUE NORTH, 332.0 FEET FROM WIT. COR. AND AN INTERSECTION OF TRUE BEARINGS FROM BLM BEARING TREES, SHOWED THE MOST AGREEMENT WITH THE 1973 BLM POSITION OF SECTION CORNER. THIS POSITION OF SECTION CORNER SEEMS TO BE IN DISAGREEMENT WITH POSITION DETERMINED FROM MAP IN CS. FILE NO. 54/76

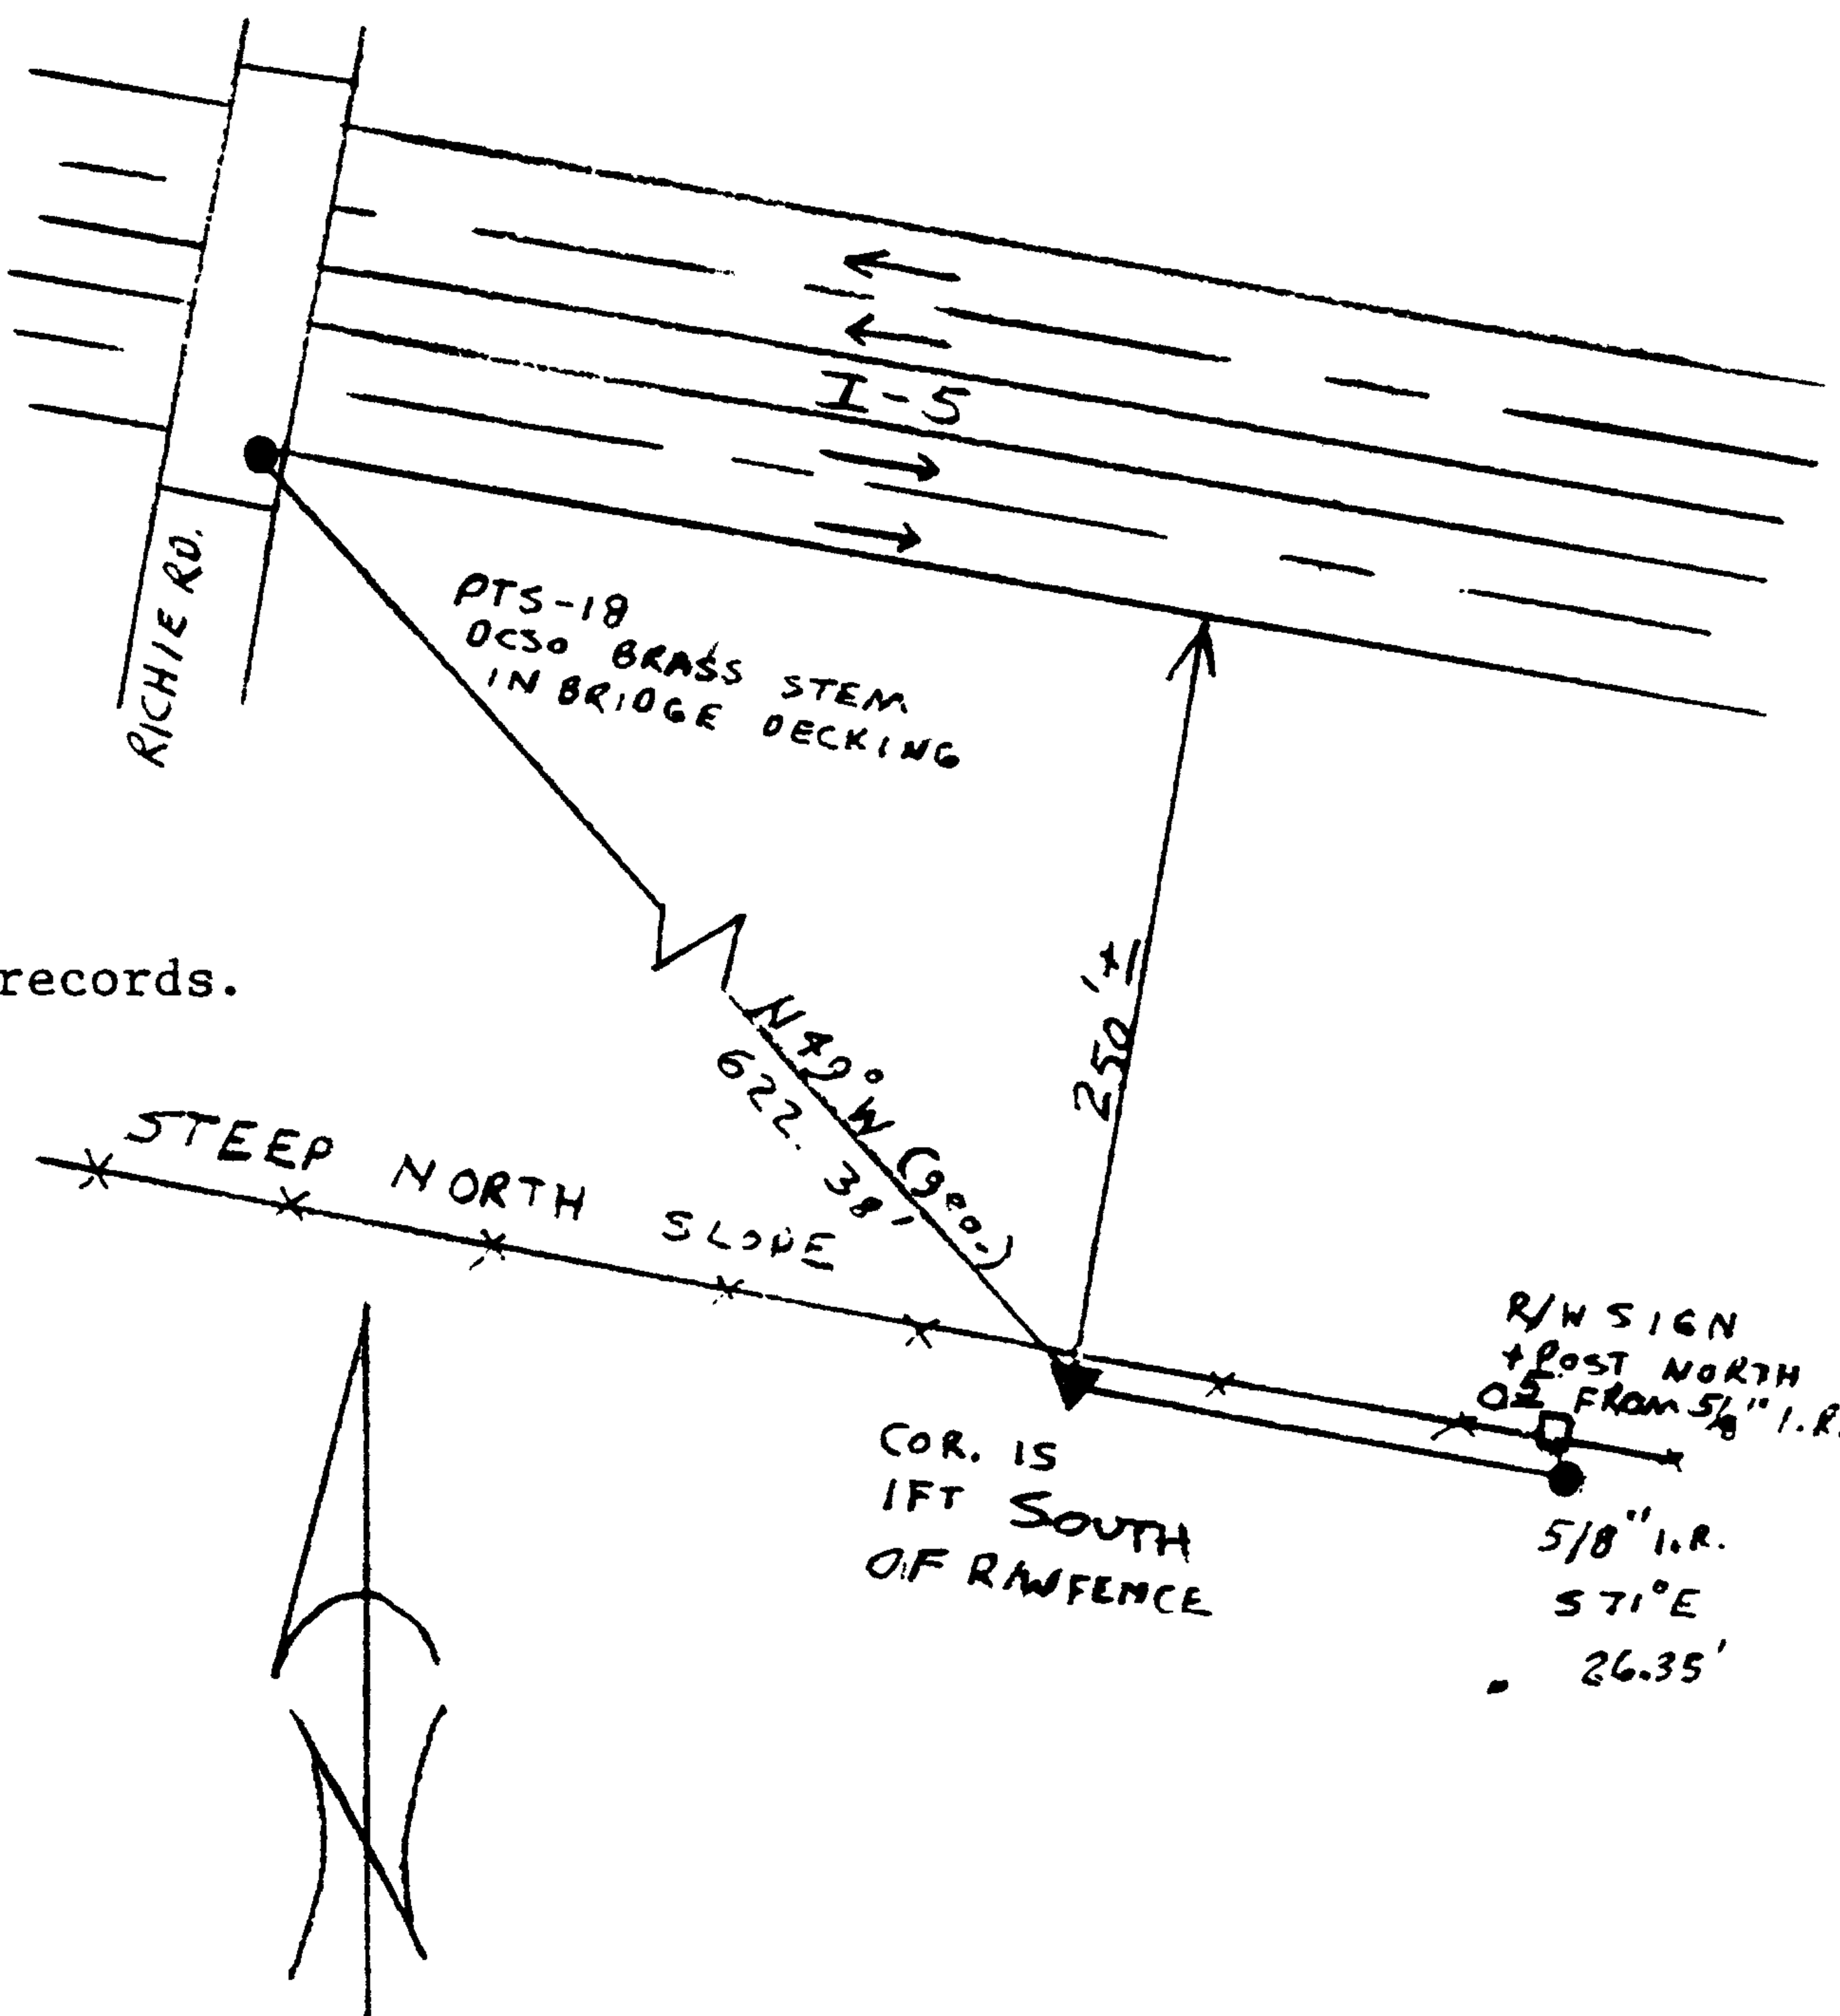
SKETCH

A DCSO disk on an I.P. stamped "T31S, R5W, W.C. 332'N. to S2 1 S11 S12 1969" protrudes 6" above ground.

From the Richie Rd. (Canyon Crk. Exit #95) overpass crossing of I-5 in T31S, R5W, Sec2, corner is approx. S49° E, 620 ft.
