GOVERNMENT CORNER RESTORATION FORM

Township 25S Range 5W Sec. 13 County DOUGLAS

State OR Date 4/4/89 No. _____

$\frac{1}{4}$ S 13 | S 18

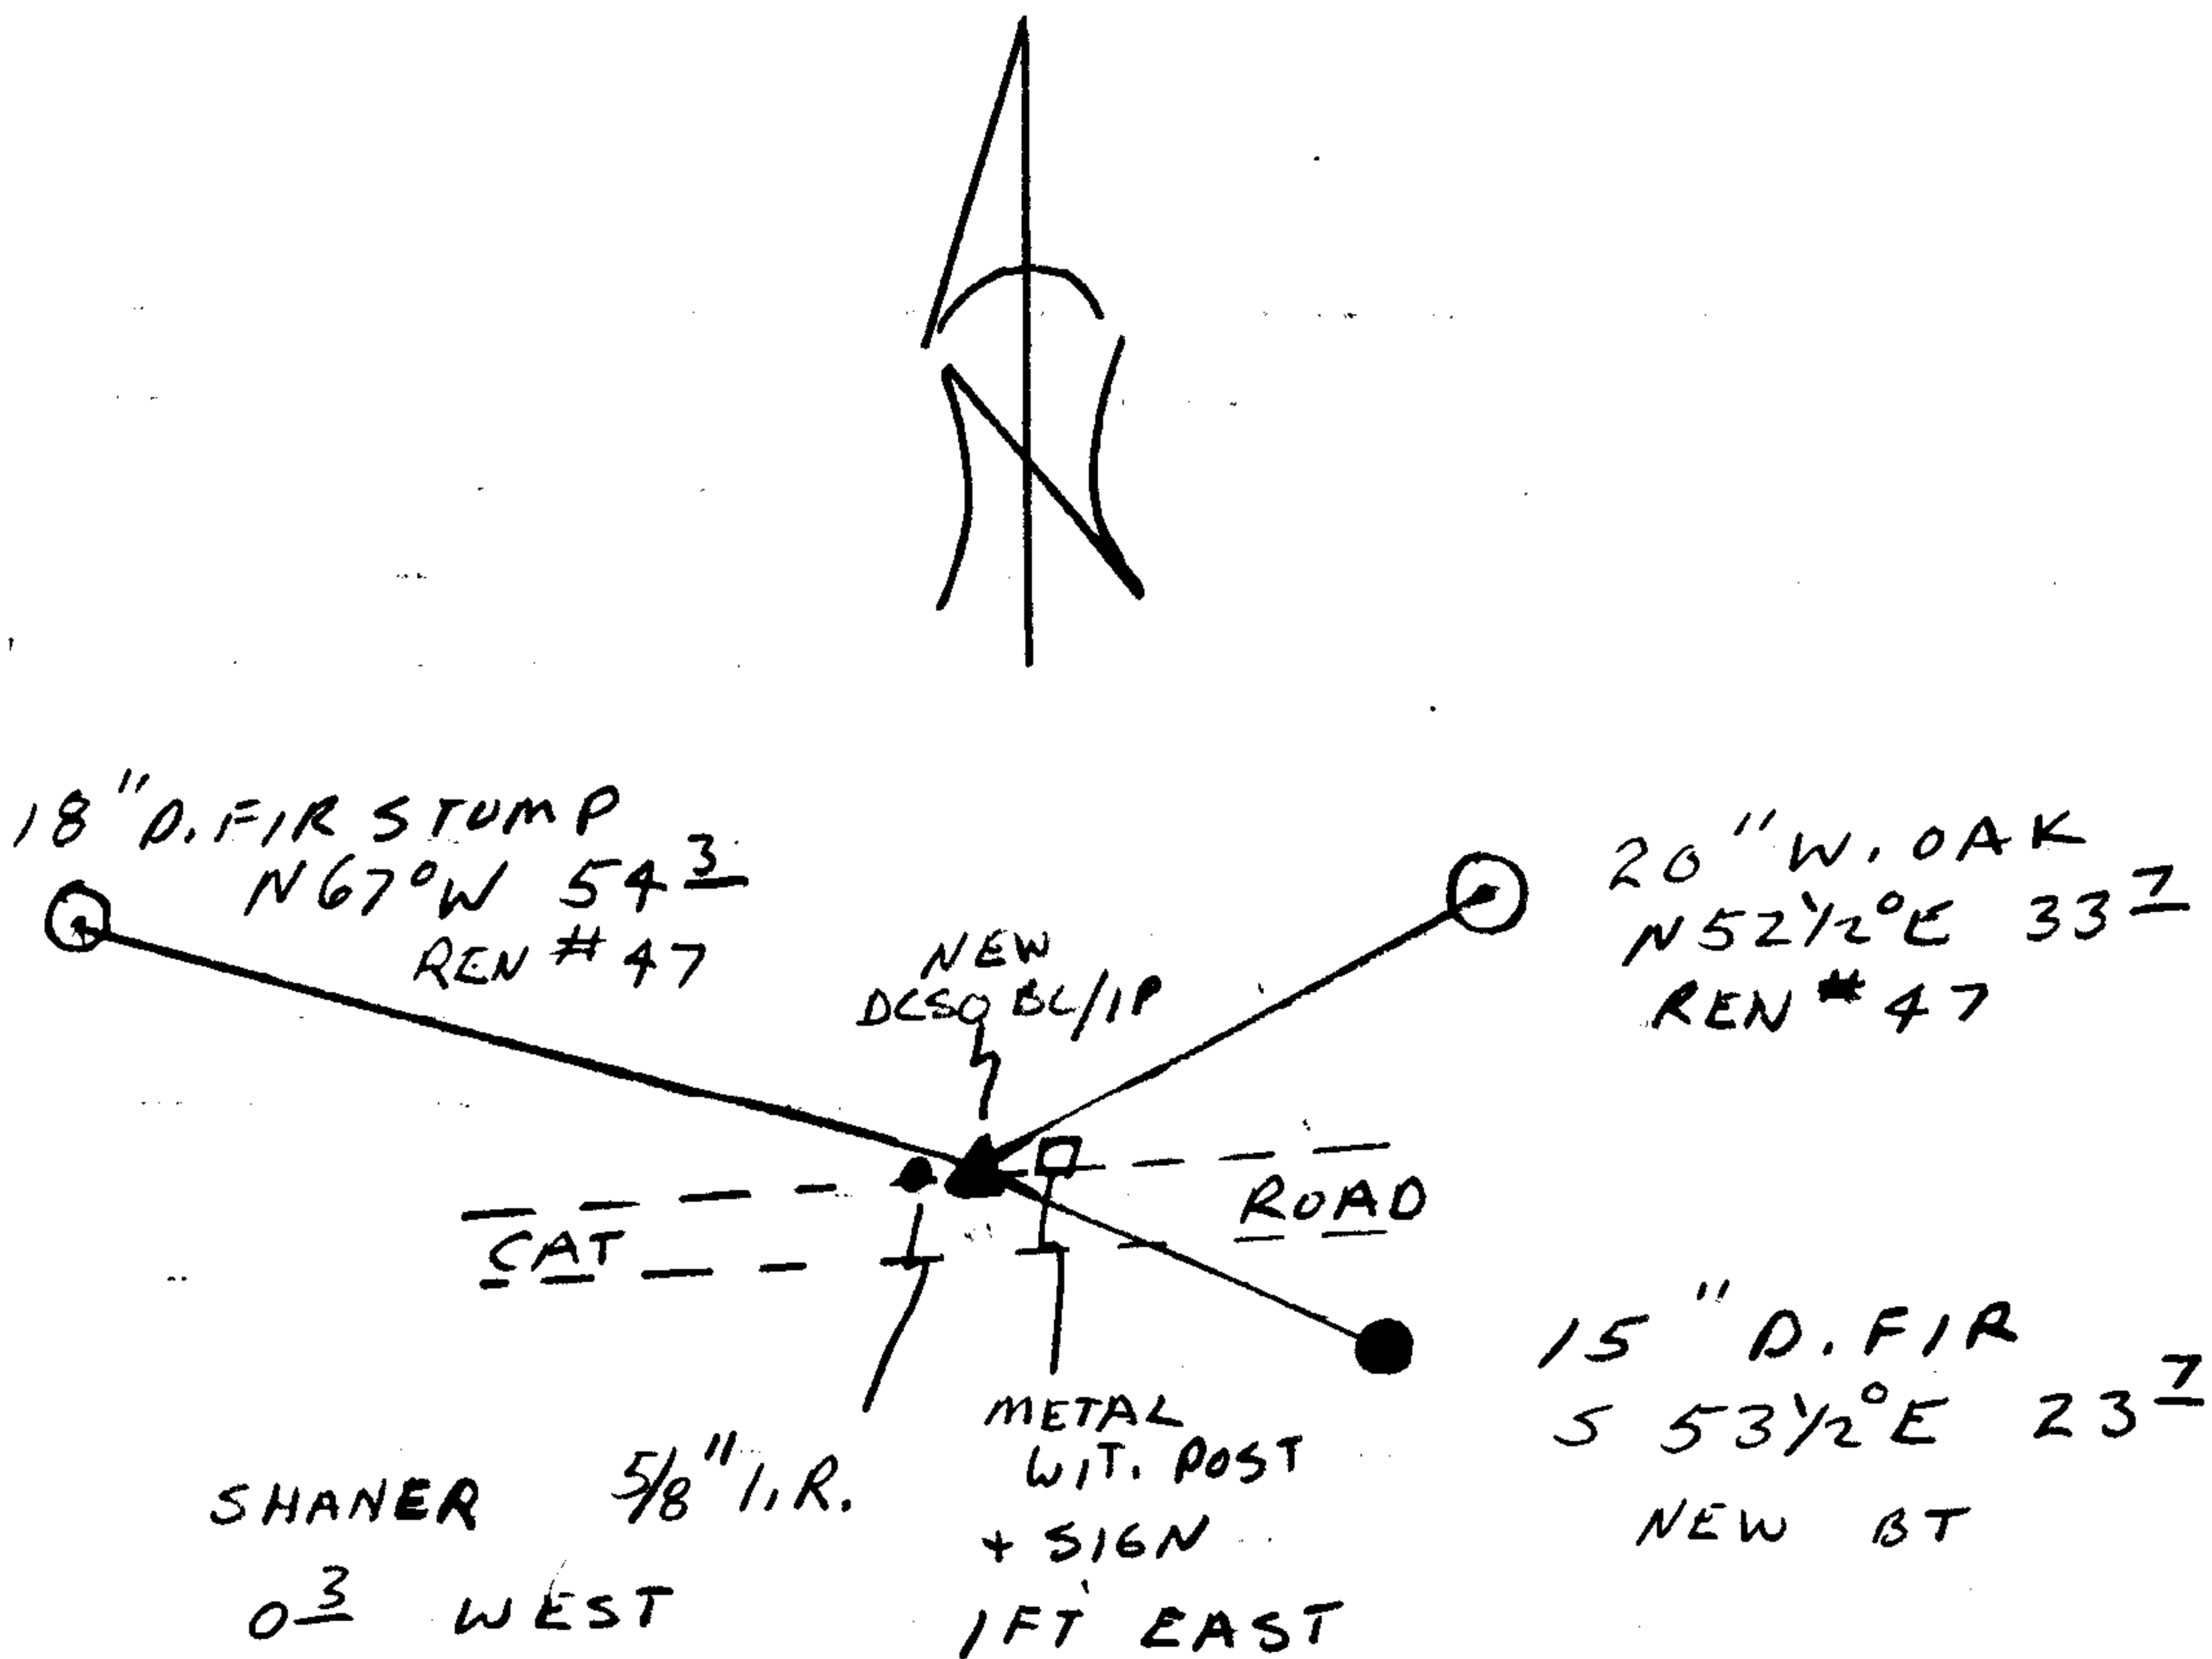
Sketch of Monument, Accessories, and General Area

A 2 1/2" DIA. DCSO BRASS CAP ON
1 1/2" O.D. BY 36" LONG IRON PIPE.
BC/IP IS BADLY BENT NORTH.

A 5/8" IRON ROD WITH AN ALUM.
CAP STAMPED "SHANER ENGINEERING."
PROTRUDING 7" ABOVE GROUND IS FOUND
0.3 FT WEST OF DCSO BC/IP PLUMB
POSITION.

MEASUREMENTS TAKEN FROM PLUMBED *POSITION OF DCSO BC/IP
NO EVIDENCE OF ORIGINAL RT'S FOUND

14" NOW 18" DIA. 2 FT HIGH D. FIR STUMP WITH A FULLY HEALED
LOWER BLAZE, BEARS N67°W, 54.3 FT (PER REN #47) AGREES
WITH RECORD.

15" NOW 20" DIA W. OAK WITH FULLY HEALED DOUBLE BLAZE,
BEARS N52 1/2°E, 33.7 FT (PER REN #47) AGREES WITH RECORD.

PLUMBED POSITION OF 1958 DCSO BC/IP AND SHANER 5/8" I.R. REFERENCED. A NEW 2 3/8" DIA BRASS CAP ON A 1 3/8" O.D BY 32" LONG IRON PIPE IS SET AT 1958 DCSO BC/IP PLUMBED POSITION, PROTRUDES 6" ABOVE GROUND. SHANER 5/8" I.R. WITH ALUM. CAP IS SET AT IT'S REFERENCED POSITION, PROTRUDES 4" ABOVE GROUND.

15" D. FIR DOUBLE BLAZED AND SCRIBED " 1/4 S18 CS BT"
BEARS S53 1/2° E, 23.7 FT
