GOVERNMENT CORNER RESTORATION FORM

Township 21S Range 5W Sec. 34 County DOUGLAS

Corner Designation

$\frac{1}{4}$
534 | 535

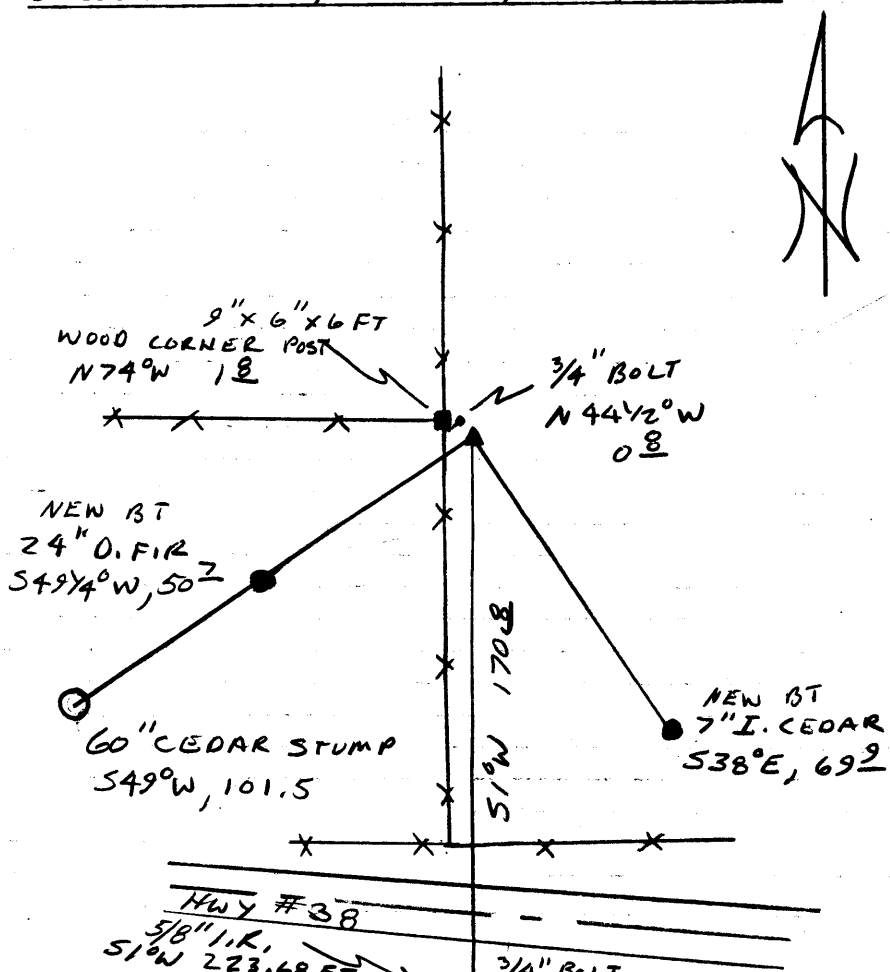
Sketch of Monument, Accessories, and General Area

2 1/2" DIA. DCSSO BRASS CAP ON A
1 1/4" O.D. IRON PIPE, 2 IN BELOW
GROUND LEANING 8 IN SOUTHEAST
OF PLUMB. (PER M19-53)

3/4" BOLT WITH NUT PROTRUDING 8" ABOVE
GROUND BEARS N 74 1/2° W, 0.8 FT
FROM DCSSO BC/IP PLUMB POSITION
(SOURCE UNKNOWN)

18" FIR PER M 19-53 IS GONE PROBABLY REMOVED BY
ROAD WORK ON HIGHWAY

54" NOW 60" DIA 2 1/2 FT HIGH CEDAR STUMP WITH A
PREVIOUSLY OPENED BLAZE AND AXE MARK, NO SCRIBING
FOUND BEARS S 49° W, 101.5 FT (REC. S 59° W, 100.5 FT)
(PER M 19-53).

3/4" IRON ROD NOW BENT 3/4" BOLT BEARS S 1° W, 170.8 FT
(AGREES WELL WITH RECORD) PER M 19-53.

5/8" IRON ROD BEARS S 1° W, 223.68 FT (AGREES WELL WITH
RECORD) PER M 81-72

CORNER IS APPROX
140' NORTH OF HIGHWAY

DCSO BC/IP RETURNED TO PLUMB
POSITION, BC IS FLUSH WITH
GROUND. POSITION OF CORNER
AS DETERMINED IN M19-53 PERPETUATED
BY NEW BT'S BELOW

24" D. FIR DOUBLE BLAZED AND SCRIBED "Y4 S34 CS BT"
BEARS S49Y4°W 50.7 FT

A DOUBLE TRUNKED I CEDAR DOUBLE BLAZED AND SCRIBED
"Y4 S35 CS BT" ON 7" SOUTHWEST TRUNK BEARS S38°E, 69.9 FT
TO ROOT CROWN.
