OREGON CORNER RESTORATION FORM

Section 11 Township 22S Range 26W

EAST 1/4 CORNER, ALSO
BEING THE COMMON 1/4
CORNER TO SECTION 12

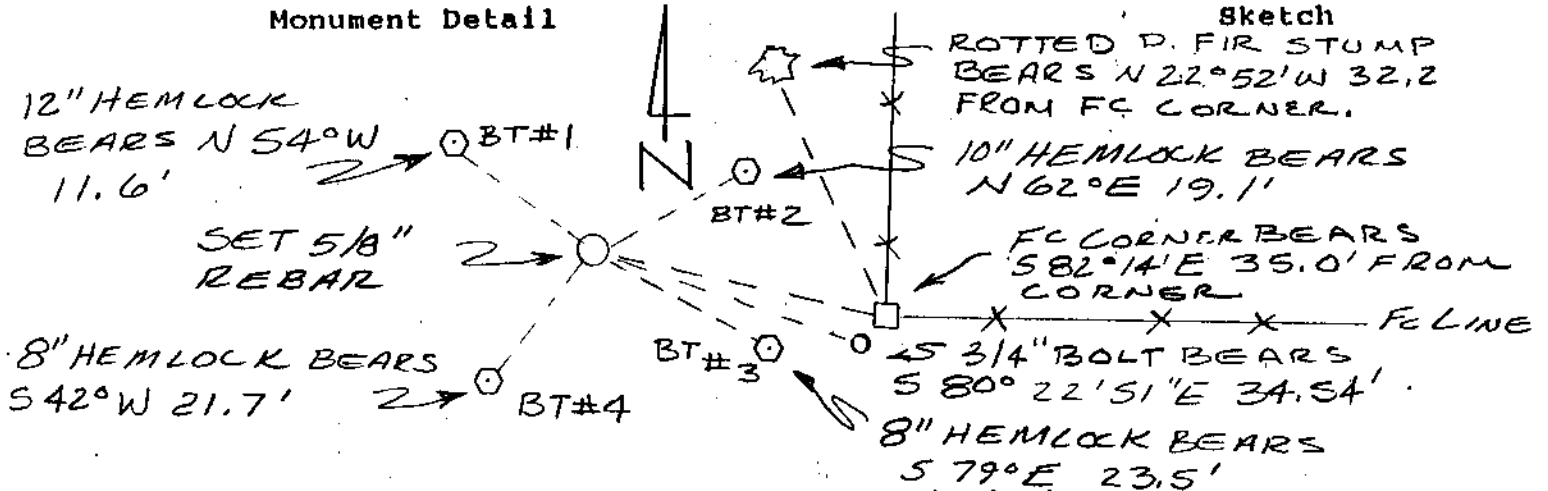
Monument Detail

NO CONCLUSIVE EVIDENCE OF THE ORIGINAL
CORNER WAS FOUND. FOUND 3/4" BOLT
BEARING S 80° 22' 51" E 34.54 FEET AND
CORNER FENCE POST BEARING S 82° 14' E
35.0 FEET FROM REESTABLISHED CORNER.
ORIGIN OF 3/4" BOLT IS UNKNOWN, ROTTED 20"
FIR STUMP BEARS N 22° 52' W 32.2 FEET
FROM FENCE CORNER, NO SCRIBE MARKS FOUND.

SET 5/8" X 30" REBAR WITH YELLOW
PLASTIC CAP MARKED "BRANCH ENG
LS 1138". CORNER WAS SET BY PROPORTIONATE
MEASUREMENT, ON LINE AT THE MIDPOINT
BETWEEN THE NE AND SE SECTION CORNERS.
