OREGON CORNER RESTORATION FORM

Section 22 Township 31S Range 5W

22/23  
27/26

C.S. File No. 63/138-12c

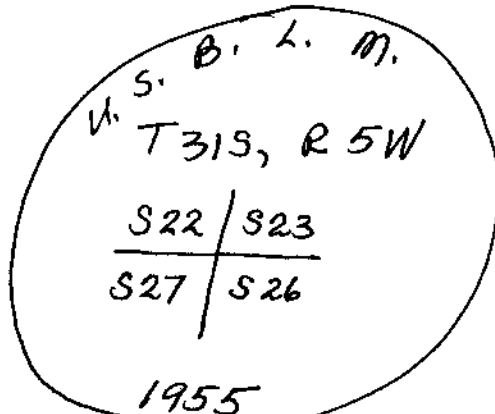
Monument Detail

35" D. Fir BT, face badly burned, bears S40°E (Record S45°E), ~~22~~ feet.

32" D. Fir BT, healed blaze, bears S12°E (Record S14°E), 23 1/2 feet.

21" D. Fir BT stump, badly burned, bears S36°W (Record S31°W), 28 1/2 ft.

36" D. Fir BT, healed blaze, bears N68°W, 23 1/2 feet.

19" D. Fir BT, bearing S25°W, 30 1/2 feet, Now Gone.

18" Madrone BT, face overgrown, bears N8°W, 21 1/2 feet.

Found 2 1/2" Brass Cap on a 2" Galv. Iron Pipe.

(Set Steel Fence Post Along Side.)

I marked a 12" D. Fir BT, "T31S, R5W, S27, BT", S76°W, 41 1/2 feet from corner.
