OREGON CORNER RESTORATION FORM

S.W. CORNER Section 18 Township 23S Range 5W

County DOUGLAS Date 3/27/93

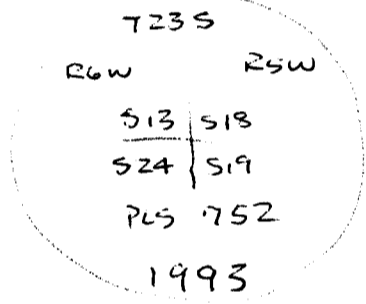
ROVEVALE & THUD
THE 1943 G.L.O. MONUMENT
WAS SET AT

PROPORTIONATE DISTANCE, NO REMAINING EVIDENCE
OF ORIGINAL CORNER.

I FOUND EVIDENCE OF THREE OF THE ORIGINAL
(1853) BEARING TREES. I ADVISED THE B.L.M.
OF FINDING SAID B.T. & THEY SENT SOMEONE
TO VERIFY THE FIND. THEY ADVISED ME TO
SET MY OWN CORNER MONUMENT ^{SAGED ON 1853 B.T.} AND
THEY WOULD ACCEPT MY MONUMENT.

ROTTED REMAINS OF 28" FIR (PITH STUB & BARK RING, ROTTED OFF)
AT GROUND LEVEL - NO MARKS
N 81 3/4 W, 10.5 FT

36" FIR STUMP, (I CHOPPED OPEN TO VISIBLE SCRIBE "T235 524")
S 62 W, 17.2 FT.

ROTTED REMAINS OF A 32" FIR OR POSSIBLY A DOUBLE FIR
AS THERE WAS SOME BARK ON THE INSIDE OF THE ROTTED
CLUMP OF WOOD (NO MARKS)
S 55 1/4 E, 10.5 FT.

1943 B.T. (37" FIR SNAG - VISIBLE SCRIBE) - S 22 1/2 W - 78.3 FT.

I SET A 2" X 42" IRON PIPE WITH BRASS CAP
