GOVERNMENT CORNER RESTORATION FORM

Township 23S Range 5W Sec. 15 County DOUGLAS

Corner Designation AS DETERMINED BY RLS #536 ON RM 2-29

SW COR  
DLC 45

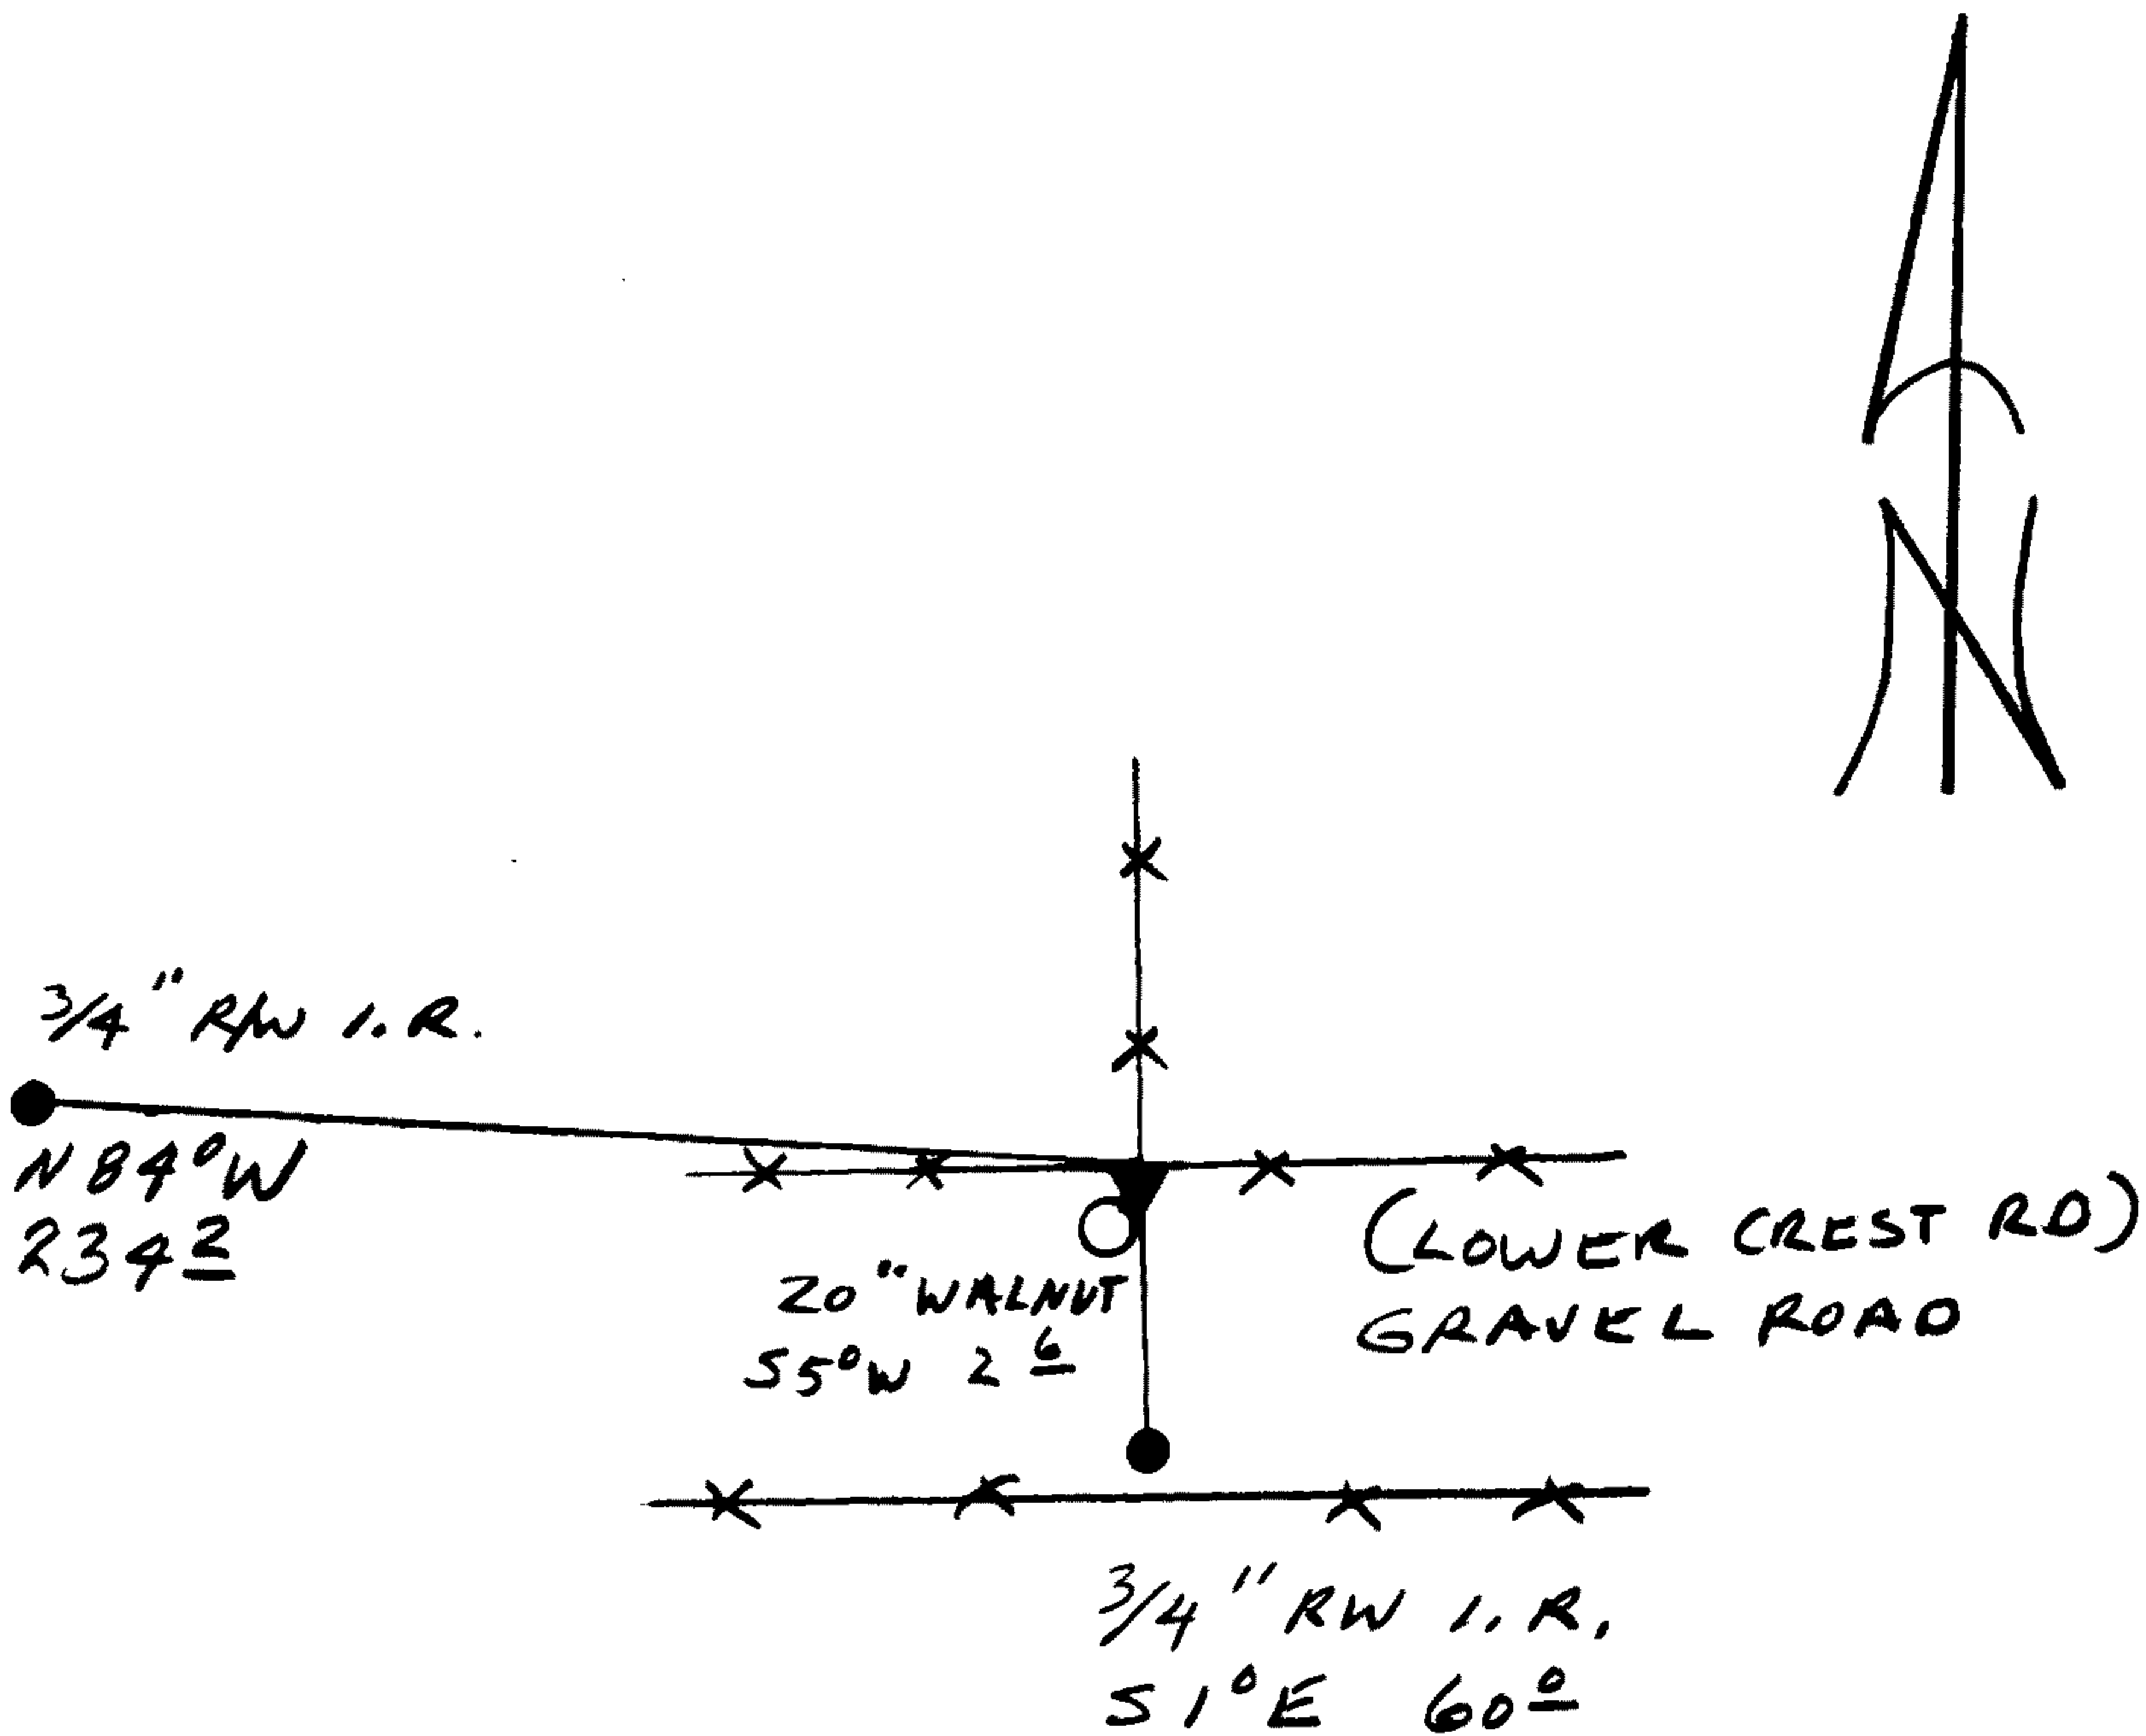
Sketch of Monument, Accessories, and General Area

2 1/2" DIA BRASS CAP ON A 1 1/4" O.D.  
IRON PIPE PROTRUDING 18" ABOVE  
GROUND. BC/IP LEANS 0.5 FT  
NW OF PLUMB.

20" WALNUT WITH AN OPEN ROTTED BLAZE FAINT SCRIBING  
VISIBLE "45" BEARS S5°W 2.6 FT (REC FROM RM 2-50  
S5°W 1.7 FT DIST. IS A FACE MEASUREMENT) BT FROM  
RM 2-29

3/4" BENT I.R., PLUMB POSITION BEARS S1°E, 60.0 FT  
(AGREES WITH REC.) RM 2-50

3/4" BENT I.R., PLUMB POSITION BEARS N84°W, 234.2 FT  
(AGREES WITH REC.) RM 2-50

COR. LIES 30' NORTH OF GRAVEL ROAD AT THE INTERSECTION OF A EASTERLY - WESTERLY AND NORTHERLY FENCE CORNER.

BLIP RETURNED TO PLUMB

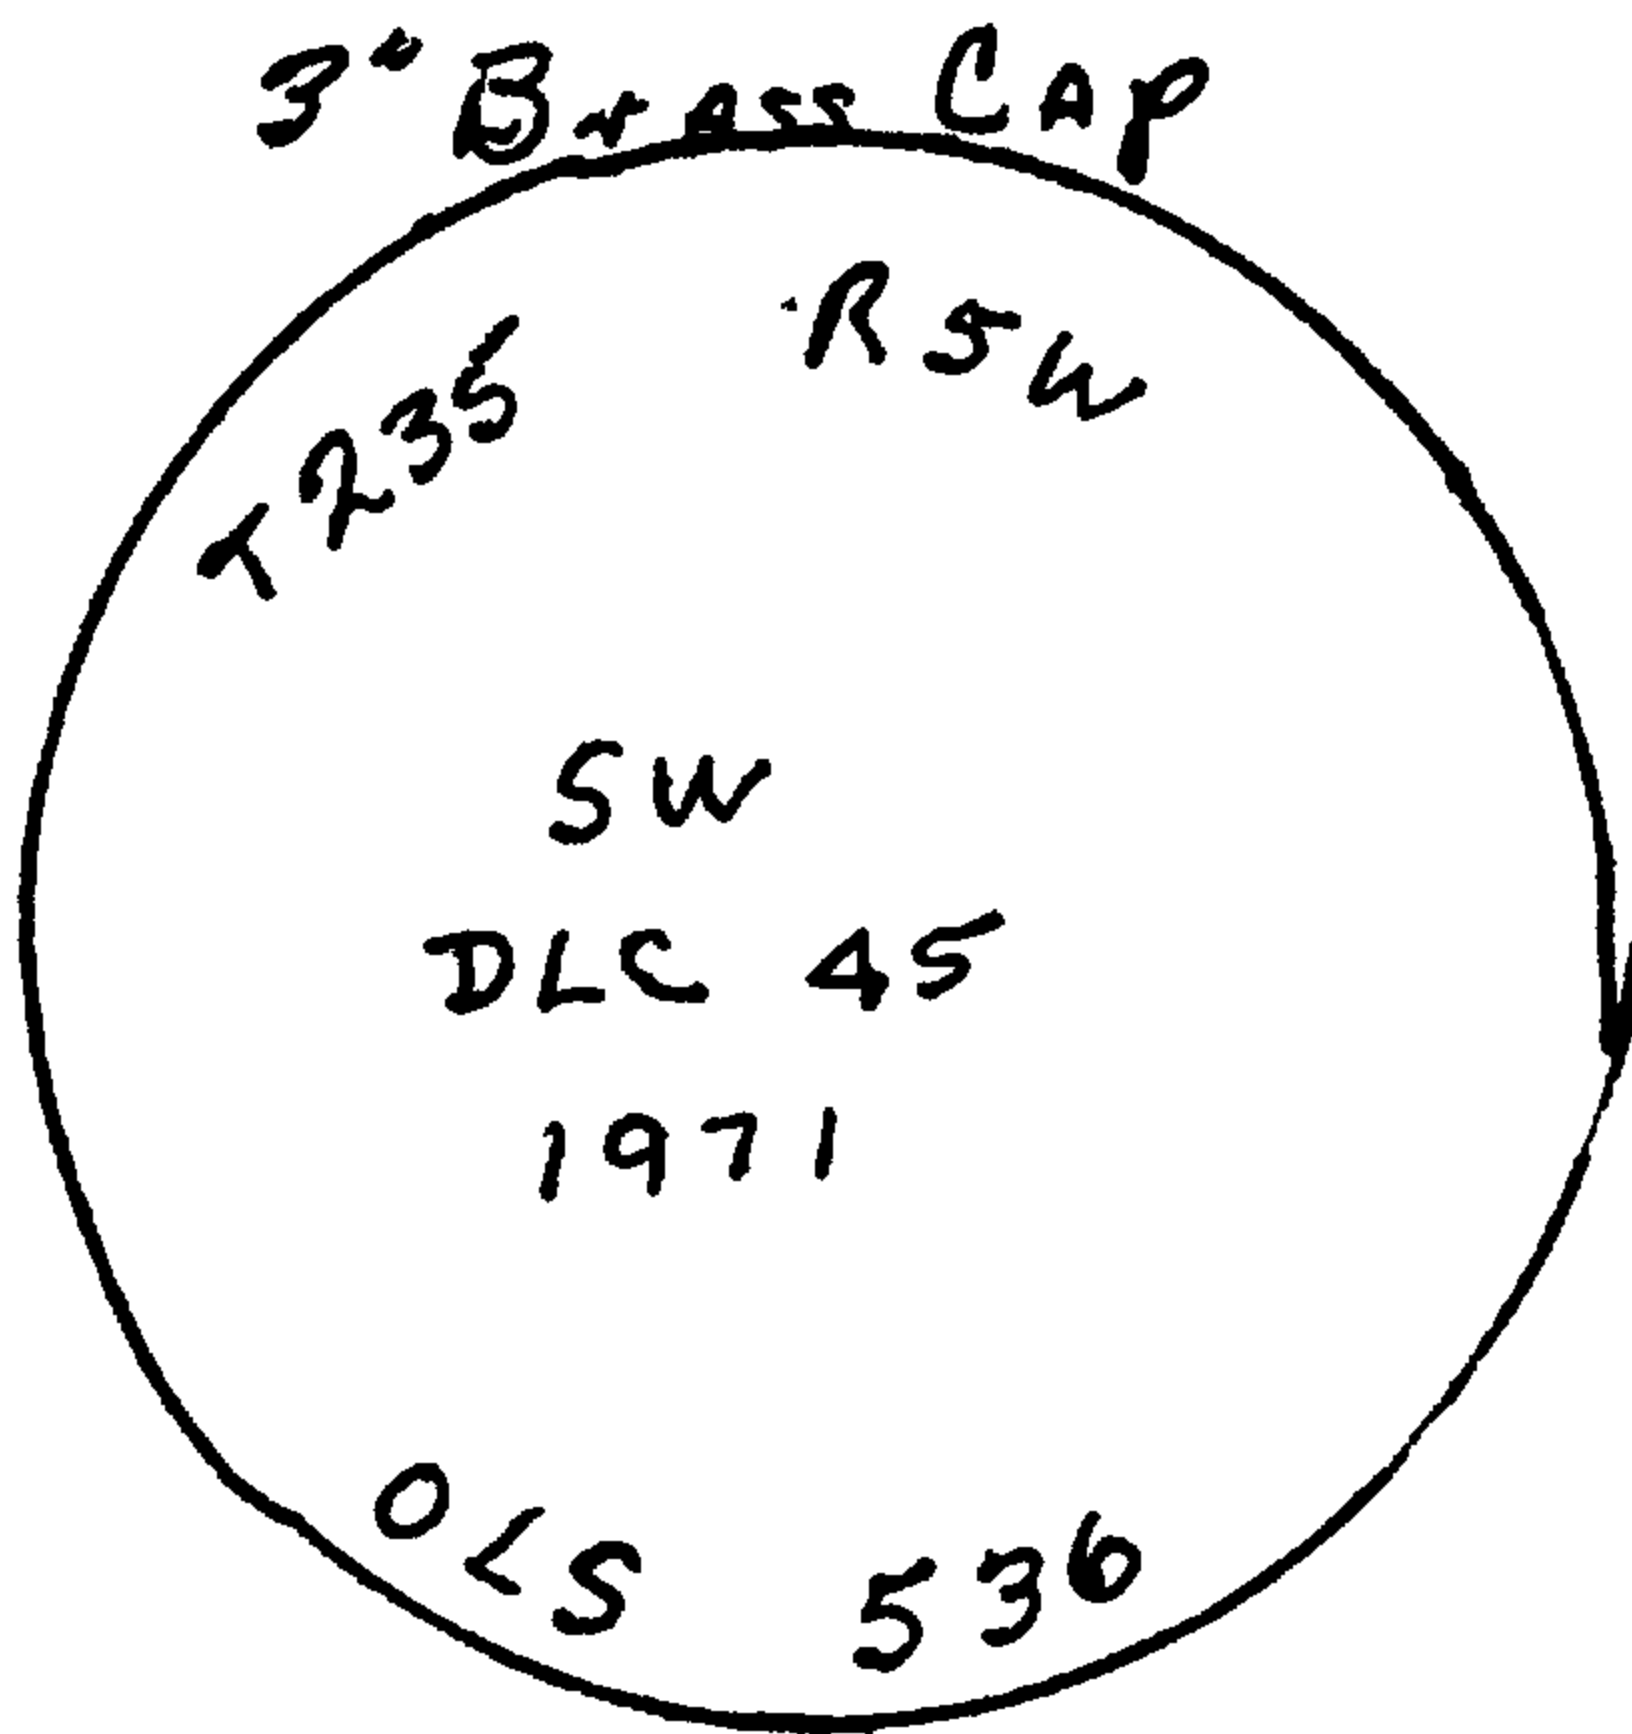
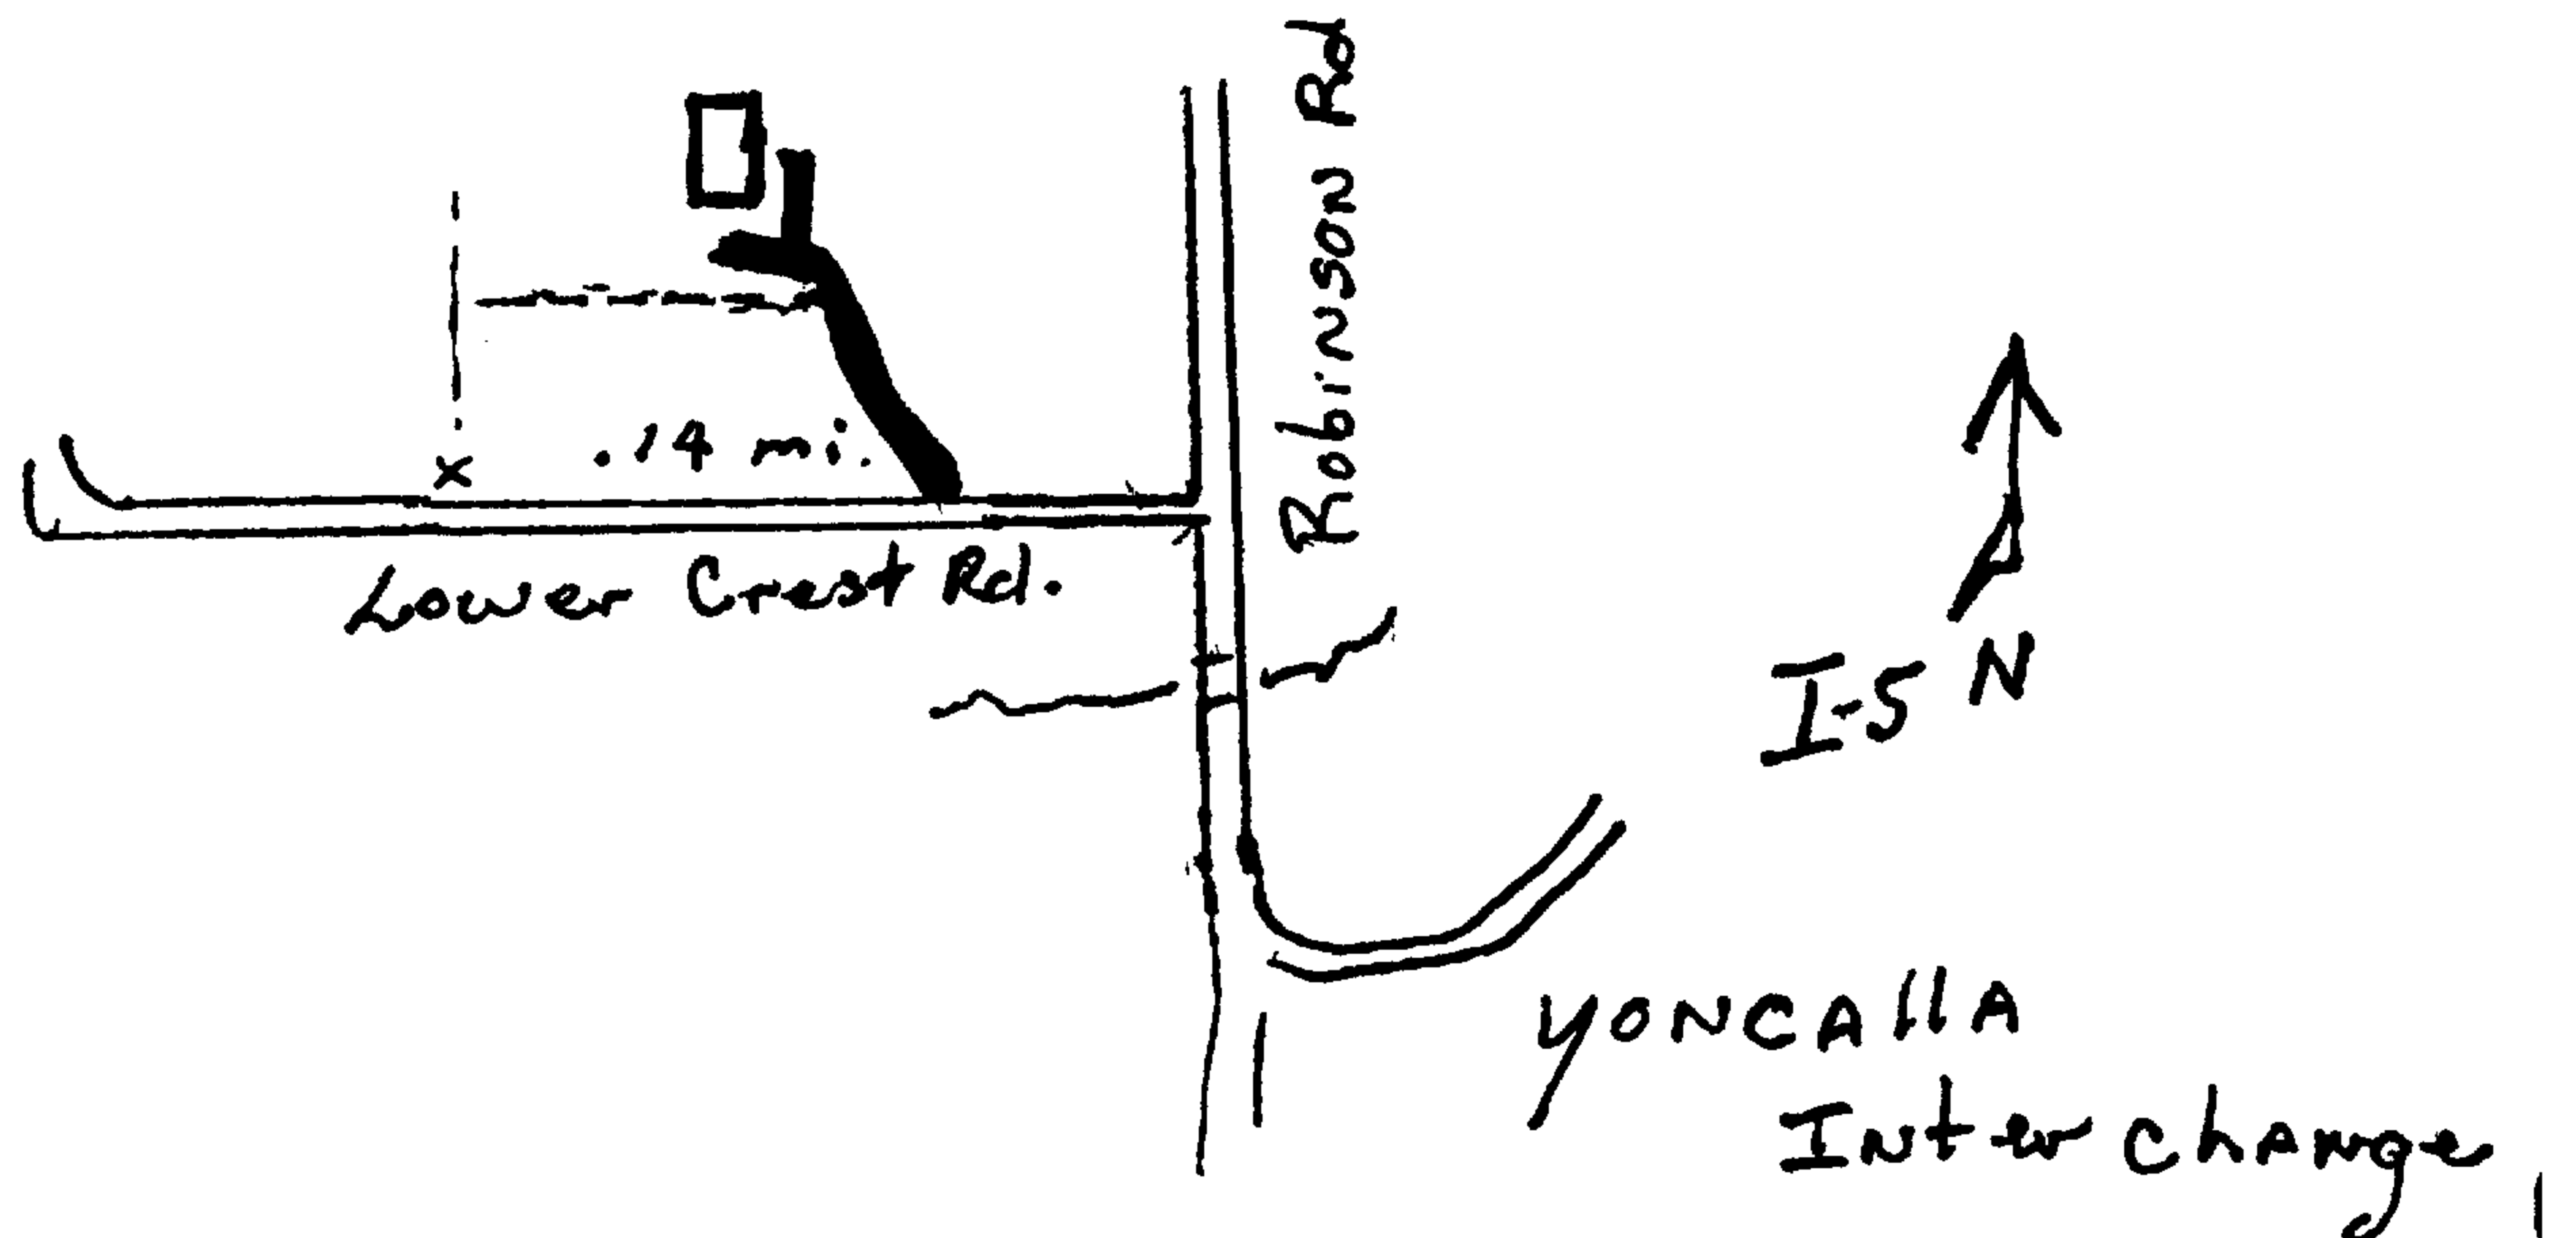
Sketch

3" Brass Cap mounted on galvanized pipe. The pipe  
with brass cap, has been pushed over (!) 1/2 foot by a wood corner  
fence post that was installed adjacent to DLC corner. D.L.C  
marker can be easily moved in any direction except thru  
fence post to original plumb position.
