GOVERNMENT CORNER RESTORATION FORM

Township 28S Range 5W Sec. 26 County DOUGLAS

Corner Designation

S27 | S26
S34 | S35

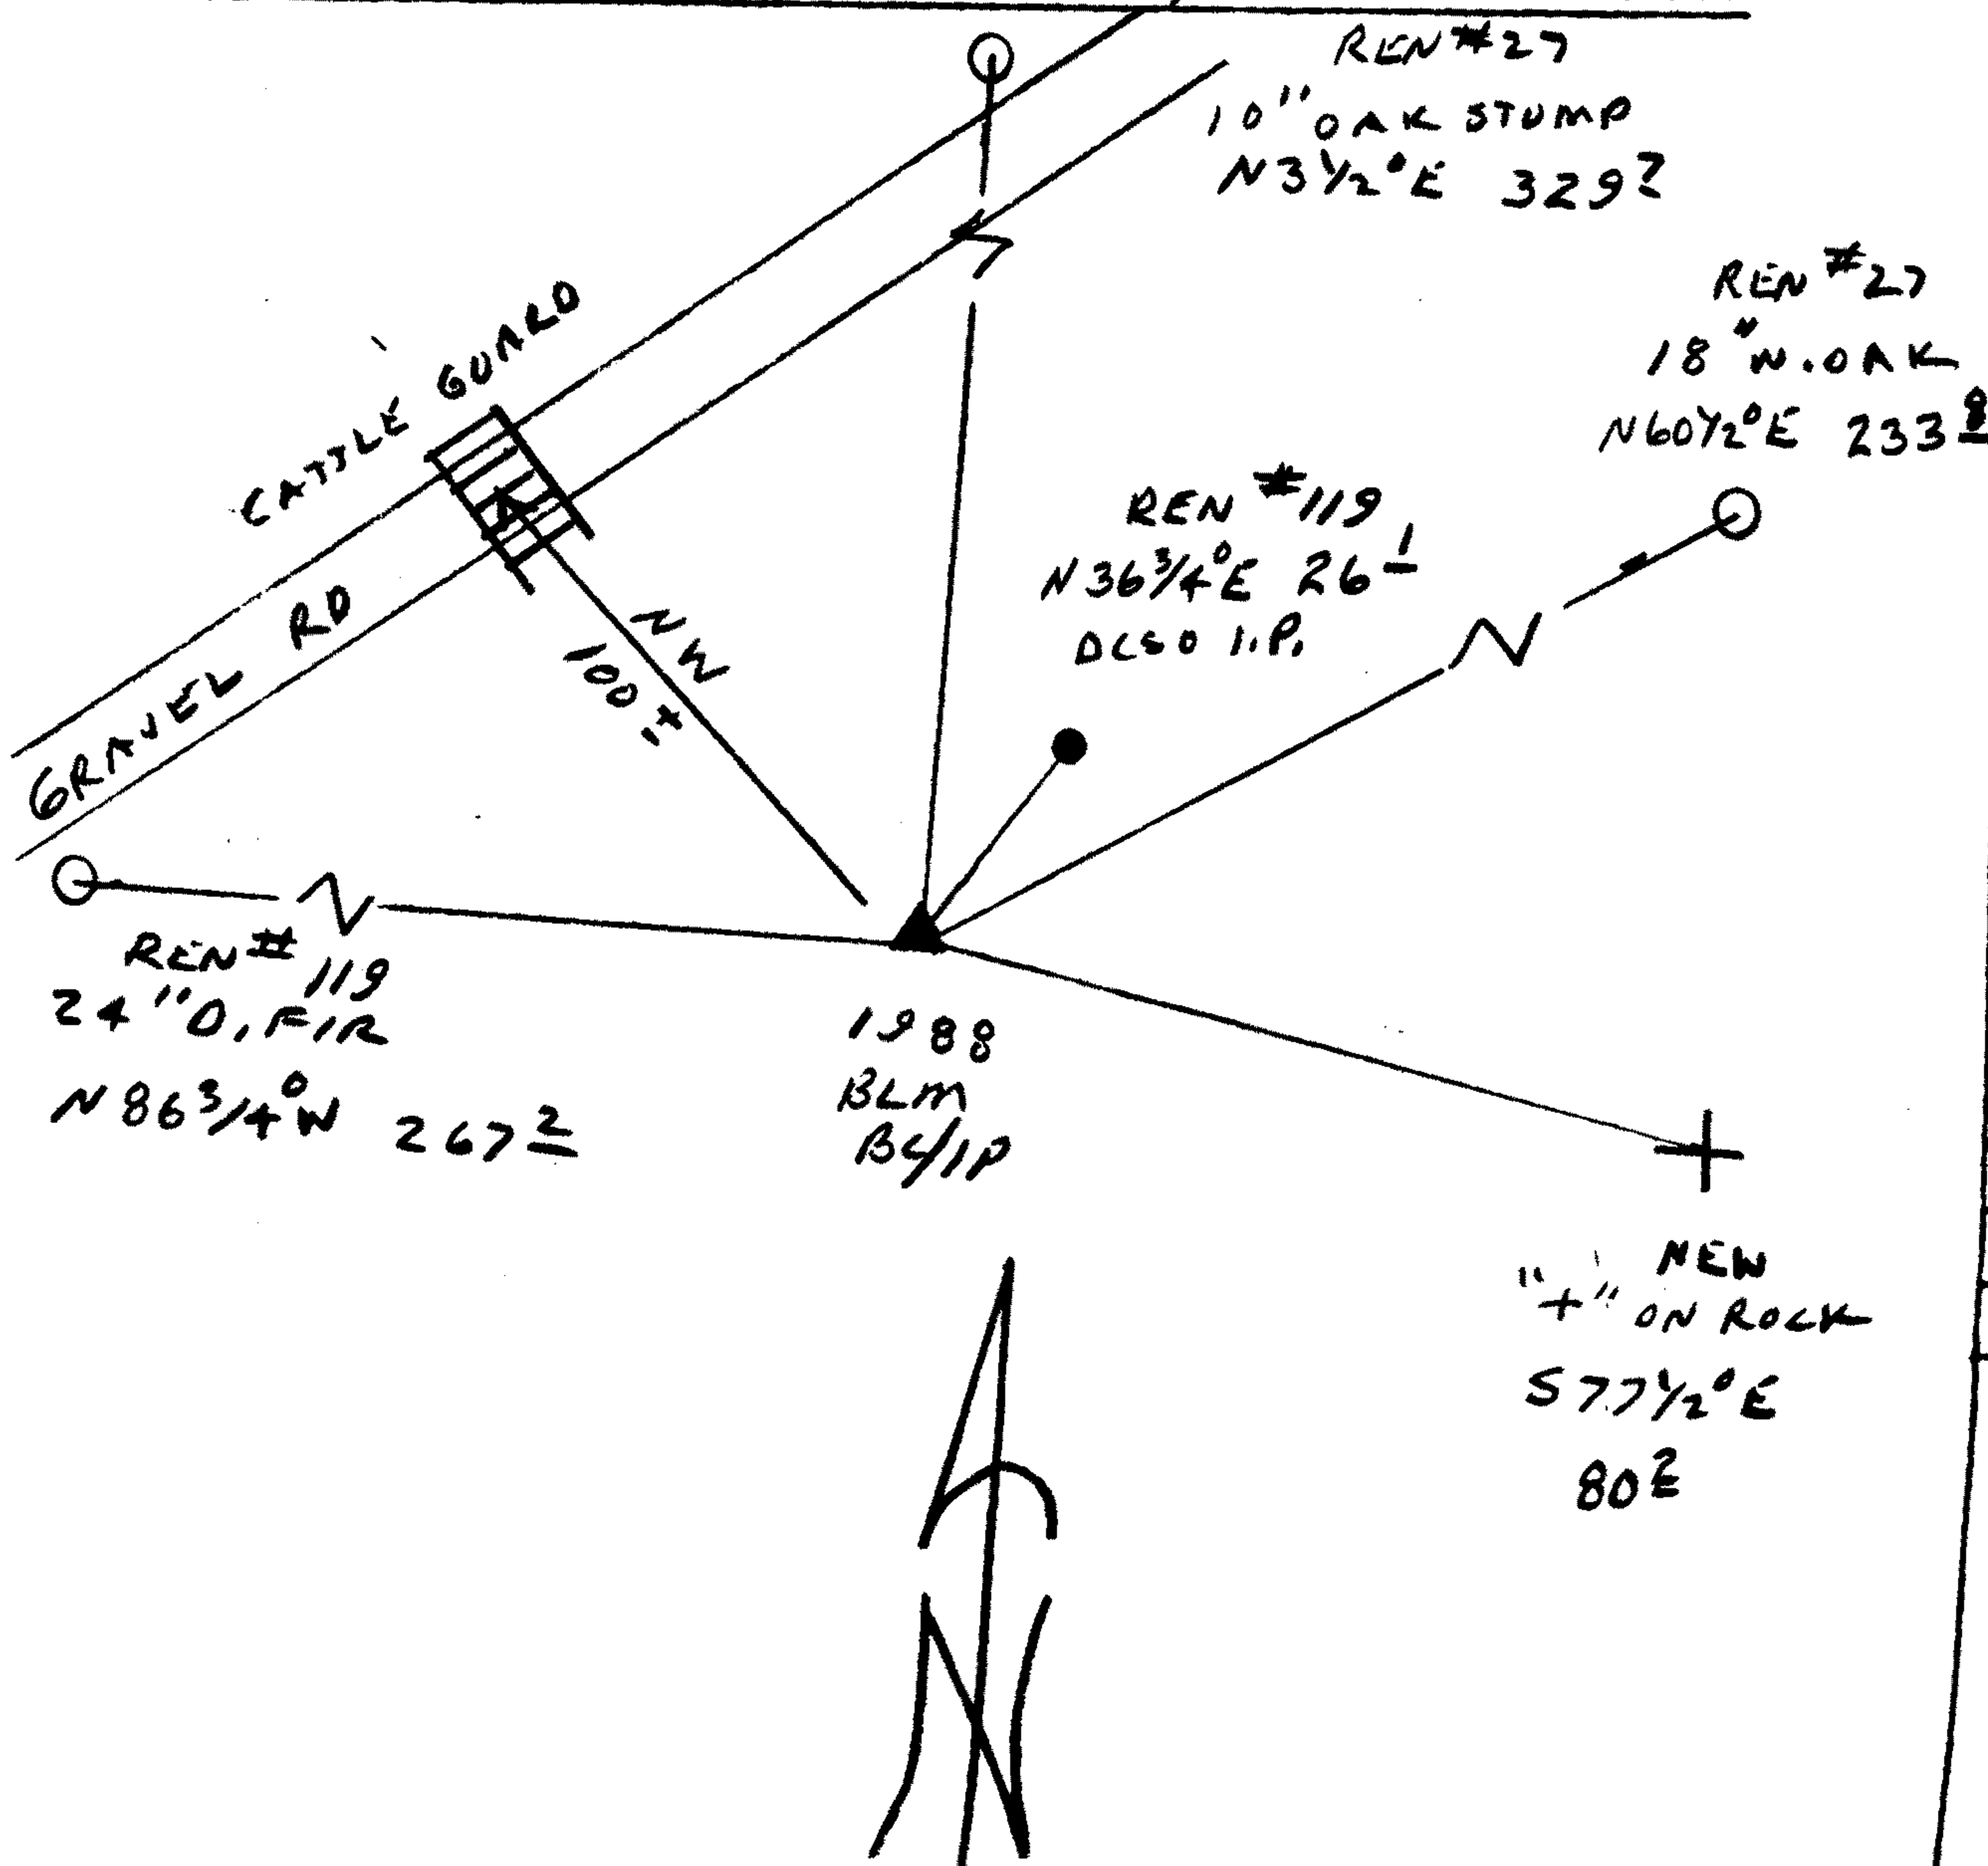
Sketch of Monument, Accessories, and General Area

3/4" BLM BRASS CAP O.N.A 2 1/2"
O.D. IRON PIPE, PROTRUDES 7"
ABOVE GROUND. (1988 BLM)

2 1/2" DCSO BRASS CAP O.N.A 1 1/2"
O.D. IRON PIPE, PROTRUDES 16"
ABOVE GROUND (REN #119)

A 1" X 2 FT LONG IRON BAR FO OUT
OF GROUND ALONG EAST EDGE OF DCSO BC/IP (REN #27)
Accessories Found:

DCSO BC/IP. FROM REN #119 BEARS N 36 3/4° E, 26.1 FT
(AGREES WELL WITH REG. FROM 1988 BLM SURVEY)

A METAL FENCE POST IS
 SET ALONG NORTH EDGE
 OF BLM B41P

CORNER IS SOUTHEAST
 OF A METAL CATTLE GUARD
 OVER GRAVEL ROAD APPROX.
 100 FT

BRASS CAP ON DCSO B41P IS
 SAWED OFF I.P. NOW PROTRUDES 7"
 ABOVE GROUND. YELLOW DCSO PLASTIC
 CAP IS SET ON TOP OF I.P. MARKED
 "DOUG. CO. SURVEYOR".
 POSITION OF CORNER DETERMINED IN
 RENEWAL # 27 AND RENEWED IN
 RENEWAL # 119 IS AT AN ERRONIOUS
 POSITION SEE 1988 BLM D. RESURVEY

6' X 12' X 2' HIGH ROCK OUTCROP A 3" + IS CHISELED ON FLAT
 SURFACE NEAR NORTHWEST CORNER, + BEARS $S77\frac{1}{2}^{\circ}E$ 80.2 FT.
