OREGON CORNER RESTORATION FORM

Section: 23 **Township:** 29S **Range:** 06W

Corner Rpt: 65/54-16A-C

E 1/16th S23
 S26

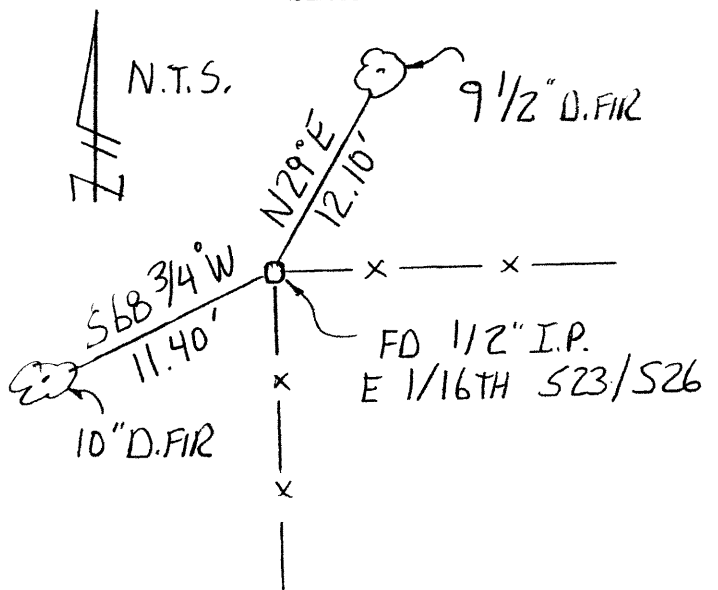
Sketch:

Found 1/2" iron pipe at a fence corner. Fence is running North & West;
remains of badly rotted 58" Fir stump (1958 record S57°E 35.6')-found 1913 scribe marks
remains of badly rotted 50" Fir stump (1958 record N17°W 29.7')
remains of badly rotted 10" Fir stump (1958 record N85°E 26.3')
remains of badly rotted 10" Fir stump (1958 record S64°W 44.5')

The corner position was checked using these stumps and was found acceptable.

9 1/2" D. Fir bears N29°E 12.1' scribed "E1/16 S23 BT"
10" D. Fir bears S68 3/4°W 11.4' scribed "E1/16 S26 BT"

NOTE: We set and measured to spikes in the base of the new bearing trees; bearings to the trees are based on Barne's 1974 survey line from this E1/16th Corner to the SE corner of Section 23 (S88°34'32"E).
