Corner Rpt: 65/54-27

OREGON CORNER RESTORATION FORM

Section: 11 Township: 21S Range: 12W

E 1/16 S2 and S11

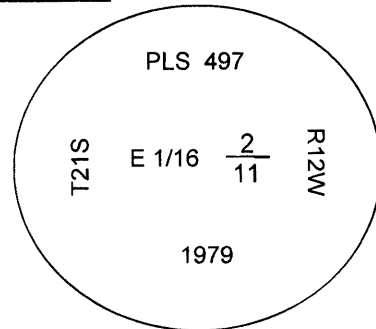
Sketch:

Fd. 2" iron pipe with 2 1/2" brass cap marked "PLS497 T21S R12W E1/16 2 11 1979"

Record Fir Bt with healed face and tag is uprooted

Record Spruce Bt with tag uprooted

Remains of rusted metal fence post bears north 1.5 FT

17" Fir, S50°E 44.3FT, scribed "1/16 S11 BT".

29" Hemlock Stump, S37°W 39.8FT to spike set in top

Distance measured to
spike set at side center on
new BT. Tag attached to
tree facing the corner
