OREGON CORNER RESTORATION FORM

Section 2 Township 31S Range 3W

County Douglas Date 1-14-2016

S3 | S2
1/4 Corner

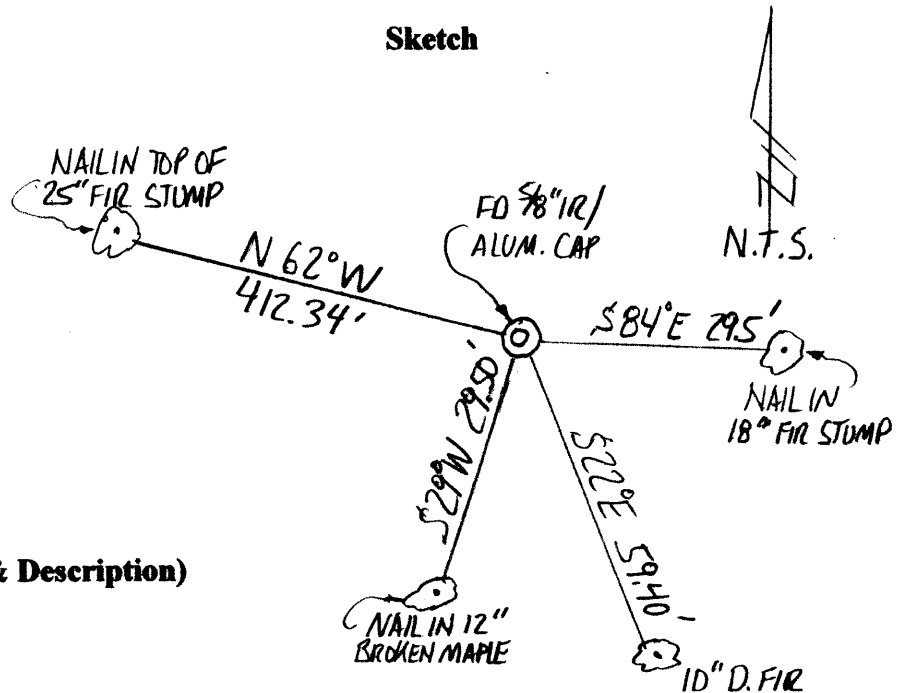
Sketch

Found 5/8" iron rod with aluminum cap in road ditch. Set by Douglas County survey crew in 1977.
25" Douglas Fir stump bears N62°W 412.34 feet. (scribed by Douglas County in 1964)
12" Broken Maple bears S29°W 29.50 feet. (scribed by Douglas County in 1977)

Corner is in the ditch of an existing rock logging road.

Set steel post at corner.
18" Douglas Fir stump with nail in top bears S84°E 29.50 feet.
10" Douglas Fir bears S22°E 59.40 feet scribed "1/4 S2 BT".

Note: Set nail in the top of the existing 25" Douglas Fir stump which bears N62°W 412.34 feet; also set nail in the top of the broken 12" Maple which bears S29°W 29.50 feet.
