GOVERNMENT CORNER RESTORATION FORM

Township 24S Range 5W Sec. 23

County DOUGLAS

1/4  
S23/S24

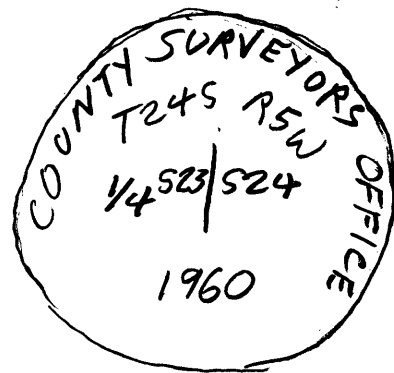
A 2 1/2 INCH DIAM. BRASS CAP MARKED AS AT RIGHT ON A 1 INCH DIAM. IRON PIPE FIRMLY SET AND PROTRUDING APPROX 14 INCHES ABOVE GROUND IN A NORTH-SOUTH RUNNING FENCE LINE. MONUMENT IS APPROX 150 FT. SOUTH FROM AN EASTERLY-WESTERLY RUNNING FENCE LINE. (1960 RENEWAL)
