GOVERNMENT CORNER RESTORATION FORM

Township 28S Range 5W Sec. 12

County DOUGLAS This survey consists of:

C.S. File No 67/25-63

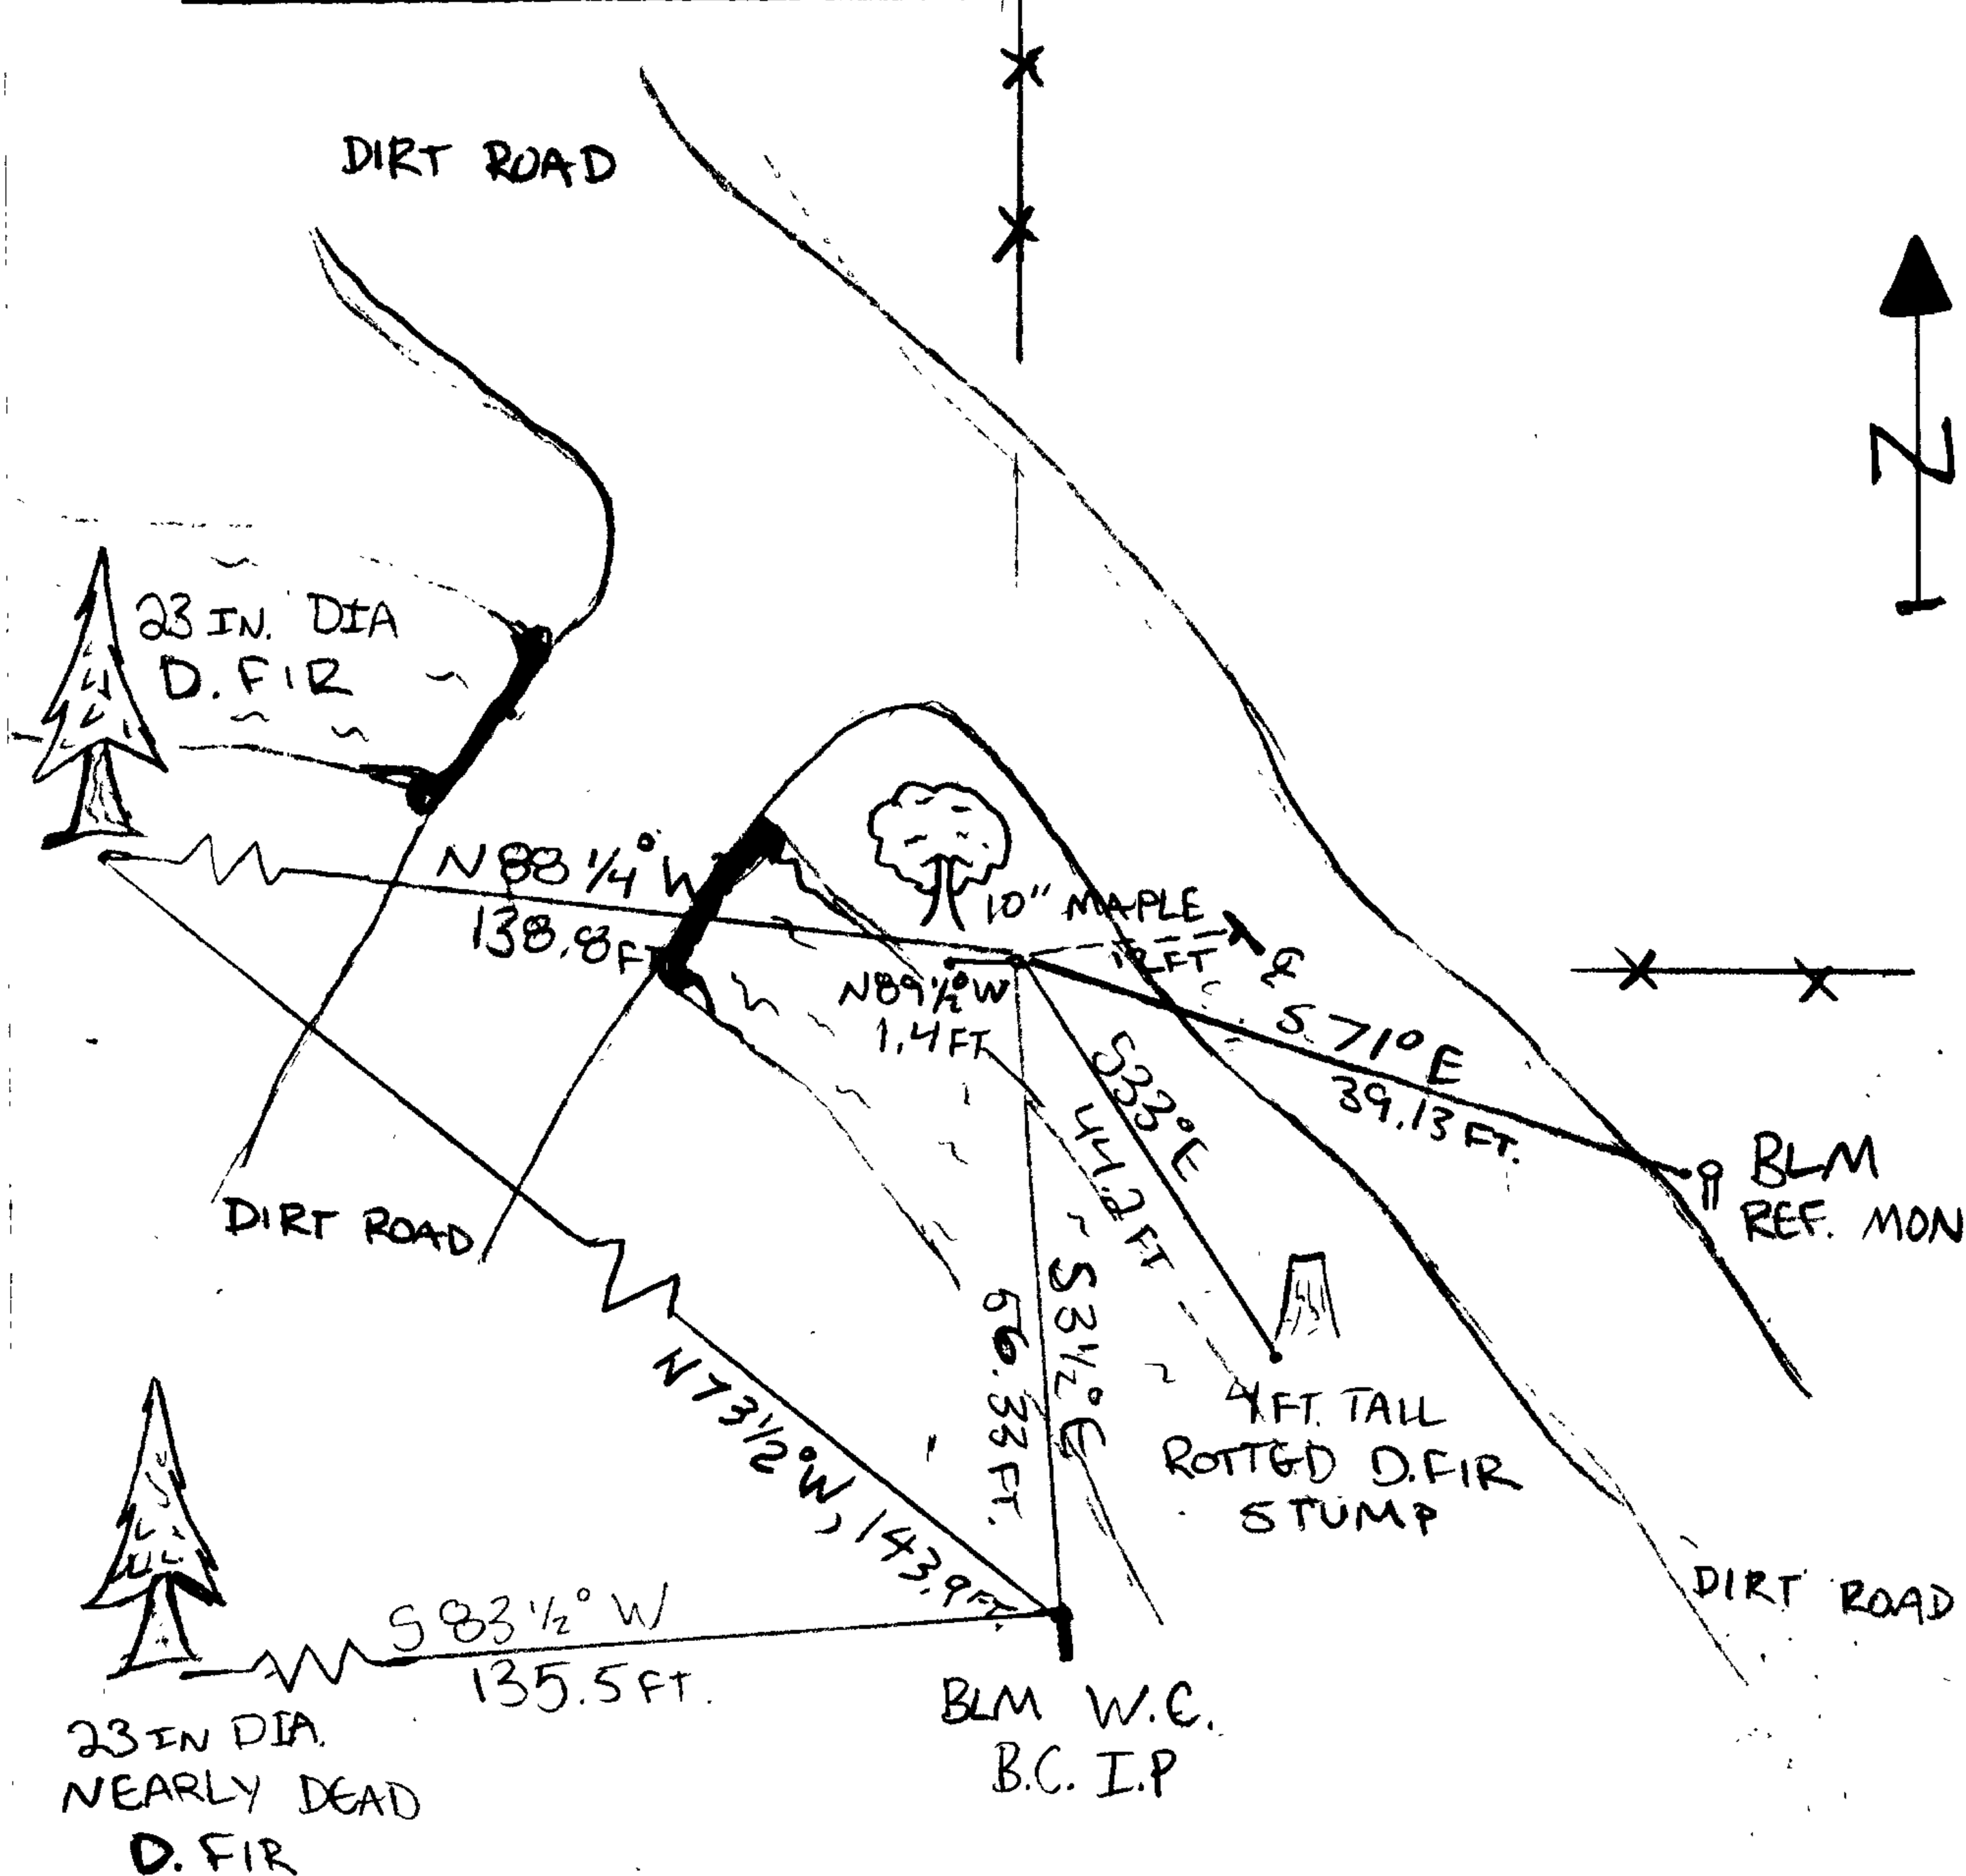
Sketch of Monument, Accessories, and General Area

1974 BLM W.C. 3/4" BRASS CAP ON A
2 1/2" O.D. I.P. PROTRUDES 5"
OUT OF A LOOSE CIRCLE OF STONES

1974 BLM RM 3/4" BRASS CAP ON A
1/2" O.D. I.P.

POSITION OF BLM MONUMENTS ARE
QUESTIONABLE. THEY HAVE A POOR
RELATIONSHIP WITH EACH OTHER
AND DON'T FIT WELL WITH THE
1/4 BETWEEN S13/S18. NEITHER
IS USED TO CALCULATE THE CORNER
POSITION

- 45" DIA 4 FT HIGH ROTTED D. FIR STUMP WITH AXE MARKS
BEARS S 33° E, 44.2 FT OBT
- 6" NOW 23" DIA D. FIR WE OPEN AND FIND PORTION OF
50 YEAR OLD BLAZE WITH ILLEGIBLE SCRIBE MARKS
BEARS N 88 1/4° W, 138.8 FT (1957 REC N 84 1/2° W 138.8 FT)
- BLM BC/IP WIT. COR BEARS S 3 1/2° E, 56.33 FT
1974 (REC. 50° 04' E, 20.46 FT.)
- BLM BC/IP REF-MON. BEARS S 71° E 39.13 FT
- 11" NOW 23" DIA NEARLY DEAD D. FIR WE OPEN AND FIND
1974 BLAZE WITH ILLEGIBLE SCRIBING BEARS
S 83 1/2° W 135.5 FT. FROM BLM WIT. COR THIS BT
BEARS N 73 1/2° W 143.9 FT (REC. N 72 1/2° W 143.9 FT)
THIS BT'S POSITION SUGGESTS THAT BLM WIT. COR HAS NOT MOVED SINCE 1974

NOTE REC BRG + DIST BETWEEN BLM BC/IP IS
N 38 1/2° E, 59.4 FT WE FIND BC/IP RELATIONSHIP
IS N 38° E, 59.8 FT.

5/8" BY 60" LONG IRON ROD
 WITH DCSO ALUM. CAP
 IS SET AT POSITION DETERMINED
 BY DISTANCE - DISTANCE INTERSECT
 FROM 1. REMAINING OBT STUMP
 AND 1957 DCSO BT. DISTANCE
 TO 1957 BT IS PER 1957 RENEWAL.
 THIS SOLUTION AGREES WELL WITH
 REC. BEARING AND DISTANCE TO THE
 OBT, POOR BEARING TO 1957 BT
 BUT GOOD DISTANCE. CORNER POSITION
 LINES UP WELL WITH OLD FENCE
 LINES RUNNING NORTH AND EAST.
 (NOTE CORNER WAS AT A FENCE
 CORNER IN 1957) 1/2" PROTRUSION
 9" OUT OF GROUND.

10" MAPLE DOUBLE BLAZED AND SCRIBED "SIRCS BT"
 BEARS N89 1/2° W, 1.4 FT.
