GOVERNMENT CORNER RESTORATION FORM

Township 285 Range 8W Sec. 13

1/4 S14 | S13

DOUGLAS COUNTY
SURVEYOR

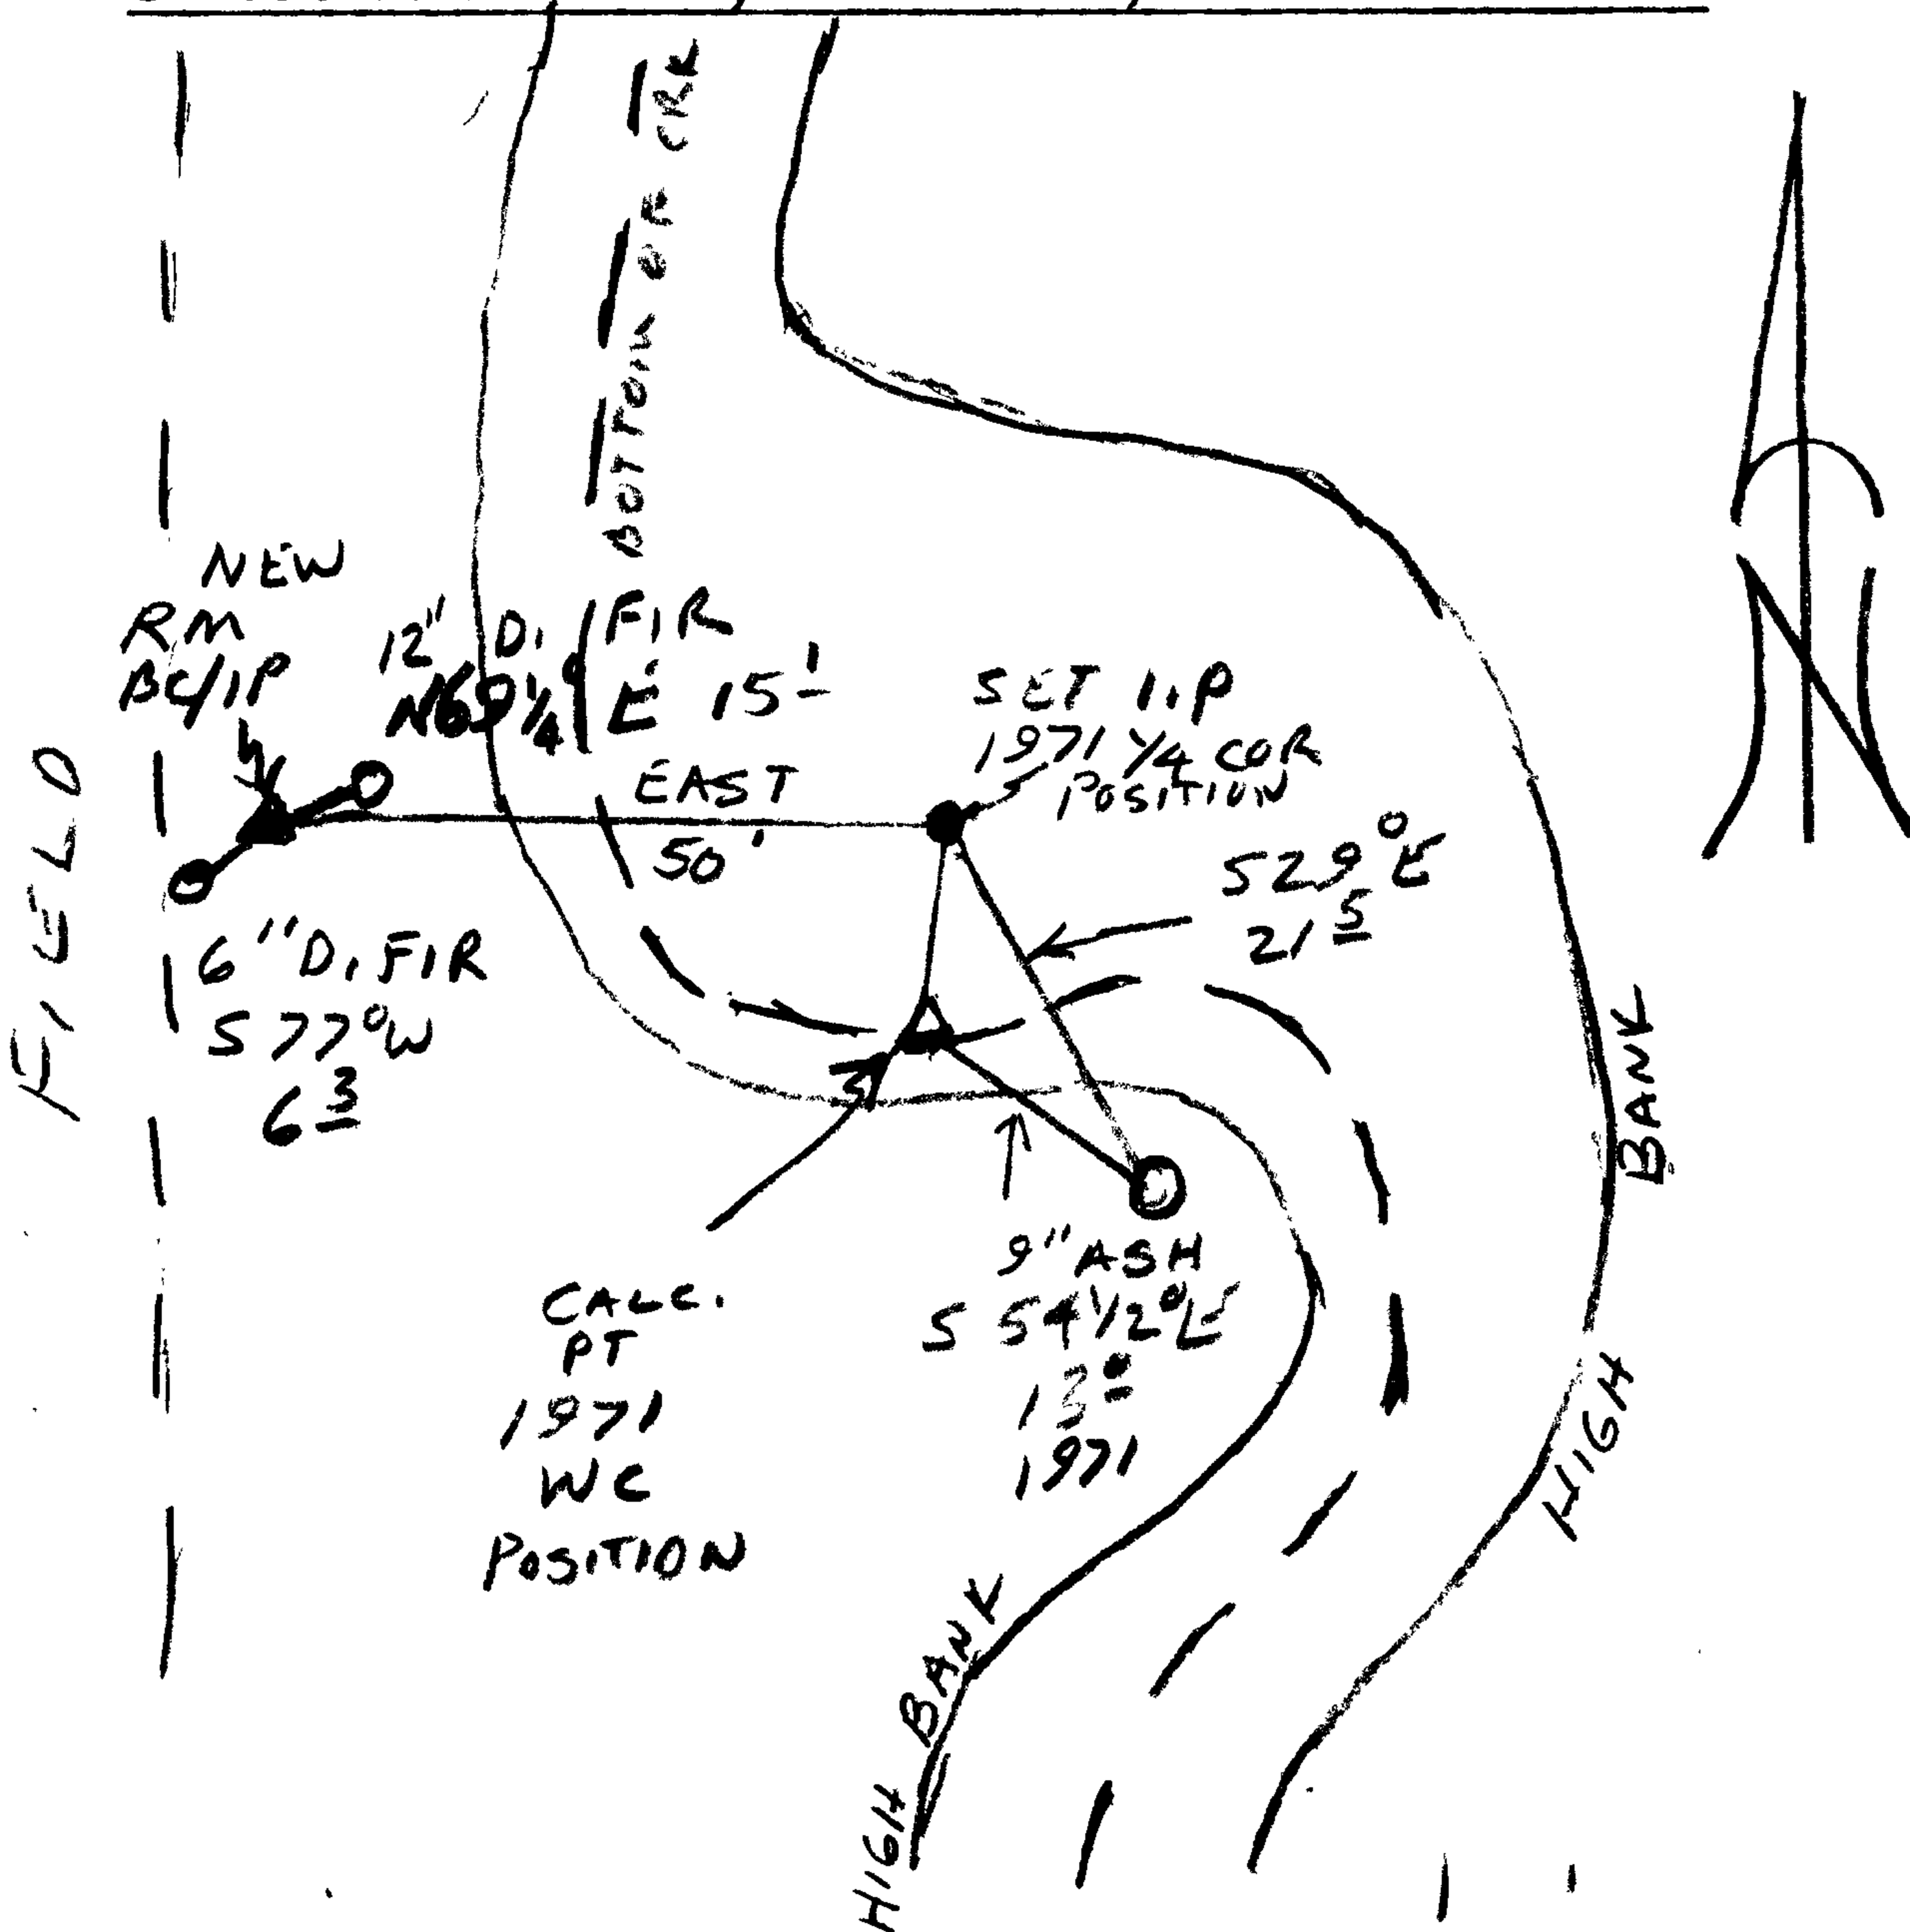
Sketch of Monument, Accessories, and General Area

1971 1" I.D. X 32" LONG IRON
PIPE OUT OF GROUND.

8" NOW 9" DIA. ASH WITH PARTIALLY HEALED DOUBLE BLAZE
SCRIBING VISIBLE "WC 1/4 S13 BT"

1971 1/4 CORNER AND
 WC. CORNER POSITIONS
 NOW BOTH FALL IN
 CREEK BOTTOM

SET 1971 IRON PIPE AT 1/4
 CORNER POSITION DETERMINED FROM
 SE WC. BT N54 1/2°W, 13.0 FT THENCE
 N1 1/4°E 11.3 FT. I.P. PROTRUDES 6"
 OUT CREEK BOTTOM.

FROM 1971 I.P. IN CRK BOTTOM
 A 2 1/2" DIA. BRASS CAP ON A 1 1/2" DIA
 BY 32" LONG IRON PIPE IS SET AS
 AN R.M. CORNER WEST 50.0 FT
 DCSO R.M. BC I.P. PROTRUDES 6"
 OUT OF GROUND
