GOVERNMENT CORNER RESTORATION FORM
DOUGLAS COUNTY SURVEYOR

Corner Form: CS 67/45-3

TOWNSHIP 28S RANGE 05W SECTION 04

CORNER DESIGNATION: NORTH 1/4 SECTION 4 ONLY

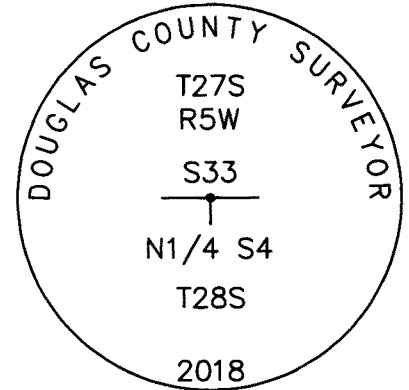
MONUMENT DETAIL

- The 1961 brass cap was searched for and not found.

The original corner position is being restored from the C.S. File No. 49/64 bearing trees.
Set a 1" x 32" i.d. iron pipe 20" in the ground on solid rock in a 18" diam. x 11" high mound of stone with a 2 3/8" diam. brass cap marked as per monument detail:

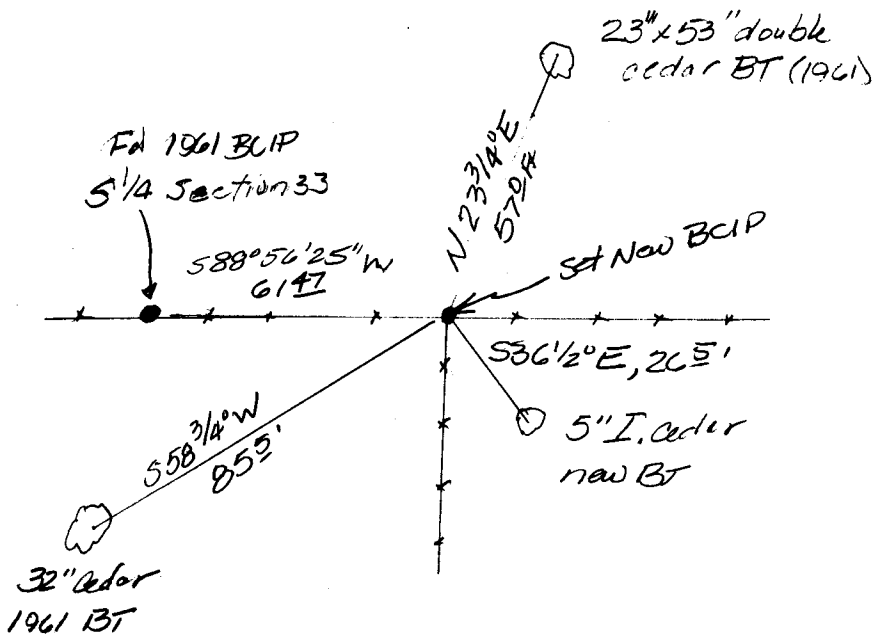
Sketch of Monument, Accessories, and General Area

Falls on a mod. NW Slope, 12 W, of old cedar fence post 5' 12" N. of a new 4x4 PT Post in E-W-S fence corner. Scattered fir-cedar ± 50' S. of timber
