(1935-1939)

City of Roseburg

BEN B. IRVING

RENEWED GOVERNMENT CORNERS.

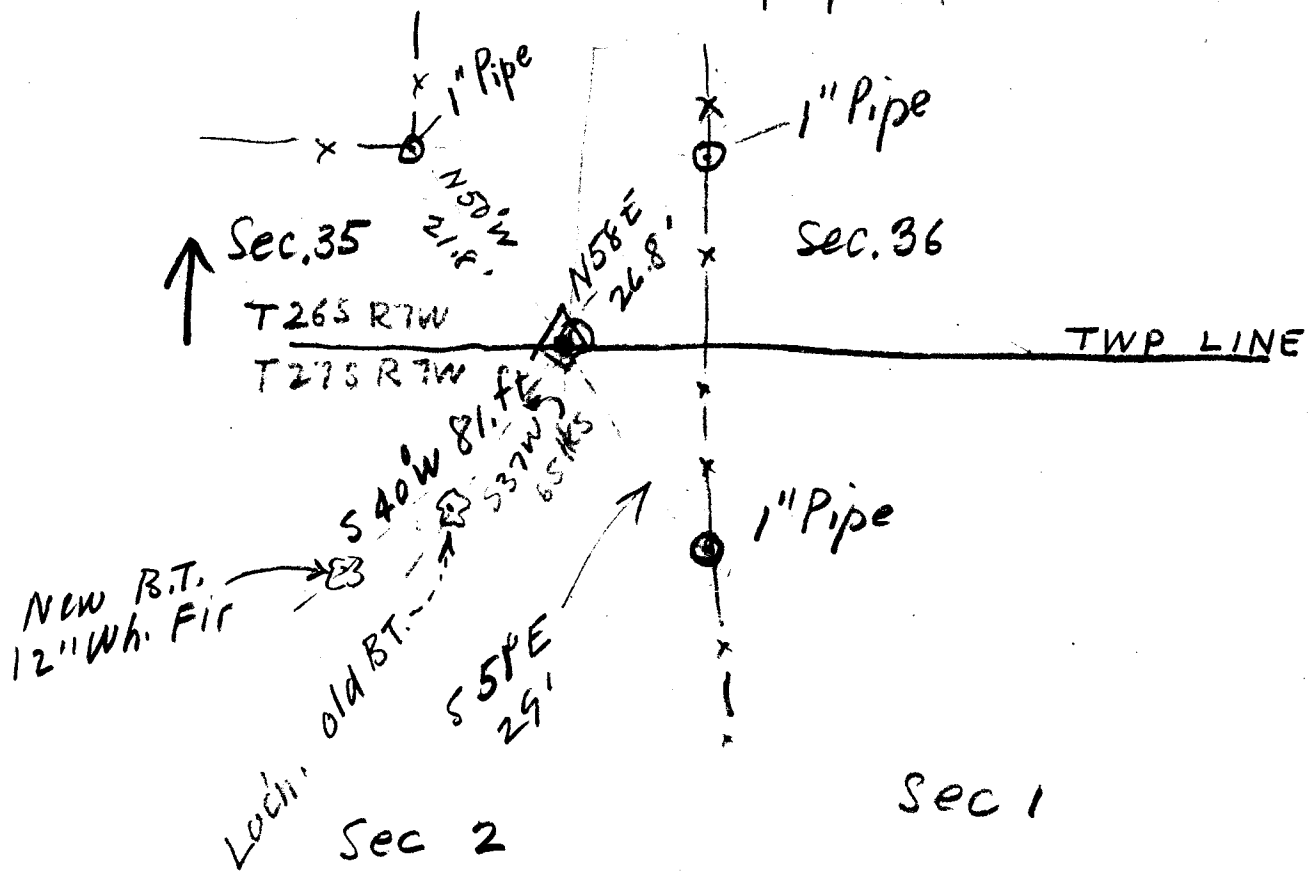
Section Corner Renewed

Renewed from old remains of Bearing tree to the SW in sec 2 - stump of Oak tree. There are no trees in any other section so set pipe in all other sections - Drove a 1 1/2" pipe for corner

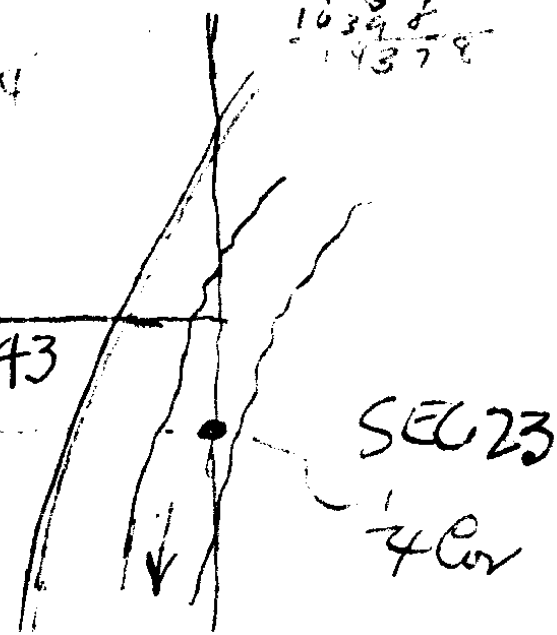
45)
SEC. 22
T. 26-6

Henry
Evans D.L.C. 43

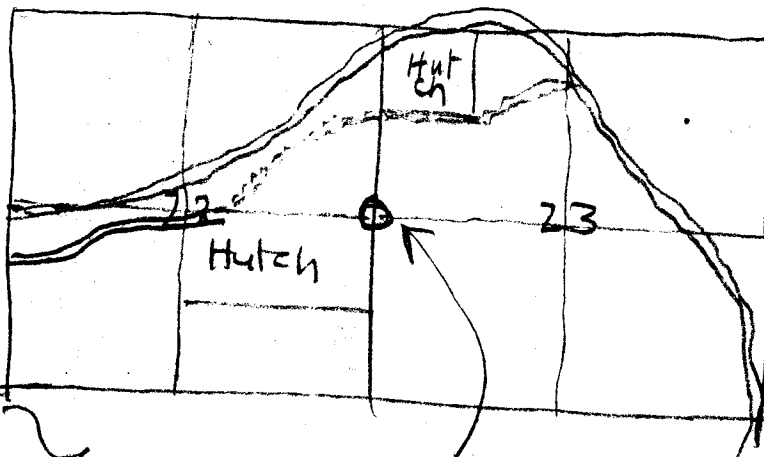
48)

1/4 Cor 2223 zone
a B 0 20" N. 27 W. - 163 L
a W 0. 10" S. 38 E - 182 L

Iron Bar 1 1/2 x 1/4 x 36"

14" Fir S. 44° W. 115 Ft.
