Survey for Coos Head Timber Co.

Coos Bay, Oregon

Sec's 25 & 30, T23S, R9 & 10 W

C. S. File No. 42/379

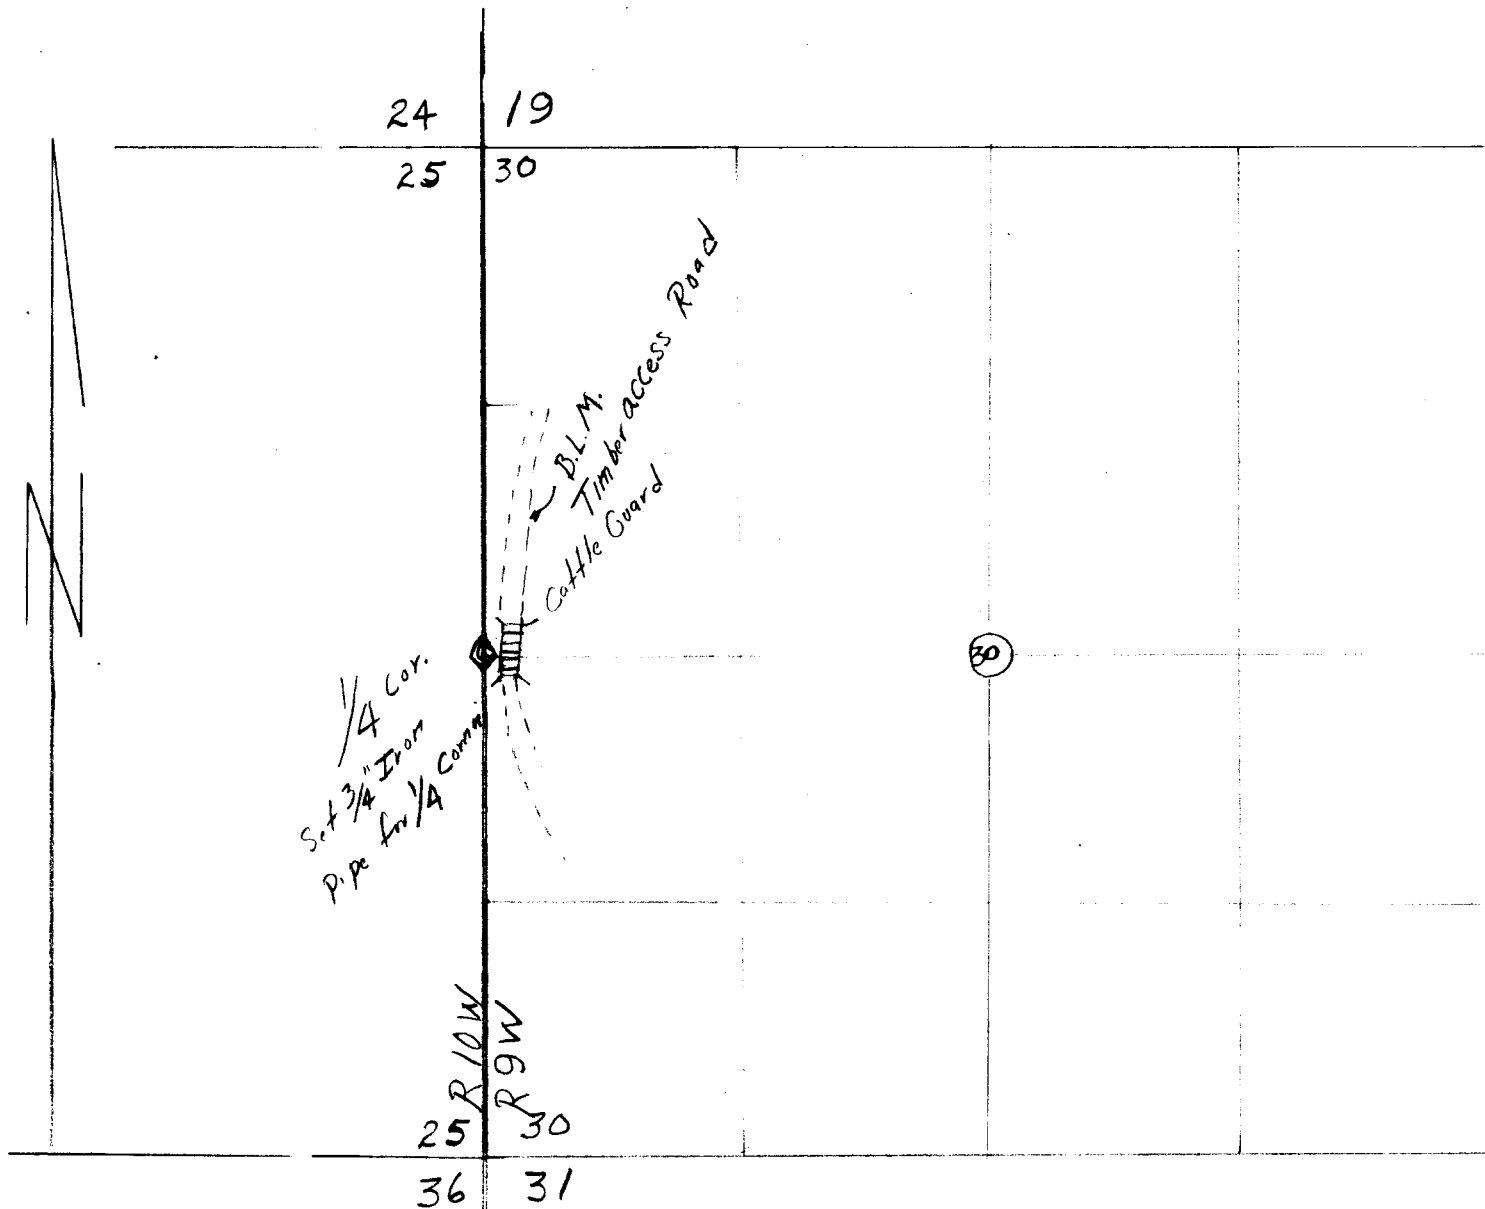
Returning at the above date, I find that in the construction of the B.L.M. road, the 2 original BTs had been destroyed. The 3/4" iron pipe had been bent over, but still in place. I straightened out the pipe and added the "cattle guard" as a B.O. as follows:

A B.O., the SW cor. of the concrete cattleguard base brs. N47½degE 8.8 feet.
