REN. T 28 S R 4 W COR. SECS. 3 | 2
10 | 11

C.S. File No. 113/63-3A

Section 3 Twp 28 S Rge 4 W 19-63 Date: 3-19-63

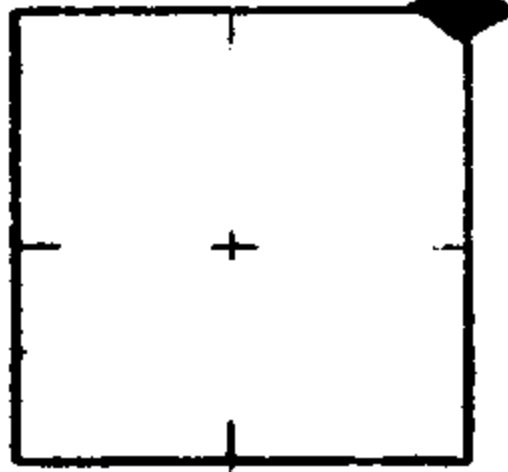
How was corner identified? Brass Cap

Condition of corner:

Quadrant	NE	NW	SE	SW
Species & Size	11" I. Cedar	32" D. Fir	22" D. Fir	34" D. Fir
Dist. & Bearing	144 lks. N20 1/2 E	43 lks. N51 3/4 W	22' S32 E	30' S31 W
Condition of Scribe			Bark scribe	Bark scribe
Original or Resurvey				
Appearance of B.T.	Sn + 9	Wind throw	Wind throw	Wind throw
Tags, Marks, etc.

RENEWED
