WITNESS CORNER SET

19/20 T245 R2 W
30/29

PUBLIC LAND CORNERS

TOWNSHIP 24S RANGE 2W
SECTION 29 CORNER NW
COUNTY Douglas OREGON

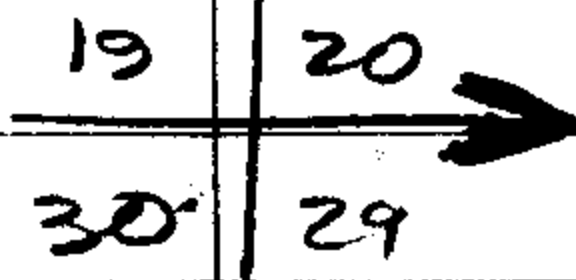
THE ORIGINAL NW BEARING TREE WHICH IS NOW A STUMP. IT IS SITUATED ON THE TOP EDGE OF A ROAD CUT AND HAS SLID OUT OF ITS ORIGINAL POSITION.

THERE IS NO TRACE OF ANY OTHER ORIGINAL EVIDENCE

FROM THE TRUE POSITION FOR THIS SECTION CORNER, WHICH FALLS ON A STEEP CUTBANK, WE FIND THE FOLLOWING WEYERHAEUSER CORNER ACCESSORIES:

A 40" D. FIR STUMP WITH RAILROAD SPIKE IN THE CENTER BEARS S 50° W 40[±] FT. (WEYERHAEUSER RECORD S 50° W 40[±] FT.)

A 36" HEMLOCK STUMP WITH "W" NAIL BEARS S 67° W 28[±] FT. (WEYERHAEUSER RECORD S 67° W 28[±] FT.)

A 44" D. FIR STUMP WITH "W" NAIL BEARS ~~124[±] FT.~~ S 62° W 124[±] FT. (WEYERHAEUSER RECORD S 62° W 124[±] FT.)

A 40" D. FIR STUMP WITH "W" NAIL BEARS S 86° W 79[±] FT. (WEYERHAEUSER RECORD S 86° W 79[±] FT.)

A 48" D. FIR STUMP WITH "W" NAIL BEARS N 49° W 125[±] FT. (WEYERHAEUSER RECORD N 49° W 125[±] FT.)

A $\frac{3}{8}$ " x 30" I. ROD, DRIVEN 16" ^{DEEP} IN THE
 CENTER OF A 38" HEMLOCK STUMP, BEARS
 S 36° W 39 $\frac{1}{2}$ FT.,
 WITH ALUMINUM CAP ATTACHED, MARKE
 "DOUGLAS COUNTY SURVEYOR

WC RP 2 " THIS STUMP HAS
 BEEN NOTCHED FOR USE AS A LOGGING
 ANCHOR.

AND A BRIDGE SPIKE DRIVEN IN THE
 CENTER OF A 38" D. FIR STUMP, MARKED
 "WC RP 3" BEARS N 36° E 10 $\frac{1}{2}$ FT.

THIS CORNER IS LOCATED APPROX.
 50 FT. WEST OF WEYERHAEUSER
 ROAD # 317.

WE RENEW THIS CORNER BASED ON NOTES SUPPLIED TO US BY WEYERHAEUSER COMPANY. (SEE ATTACHED NOTES.)

THEIR RECORD INDICATES THAT A $\frac{1}{2}$ " I. PIPE WAS SET FROM ORIGINAL EVIDENCE IN 1972. AT THAT TIME THEY IDENTIFIED SEVERAL NEW CORNER ACCESSORIES WHICH WE FIND AND USE TO RE-ESTABLISH THIS CORNER.

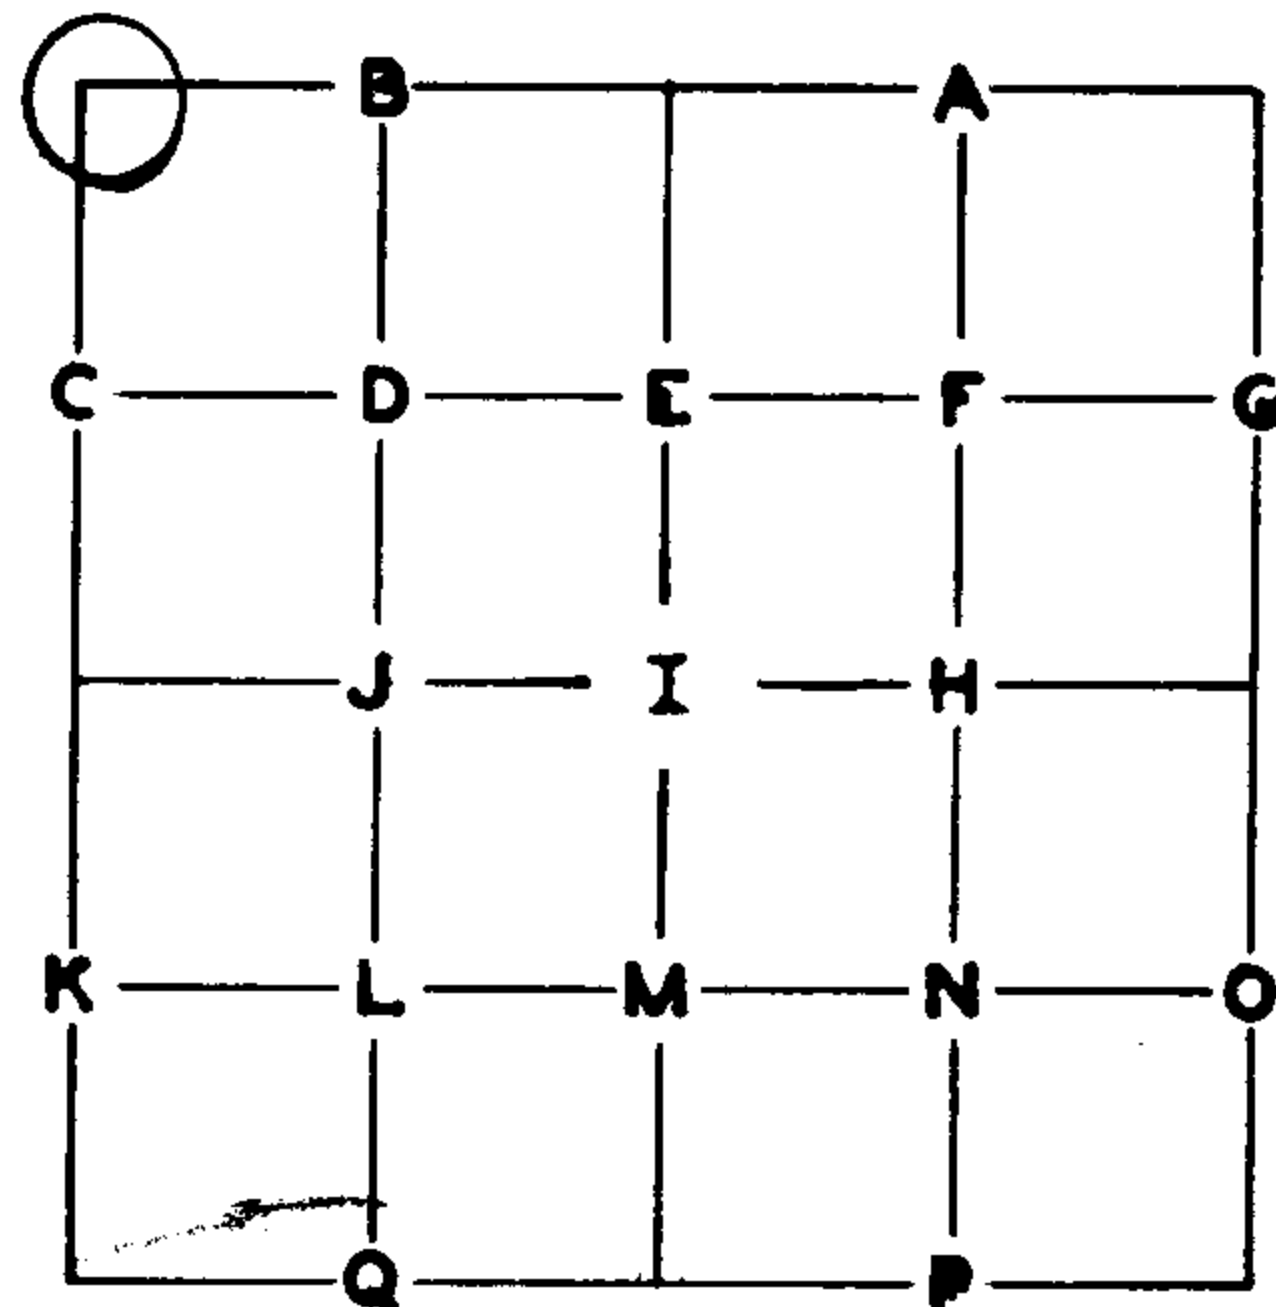
GLO SURVEY RECORD DATE: <u>June 1883</u> CORNER <u>Yew Post</u>	PRESENT CONDITION - (DESCRIBE FULLY - USE PAGE 2 IF NEEDED FOR EXPLANATION.) No trace
--	---

(A) 6" Hemlock	BEARING-	LINKS-	FEET-	PRESENT CONDITION
	N50°E	17	11.2	20" hemlock stump, scribing visible, now pushed out of original location by road const.
(B) 18" Hemlock	S60°E	40	26.4	Root hole of down, badly rotted hemlock, but could find no indication of a face.
(C) 18" Hemlock	S70°W	15	9.9	20" down, shattered hemlock, broken off and stump still in place - old face.
(D) 36" Fir	N50°W	17	11.2	36" fir stump - scribing visible upper face, lower face not opened.

Weyerhaeuser Co. SURVEY RECORD DATE: <u>Unknown</u> Found in field, four references (Plates & "W" nails.) Plates removed & new plates put up with new bearings & distances. Old plates read:	PRESENT CONDITION: <u>3/14/72</u>
(A) 20" Hemlock S52°W 10.5' (BT) 34" Fir S74°E 33.7' 36" Hemlock S67°W 29.2' (D) 36" Fir stump N52°W 10.5'	Removed and plate not renewed. 34" fir stump S74°E 32.7' 36" hemlock S67°W 28.3' 36" fir stump N61°W 10.2' (original BT)

CORNER SET: ½" pipe set by distance & bearing from MAG. DECL.: 20°
identified NW and SW original BTs and new bearings recorded.

BEARING-	FEET-	SURVEY -	DESCRIPTION
(A) N07°W	70.0	1883	To present position on lower slope of road
(B) S60°E	31.0	1883	Old root hole of possible BT
(C) S60°W	9.9	1883	To center of shattered stump
(D) N61°W	11.2	1883	To center of fir stump

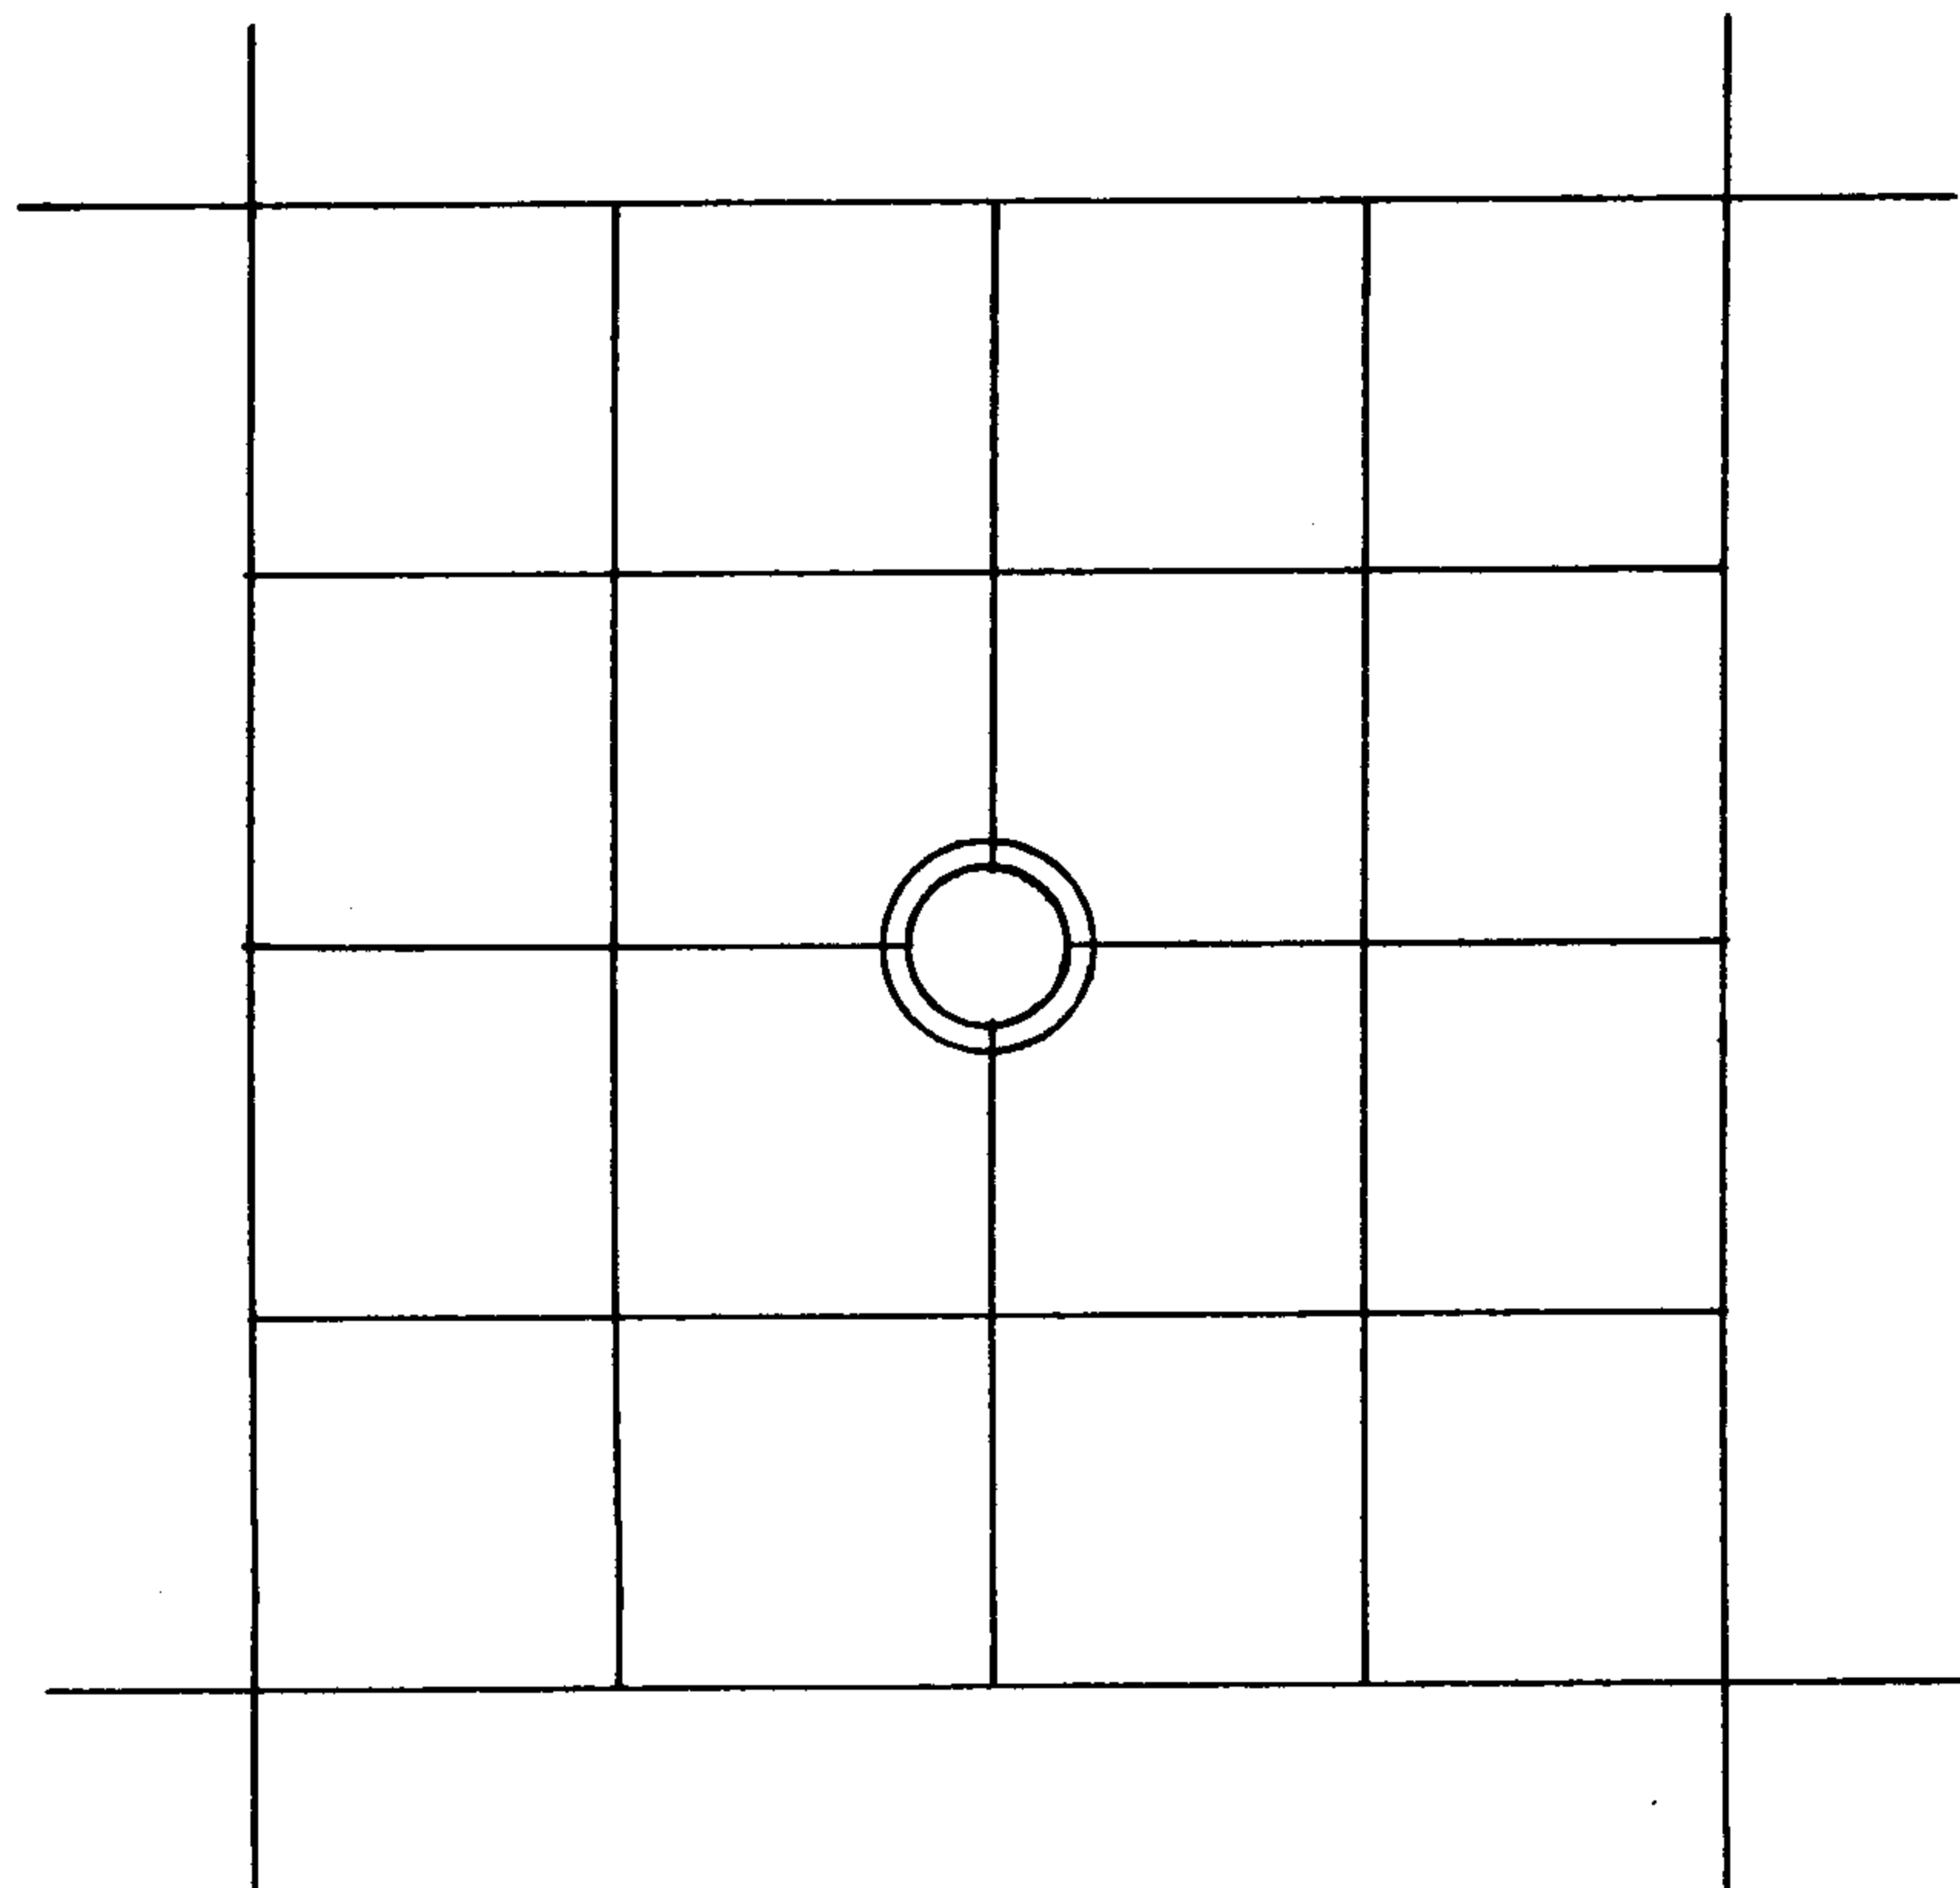
6/15/72: Timber all felled in vicinity of corner and landing area has been built. The

34" fir stump $S74^{\circ} E, 32.7'$ was removed by landing construction, all other references, though now stumps, are intact. I have added an additional reference this date, a rail-

road spike in the center of a 40" fir $S50^{\circ} W, 40.6''$.

GROUND COVER: Edge of R/W top of slope

NORTH: -60% 30' to center line of 317 Road
