RENEWAL

Monument Set (Procedure and Description)

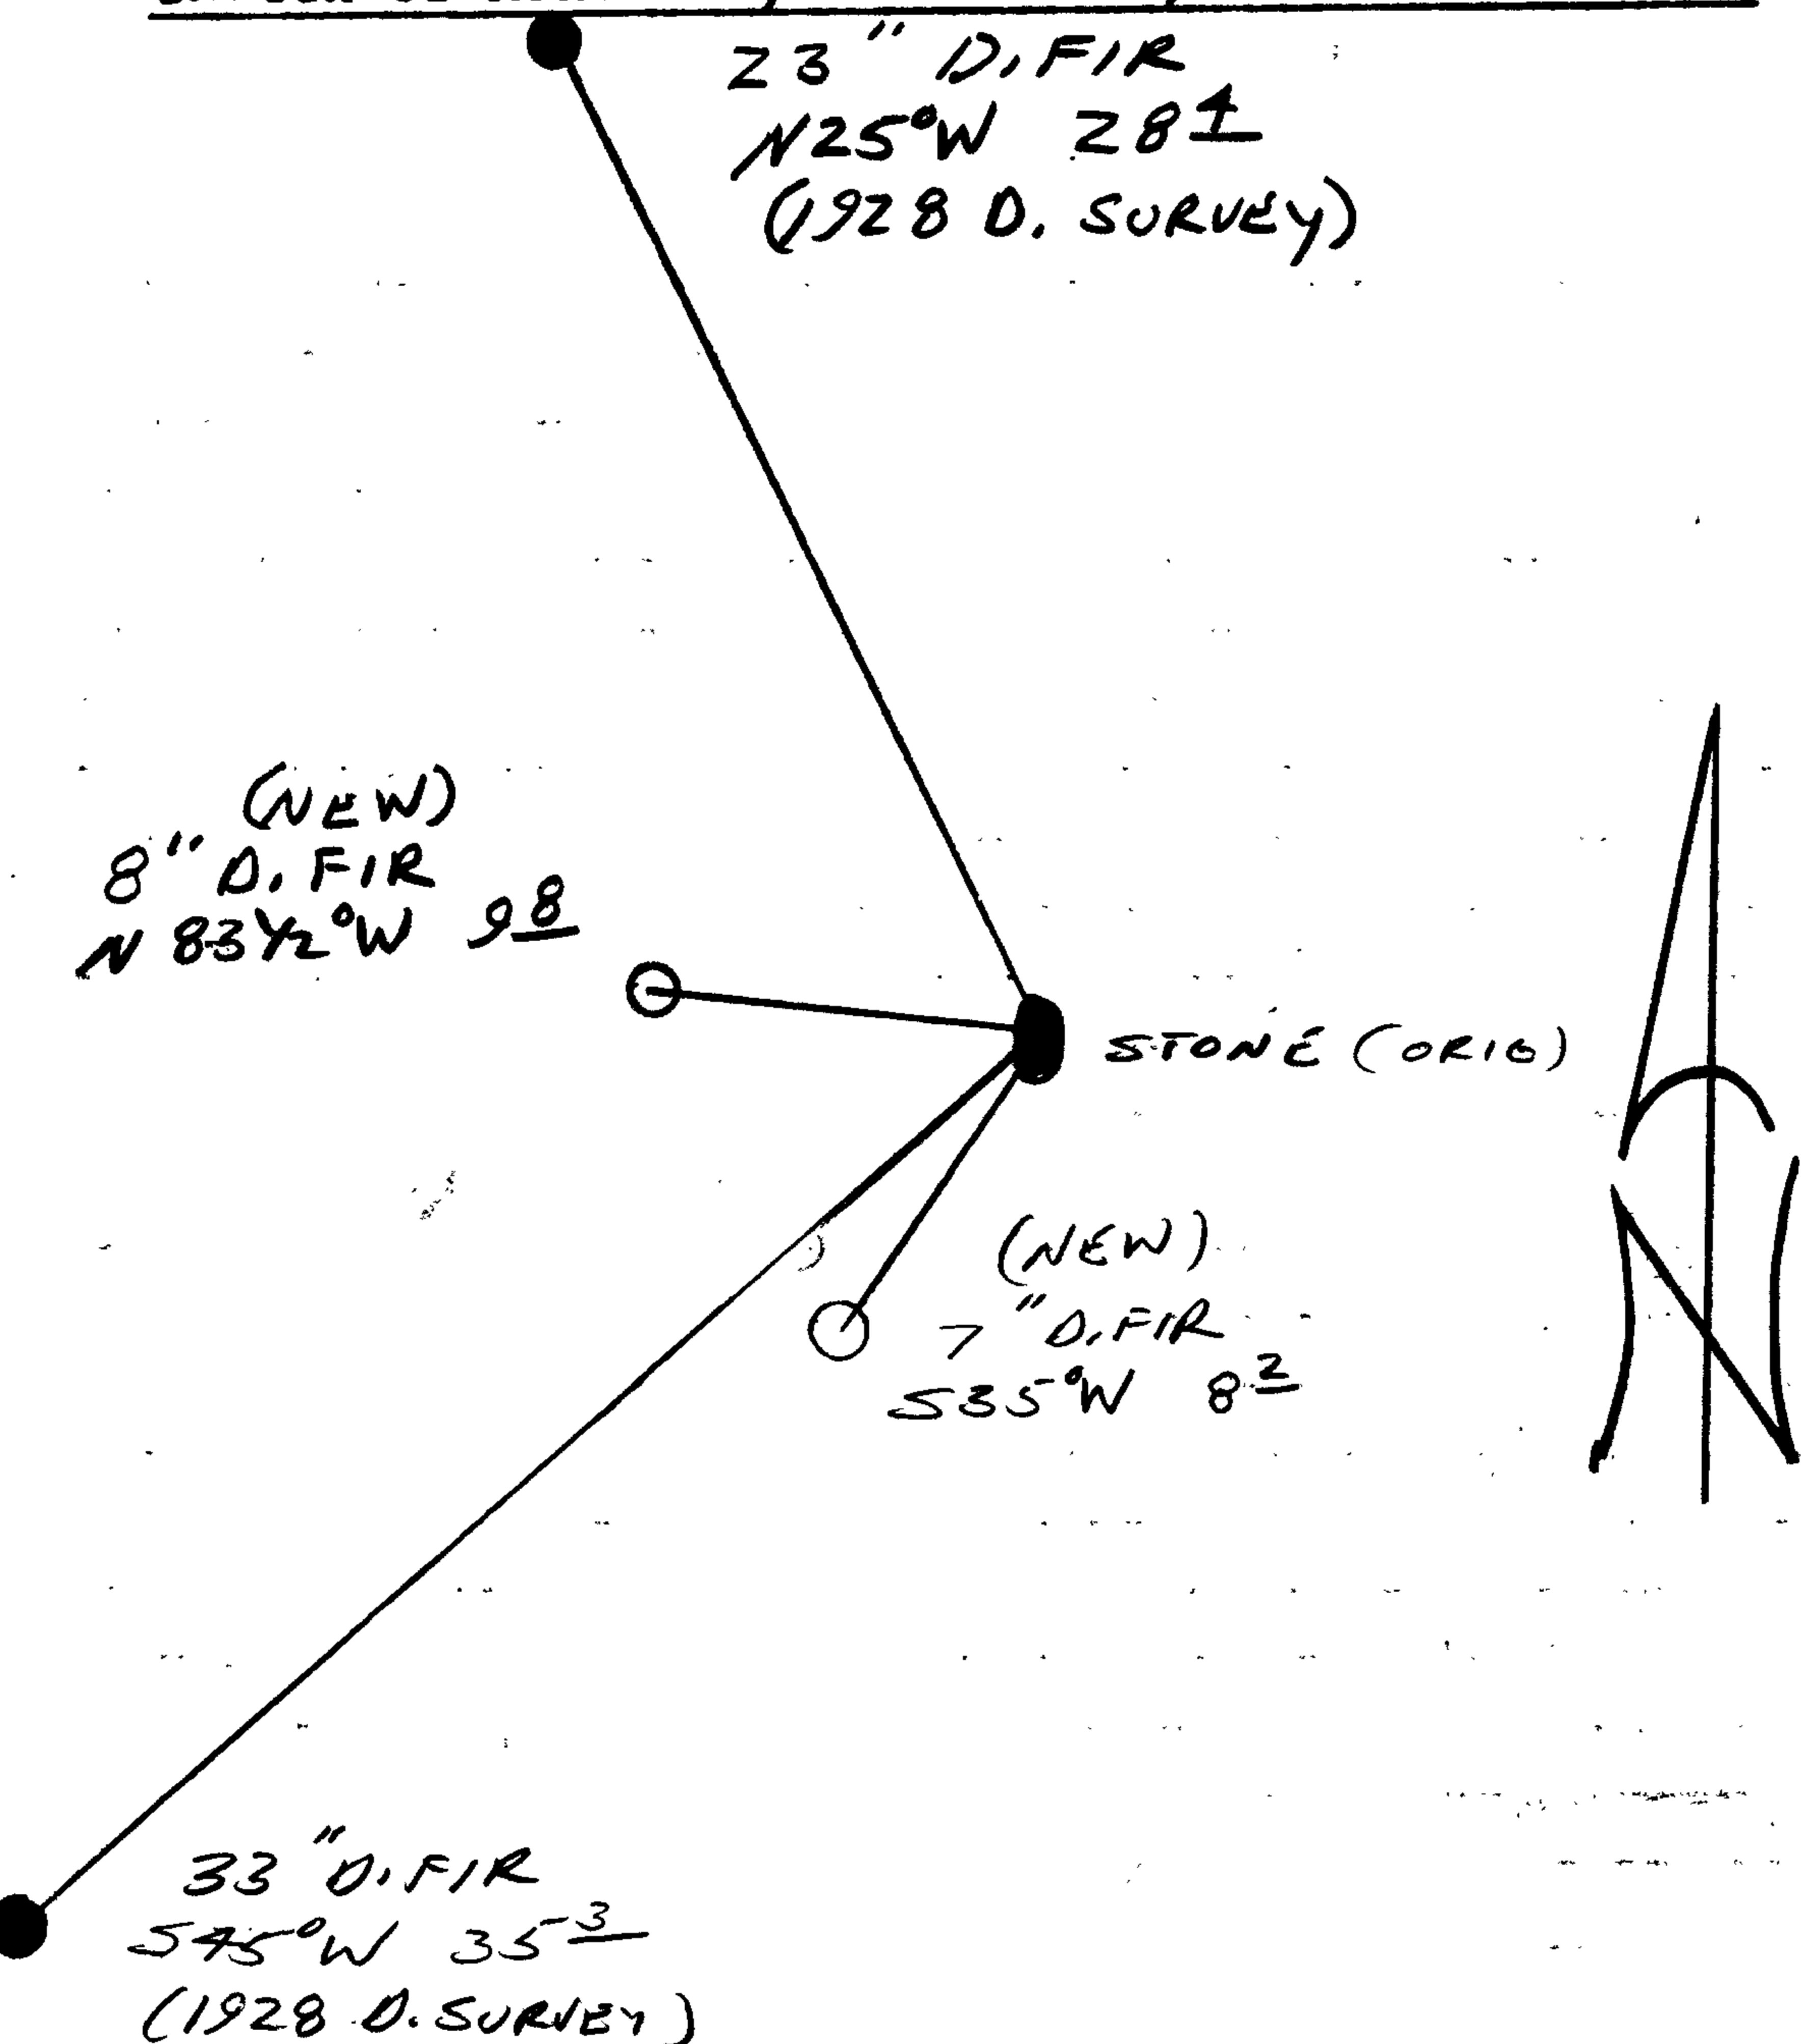
Sketch of Monument, Accessories, and General Area

ORIG. STONE IS IN GOOD SHAPE,  
GOES INTO GROUND AND GETS  
LARGER, DOES NOT APPEAR TO BE  
EASILY MOVED. WE DID NOT SET  
A BRASS CAP FOR CORNER.

8" DIA. D. FIR DOUBLE BLAZED AND SCRIBED "1/4 512 CS BT"  
BEARS N 83 1/2° W, 9.8 FT

7" DIA. D. FIR DOUBLE BLAZED AND SCRIBED "1/4 512 CS BT"  
BEARS S 35° W, 8.2 FT.

CORNER LIES ON A WESTERLY  
SLOPE
