RENEWAL

Monument Set (Procedure and Description)

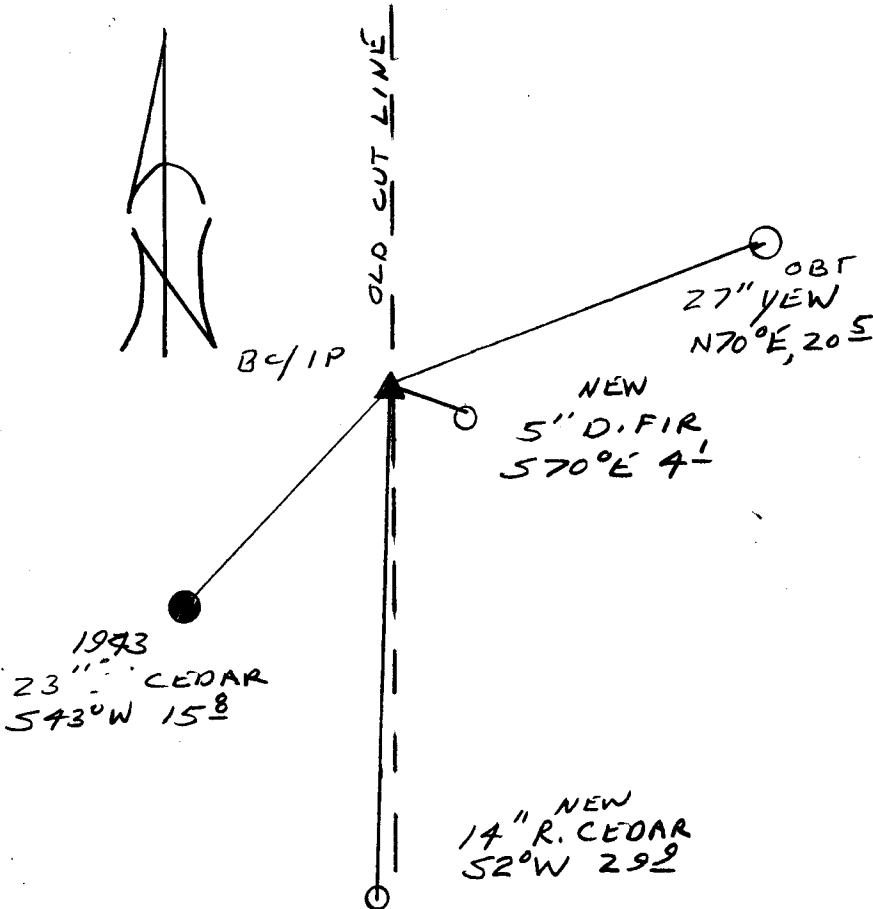
Sketch of Monument, Accessories, and General Area

1943 13.6M BC/IP IS STRAIGHTENED AND RESET AT A POSITION DETERMINED FROM BT'S AS NOTED ON FRONT. PROTRUDES 5" ABOVE GROUND THE MARKS "DCSO RESET 1998" ARE ADDED TO BRASS CAP.

14" R. CEDAR DOUBLE BLAZED AND SCRIBED "Y4524CS BT" BEARS S20°W 29.9 FT

5" DIA. D. FIR DOUBLE BLAZED AND SCRIBED "Y4S19CS BT" BEARS S70°E 4.1 FT
