Monument Set (Procedure and Description)

C092512A

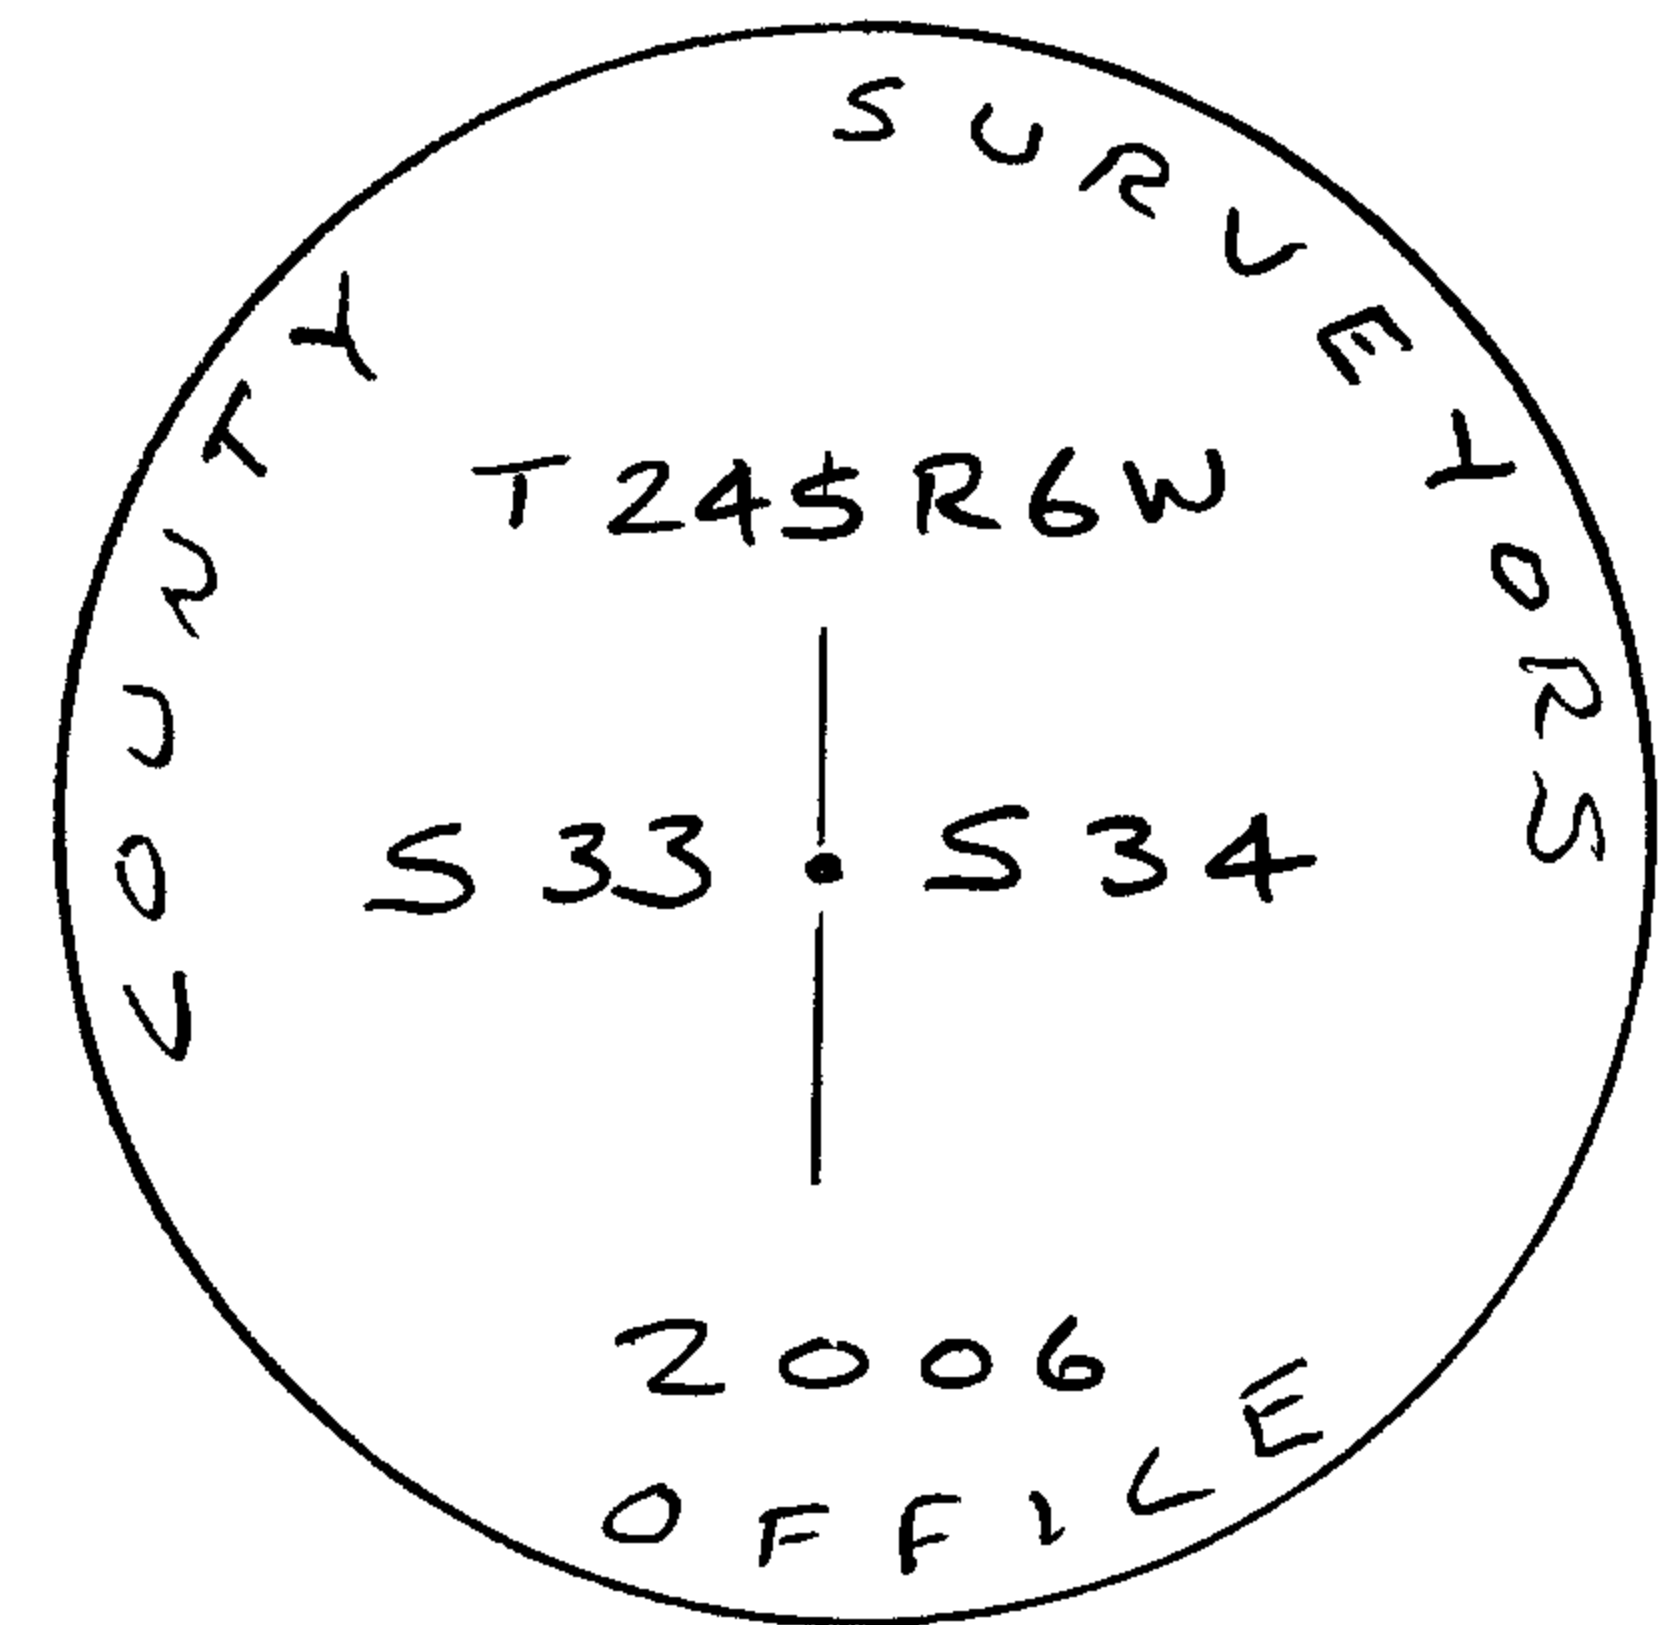
Monument Detail

2 1/2" B.C. (MARKED AS SHOWN) ON  
 1 1/4" O.D. IRON PIPE 30" IN LENGTH.  
 PROJECTS 8" ABOVE GROUND.  
 MONUMENT WAS RESET BY A DISTANCE-  
 DISTANCE INTERSECT FROM REMAINING  
 1969 ACCESSORIES. COULD NOT MATCH  
 RECORD BEARINGS TO 1969 ACCESSORIES  
 POSSIBLY DUE TO MAGNETIC ATTRACTION  
 OF FENCES AT CORNER POSITION.

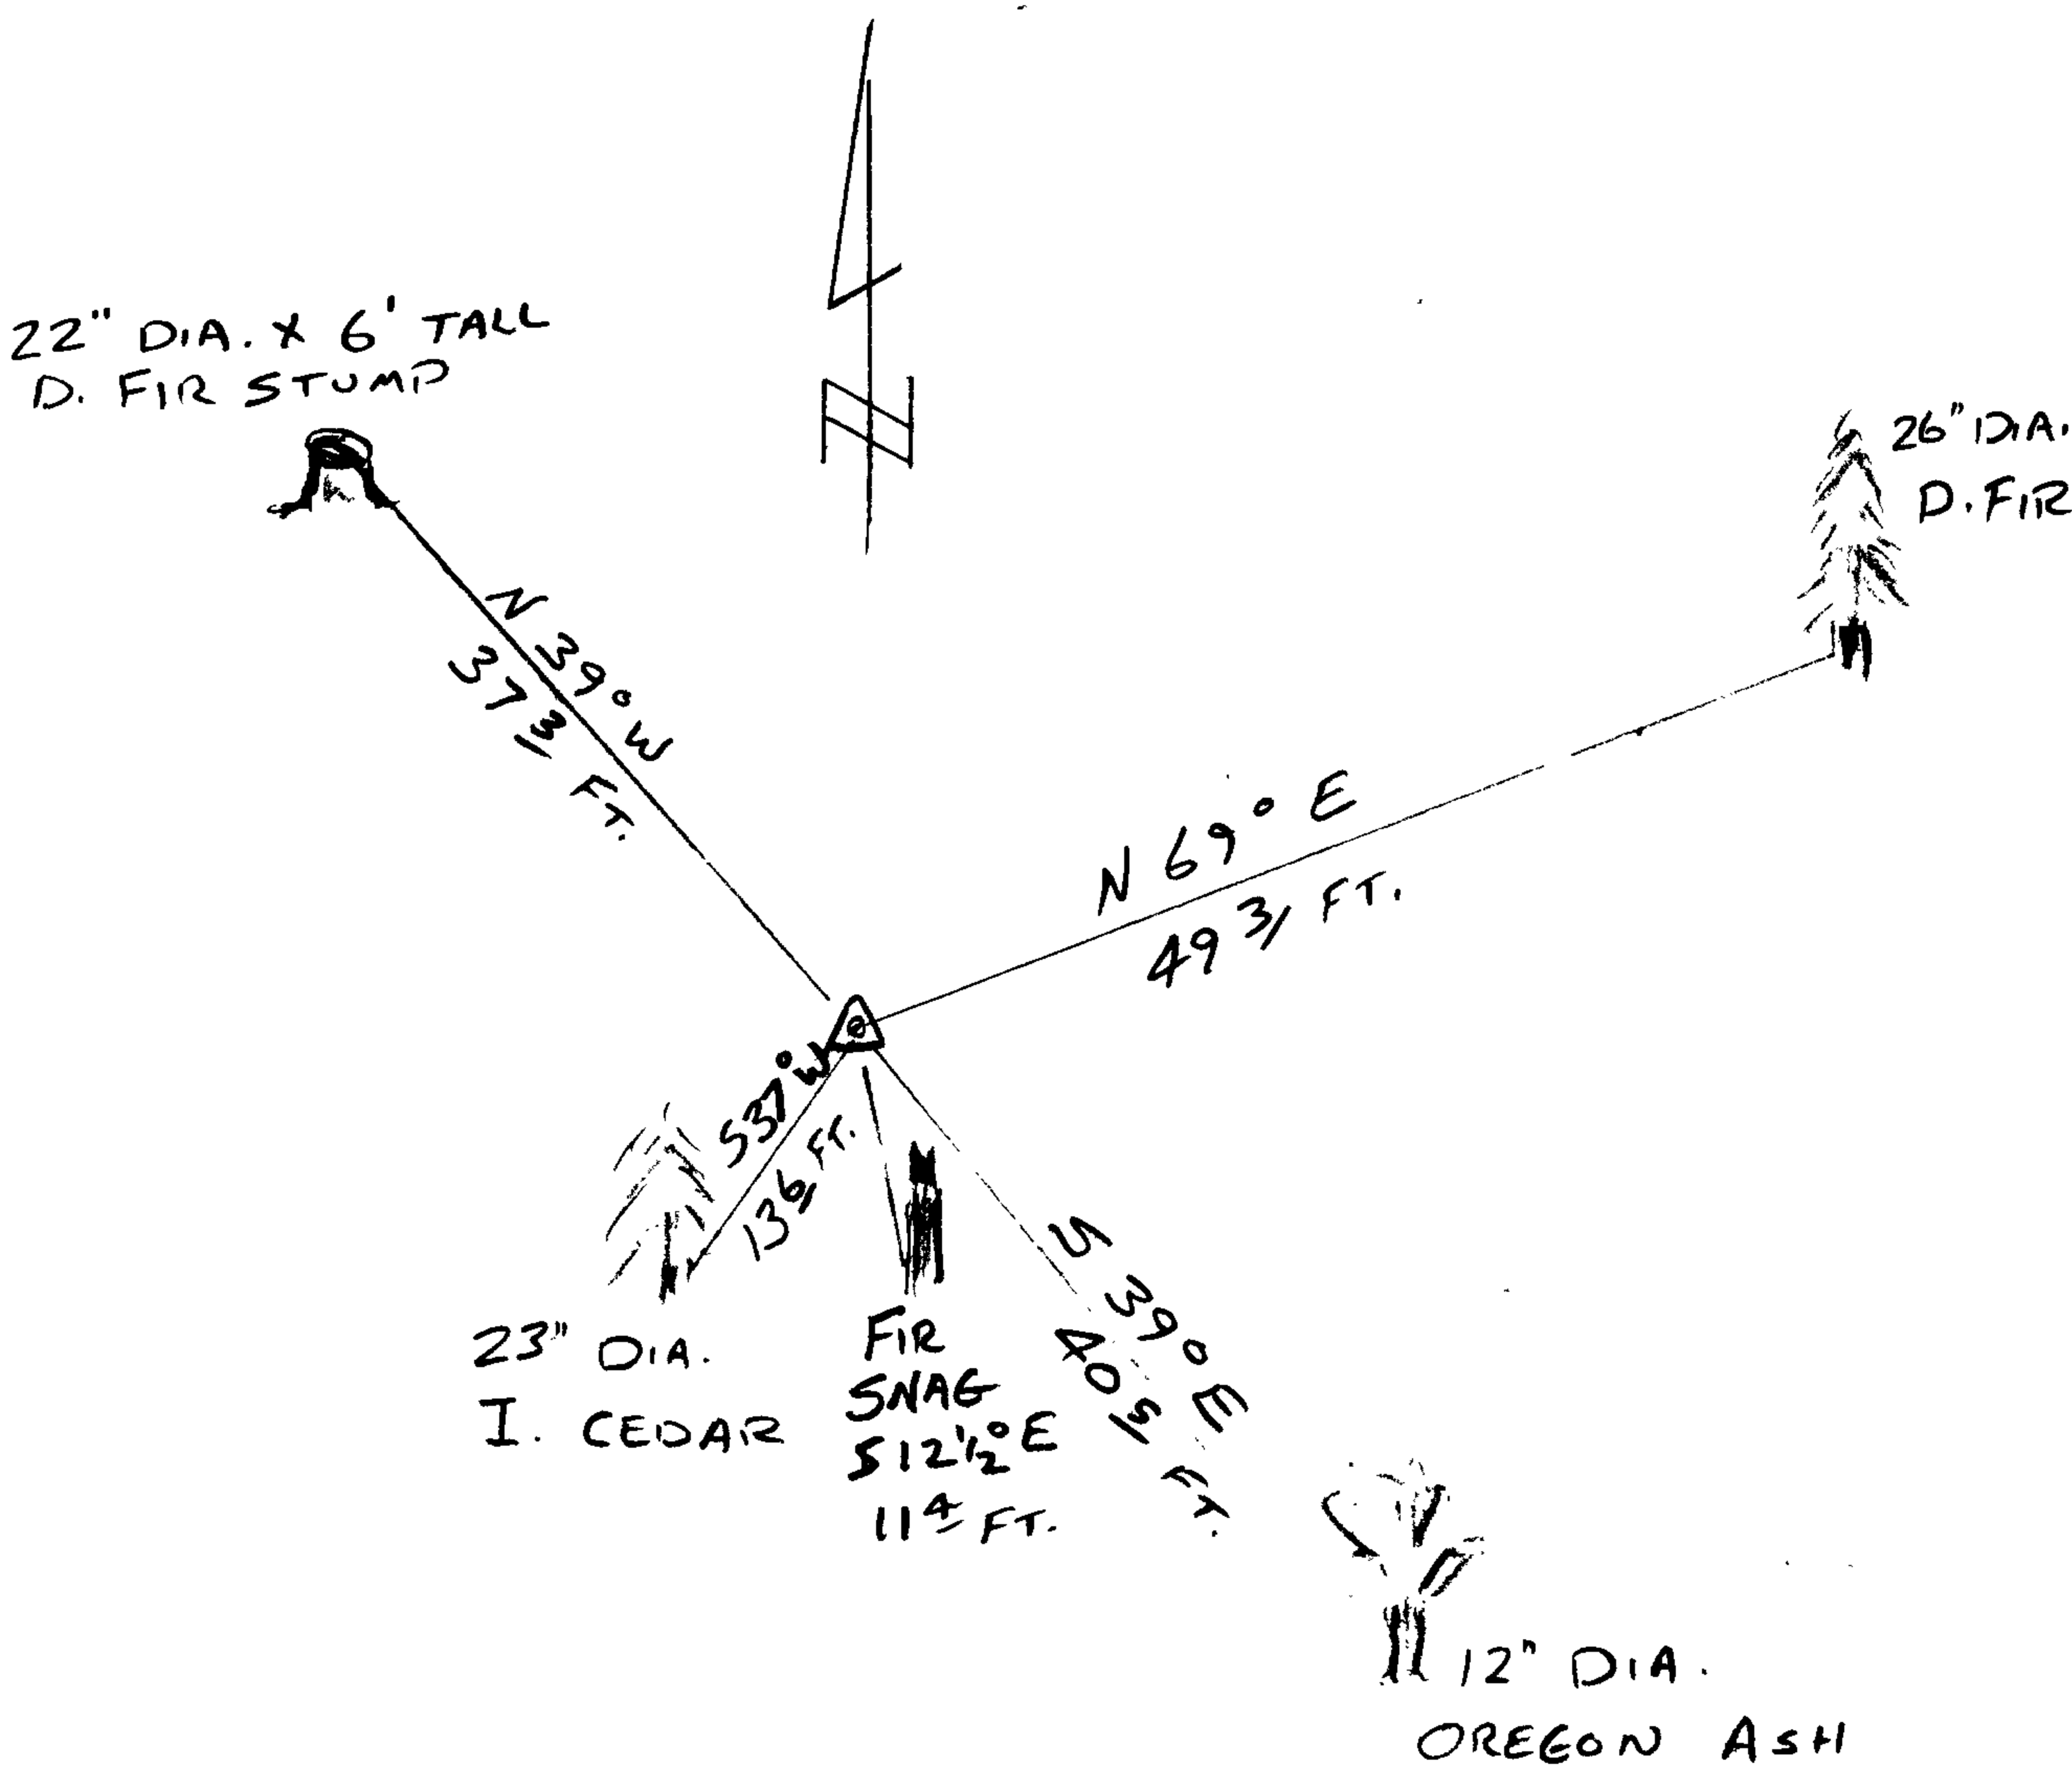
Sketch of Monument, Accessories, and General Area

APROX. 350 FT. SOUTHERLY OF  
 HWY 138 ON GENTLE NORTH  
 FACING SLOPE. APROX. 1.3  
 FT. NORTH OF DILAPIDATED  
 FENCE CORNER WITH FENCES  
 EXTENDING SOUTH & EAST
