# PUBLIC LAND CORNERS

WEYERHAEUSER TIMBER COMPANY  
 SPRINGFIELD BRANCH

TOWNSHIP \_\_\_\_\_ RANGE \_\_\_\_\_  
 SECTION 16 CORNER \_\_\_\_\_  
 COUNTY TOLLESON OREGON

## GLO SURVEY RECORD

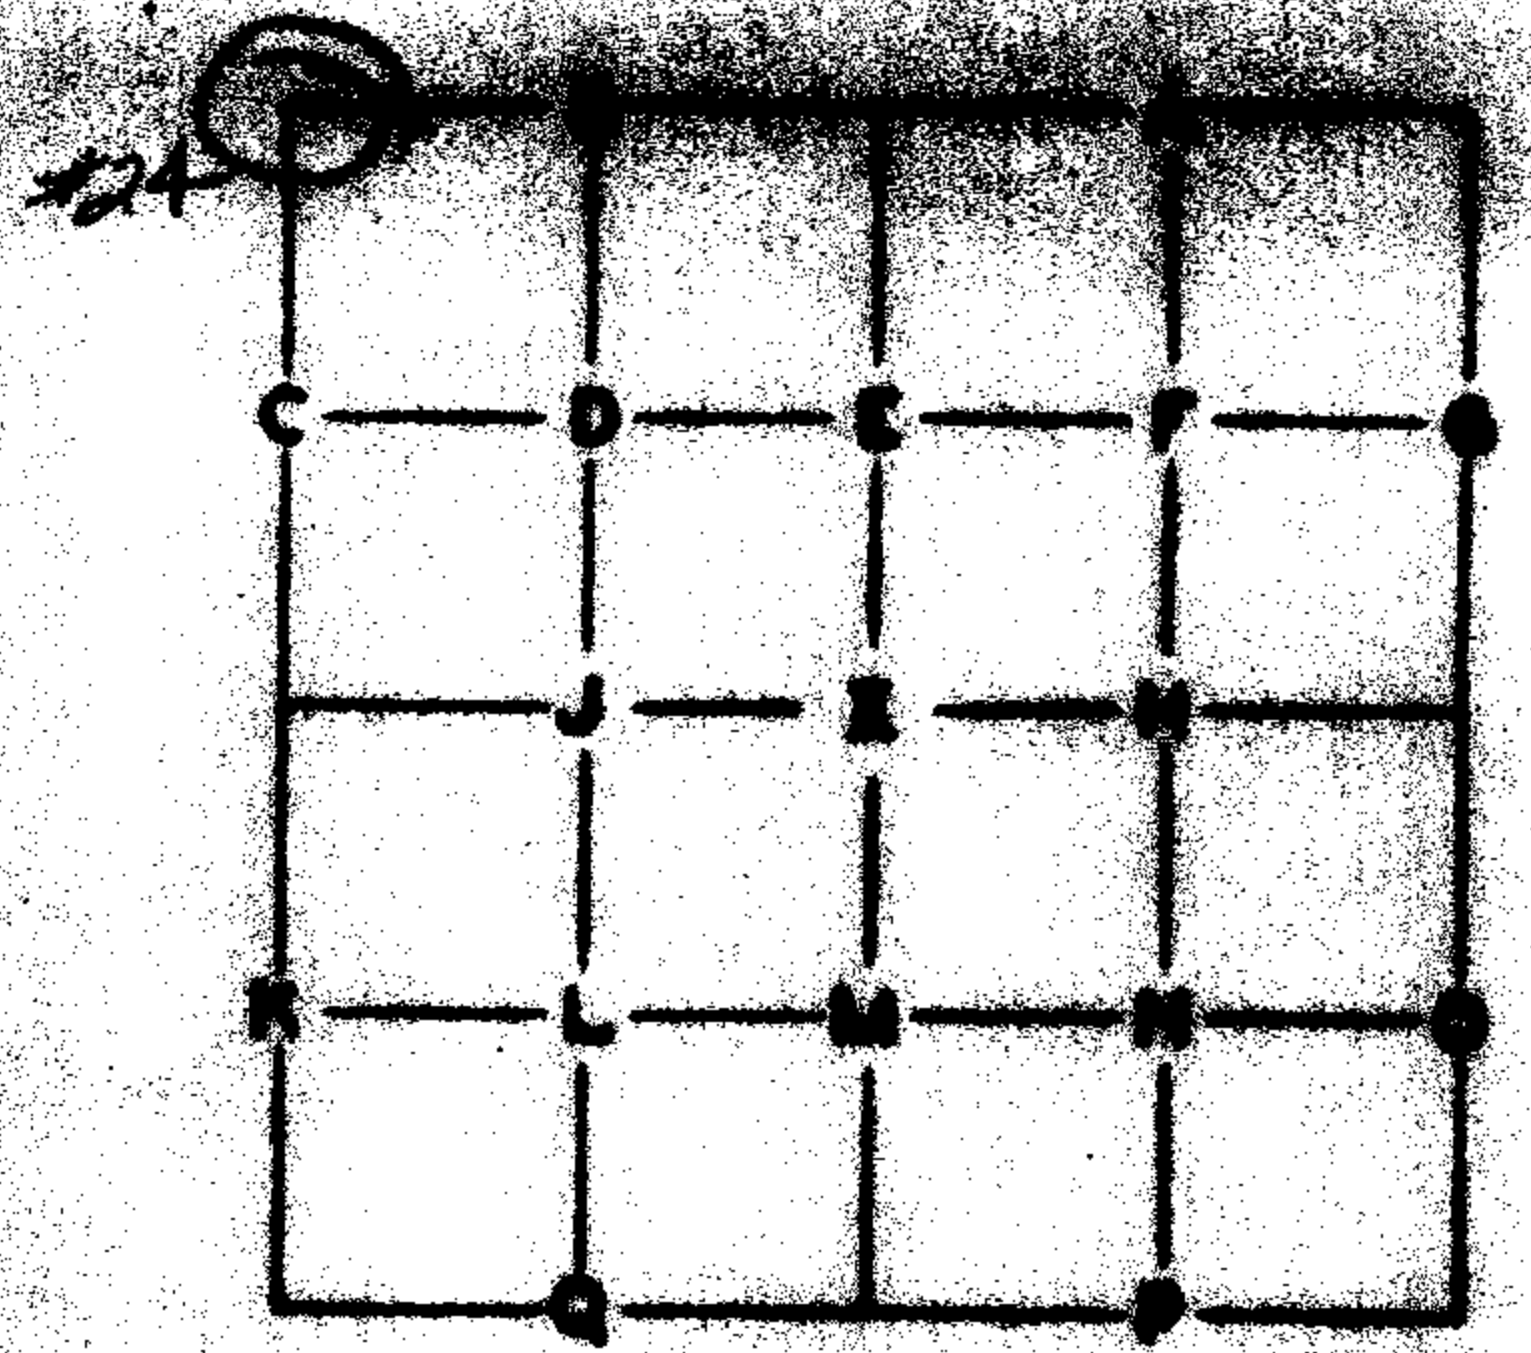
PRESENT CONDITION - (DESCRIBE FULLY)

BEARING-	LINKS-	REMARKS	
1" FIB	N 2° W	40		NO REMAINING EVIDENCE
8" FIB	S 88° W	44		NOW A 1" BLOWDOWN - SOME POINT ON FACE - EVIDENCE HAS BEEN CHIPPED OUT
2 1/2" FIB	N 55° E	50		NO REMAINING EVIDENCE
1 1/2" FIB	S 40° E	20		NOW AN 1 1/2" DIA SWAC - FACE IS CHIPPED OFF - EVIDENCE BEING PLAINLY VISIBLE

CORNER SET: 3/4" PIPE MAGNETIC DECLINATION: 20°

BEARING-	FEET-	REMARKS
S 88° W	37.0'	ORIGINAL BT - BLOWN DOWN - EVIDENCE ON FACE
S 40° E	13.6'	ORIGINAL BT - 1 1/2" DIA SWAC - SCREWMARK VISIBLE

BEARING -	FEET -	"W" NAIL -	PLATE -	BRASS DISC -
3" FIR STUMP			X	✓	
3" FIR NAIL			X	✓	
4" FIR			X	✓	
2" FIR			X	✓
