OFFICE OF THE
DOUGLAS COUNTY SURVEYOR

Station: OLA-6

VERTICAL CONTROL

DESCRIPTION and TO REACH

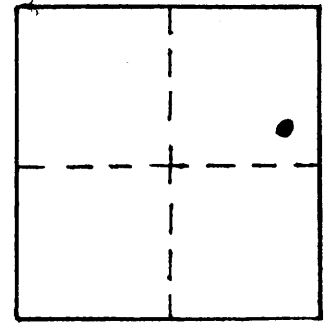
DCSO BRASS CAP IS SET IN NORTHWESTERLY CONCRETE
ABUTMENT WALL OF BRIDGE OVER OLALLA CREEK
STAMPED "OLA-6 1998"

FROM THE INTERSECTION OF OLALLA RD (CO. RD # 38) AND
HOOVER HILL RD (CO. RD # 125) IN T28S R7W SEC 37 PROCEED
SOUTHERLY ALONG OLALLA RD 0.85 MILES TO BRIDGE
AND MONUMENT ON RIGHT.
